CHARACTERISATION OF MORTAR DETERIORATION IN HISTORIC BUILDINGS IN BAGAMOYO, TANZANIA

Charles Lucian

Ardhi University (ARU), P.O. Box 351761, Dar es Salaam, Tanzania

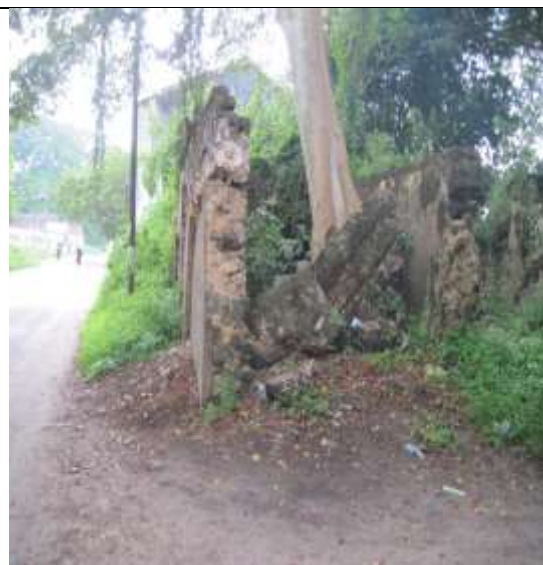
Due to years of deferred maintenance most historic buildings in Bagamoyo have suffered serious deterioration and lost their significant part of their heritage value. Some historic buildings have fallen completely into disrepair and eventually crumbled, collapsed or been abandoned (Figures 1 & 2). Over a period of time the action of weathering and erosion has eaten deep into the lime plaster and mortar progressively reducing it to powder in places. In certain cases the friable mortar has completely disintegrated into micro-particles leaving the lime-stones and coral stones completely loose. Close examination revealed that the real root cause of the disintegration in the masonry elements is the deteriorated mortar leaving the lime stones and coral stone physically intact but loose bound. It is from this fact that most physical and chemical tests were mostly directed on the mortars and little allusion was paid to the walling materials.

Figure 1: Total collapse of Building (Walls)

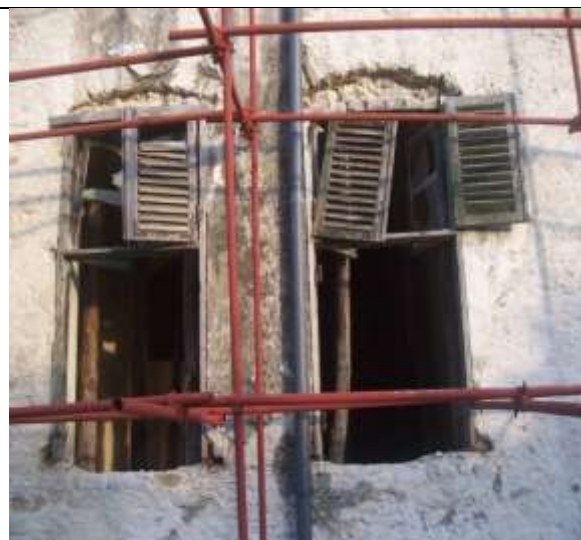
Figure 2: Deteriorated Windows

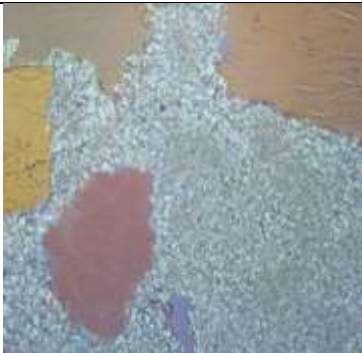
The mortars of the first group are light grey, dense, with good adhesion to the building stones, and good moisture resistance. These mortars often display high contents of shell pieces with elongated morphology or spherical in outline. Lime inclusions and traces of small pieces of charcoal fragments also were observed. The matrix of the hard mortar is characterised by fine-grained, homogeneous, cohesive binder of carbonated lime with shrinkage cracks and fragments of original limestone features. A low abundance of charcoal particles are observed homogeneously and sparsely distributed throughout the matrix. These charcoal fragments are remnants from the wood used to incinerate the limestone. The intimate contact and bond between charcoal particles and mortar are strong. Furthermore, fine discontinuous polygonal micro-cracks were found throughout the matrix in moderate abundance (Figure 3).

Figure 3: Hard mortar - good adhesion	Figure 4: Moderate hard mortar- moderate adhesion	Figure 5: Soft and friable mortar – poor adhesion

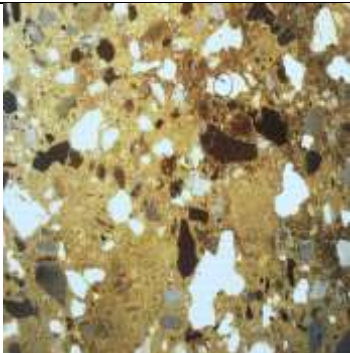
The mortars of the second group are light brown, characterised by porous lighter lime inclusions and charcoal particles. These mortars are dense but relatively soft with moderate adhesion and poor moisture resistance (Figure 4). The third group mortars are light yellowish brown, soft and friable, with very poor adhesion and moisture resistance. These mortars crumble easily, exhibit very low mechanical strengths and bonding characteristics and contain charcoal particles, soil lumps and inclusions of limestone fragments (Figure 5).

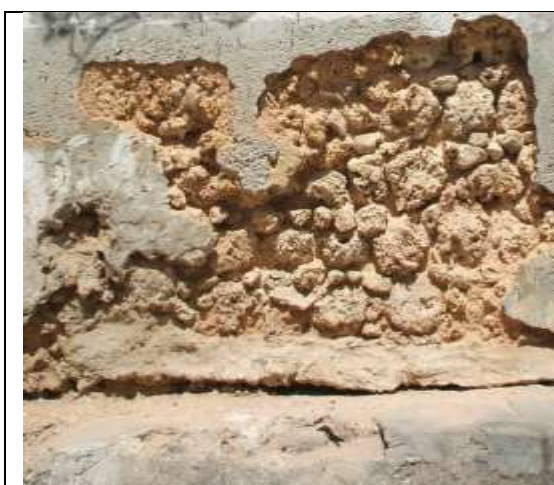
Figure 6:Peeling off plaster as a result of the use of soft and friable mortar

The condition of masonry structure to a certain extent varied depending on the type of mortar used. For example it was easy to conclude that the mortar used in Figure 6 is hard mortar as the peeling off of limestone material was not severe compared to that shown in figure 7. However the more severe damages were observed where a soft and friable mortar was noted. Generally different type of mortar used for the Bagamoyo Building heritage sites provide a key reason for the deterioration of masonry elements in some building and structures.

As it has been revealed by this study, the primary cause of the problem is neglected badly eroded mortar joints to external masonry that were allowing excessive water into the wall. The badly deteriorated mortar will need special repair known as pointing. Repointing refers to the process of removing deteriorating mortar from the joints of a masonry wall and replacing it with new mortar. Pointing involves both top-down process and bottom-up process. Joints should always be thoroughly cleaned of old mortar from top to bottom after wetting the wall, and pointing should be carried out from the bottom to up to take account of the effects of gravity. Old mortar should generally be raked out to a minimum depth of 2 to 2.5 times the joint width to prevent damage to the masonry units. Where the old mortar has been removed to a depth greater than 2 to 2.5 times the joint width, the deeper areas should be filled in layers and properly compacted and allowed to harden first. All of the old mortar should not be removed from a wall at once but working along the wall in small sections.

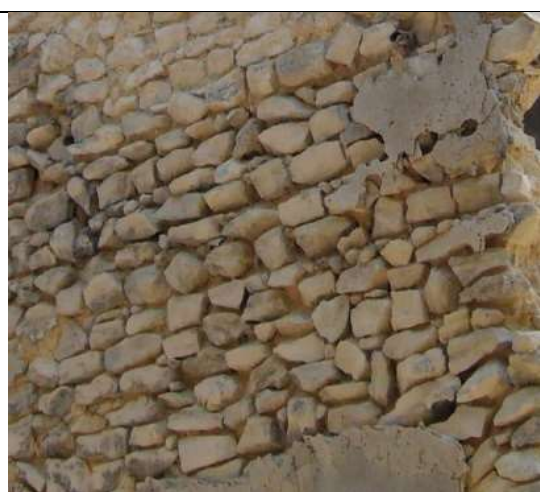
Figure 7: Deteriorated joint mortars resulting from soft and friable mortar

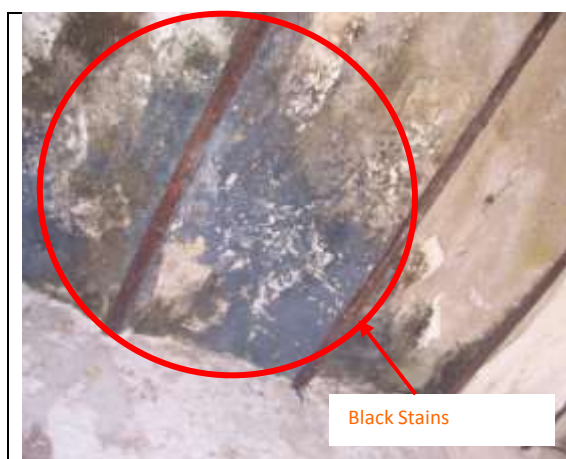
Further inspections found out that rain water ingress through friable mortar and condensation have caused development of black mould, bands of discolouration and fungal growth on the walls and slabs.

Figure 8: Condensation and black mould and stains growth on the walls

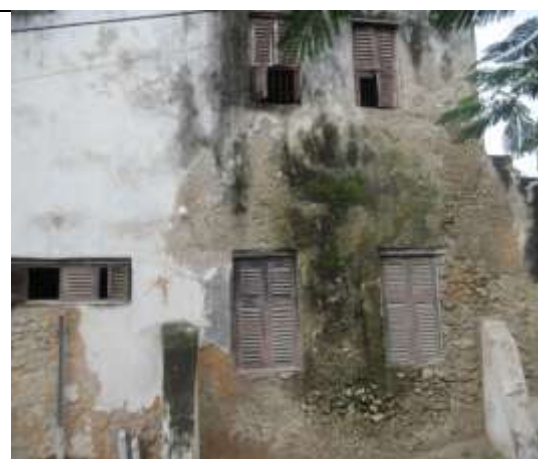
The water vapour permeability and absorbency depend on the porosity of the material. Porous Building materials have high absorption capacity that can absorb quite a large amount of water from rain, groundwater leaks and floods, capillary action, air leakage or diffusion. Once enough water has been absorbed into the walling materials it becomes imperative to get it back out. It will usually saturate building assemblies and provide the potential for large amounts of moisture accumulation that can overwhelm their ability to dry out. As a result mortar may crumble, condensations and stains may appear on the walls and slabs (Figure 8). However most of the effects on building structures of environmental agents are linked to neglect and abandonment thus exposing masonry elements to the adverse impacts of environmental agents. For example Figure 9 the growth of fungi on the walls is a result of exposure rather than differences in mortar or construction material.

Figure 9: Fungi Attach on the Walls of Old Fort resulting from exposure to environmental agents
