DIAGNOSIS OF PUMP PROBLEMS USING VIBRATION ANALYSIS

Sami A. A. El-Shaikh

Mechanical and Electrical Research Institute, National Water Research Center, Ministry of Water Resources and Irrigation, Delta Barrage, Egypt.

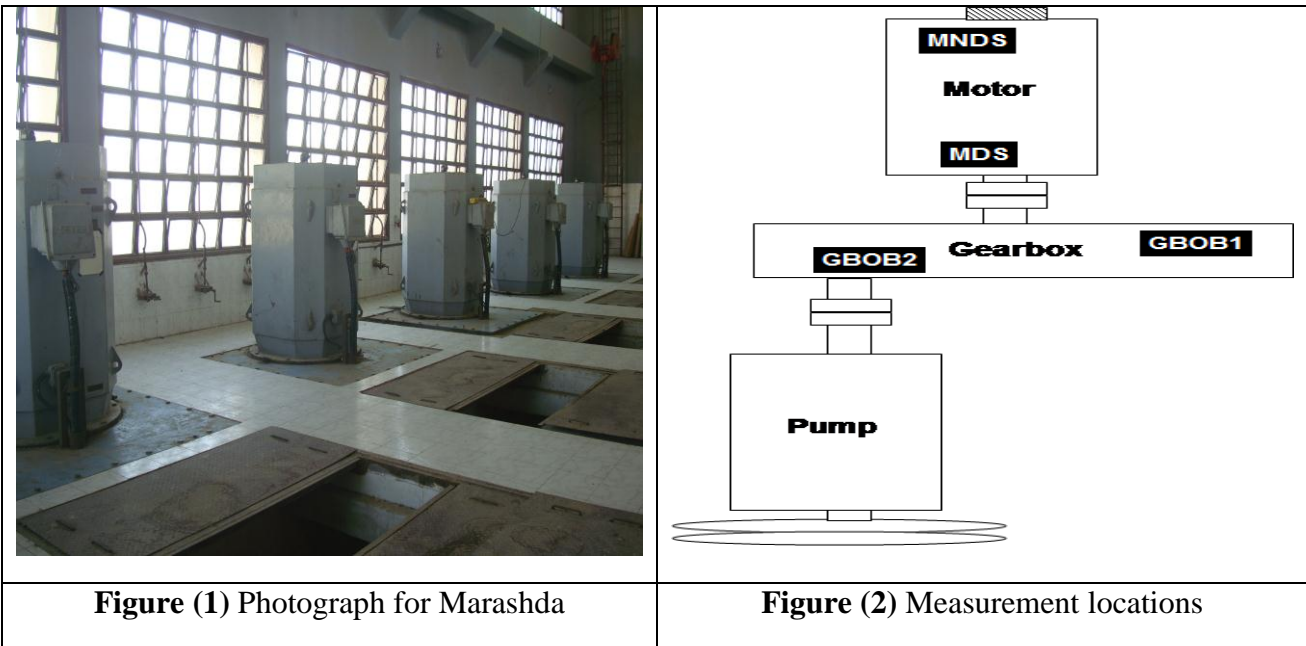
Figure (1) Photograph for Marashda

In this study, mechanical problems of Marashda (1) Pumping Station are assessed. Marashda (1) Pumping Station was constructed in 1994 to serve an irrigation area of 500 feddans in Nagaa Hamadi Area in Upper Egypt. It consists of 5 pump units as shown in **Figure (1)**. Each pump unit is of discharge 2.2 m³/sec, head 12 m, pump speed 598 rpm, motor power 456 kW, motor speed 1483 rpm, and gearbox ratio 62/25 (2.48), number of drive Gear teeth is 25, number of driven Gear teeth is 62, and rated output power is 430 KW. Vibration Severity Criteria, **(ISO 10816) 1995**, is shown in **Figure (3)** for velocity. Results of acceleration were compared with Reservoir and Grand Barrage Sector Standard, RGSB (2005) shown in **Table (1)**. Frequency analysis was done at low and high frequency to define the exciting frequencies and determine the level of vibration at each specific frequency, to determine the sources of vibration, to control vibration levels, and to solve vibration problems. Then, measurements were repeated twice after maintenance and adding supports to motor foundation with load and no load conditions to fix the high vibration level problem.

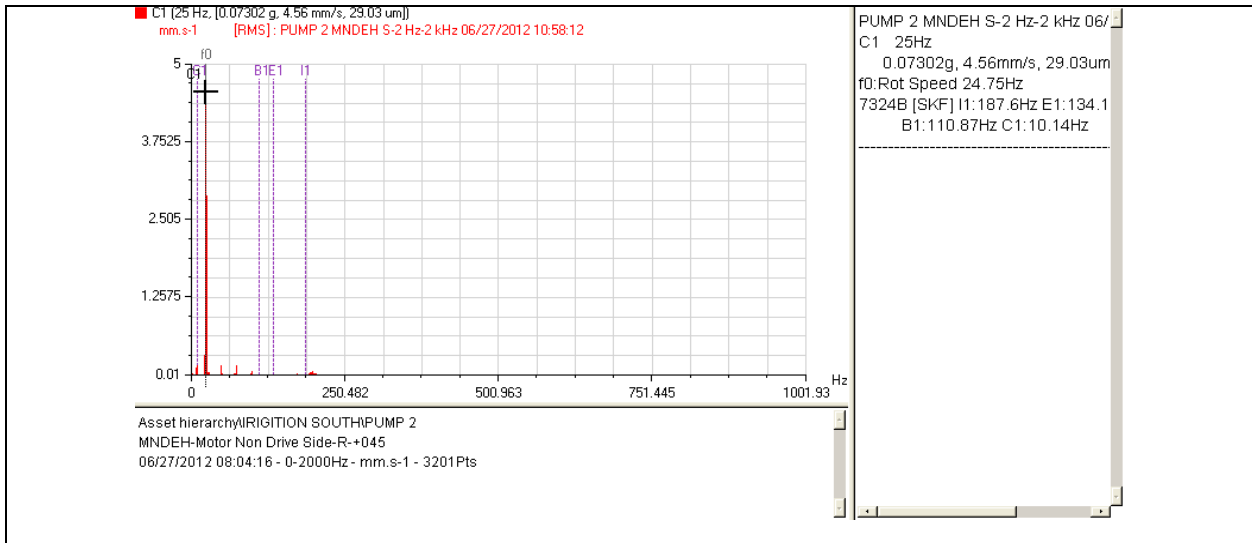
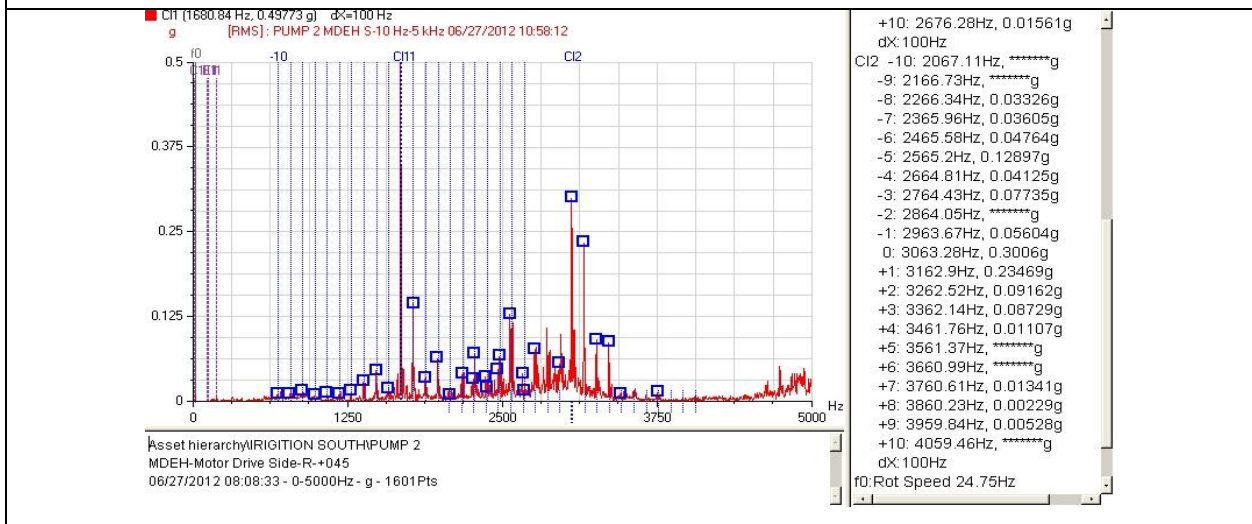
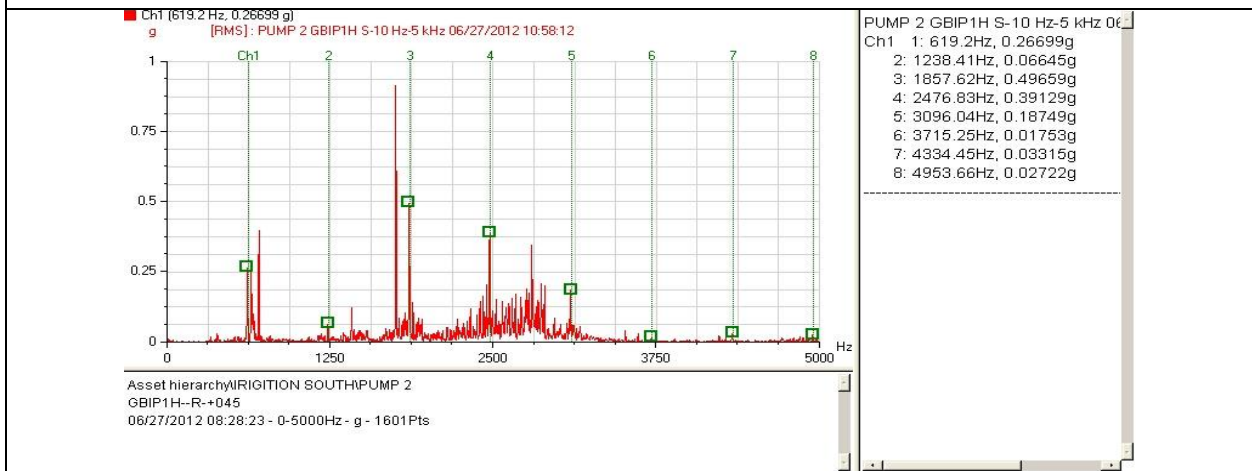
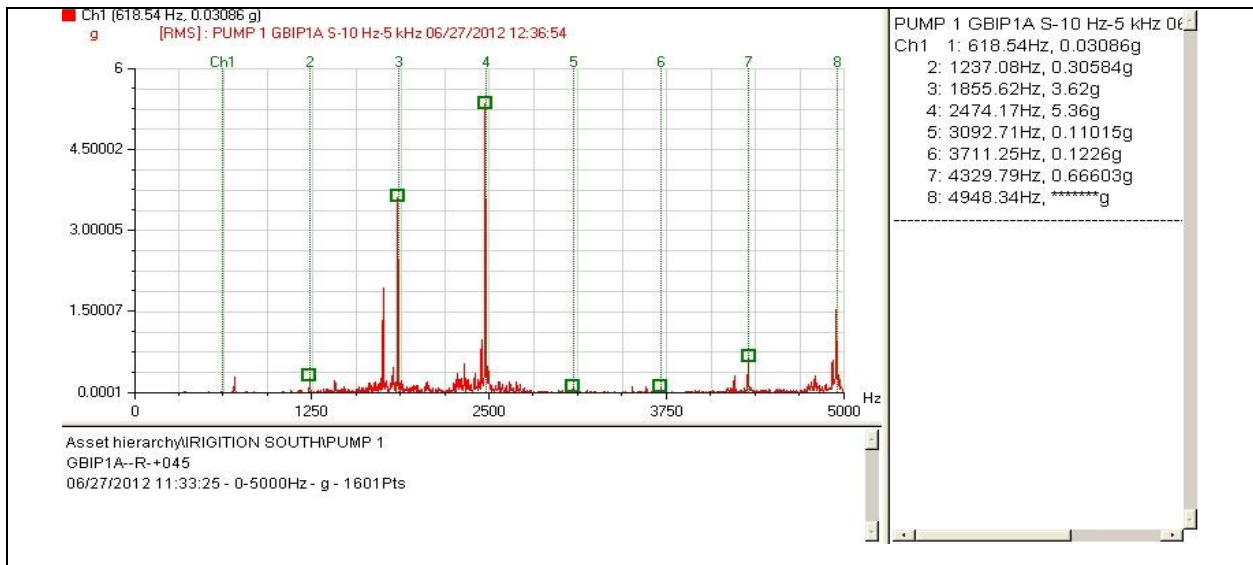
Fig. (4) Frequency analyses at full load on the motor and gearbox

Frequency analysis was done at low and high frequency to define the exciting frequencies and determine the level of vibration at each specific frequency, to determine the sources of vibration, to control vibration levels, and to solve vibration problems. Results of frequency analysis showed that there is motor unbalance problem as shown in **Figures (4-a, and 4-b)**. Also, the gearbox vibration measurement at motor side showed a problem in the gear teeth caused by misalignment as shown in **Figures (4-c and 4-d)**. Also, the gearbox vibration measurement at pump side showed a looseness problem in the gears as shown in **Figures (4-e, and 4-f)**

(a) motor non drive side horizontal

(b) motor drive side horizontal

(c) Gear Box motor side horizontal

(d) Gear Box motor side Axial

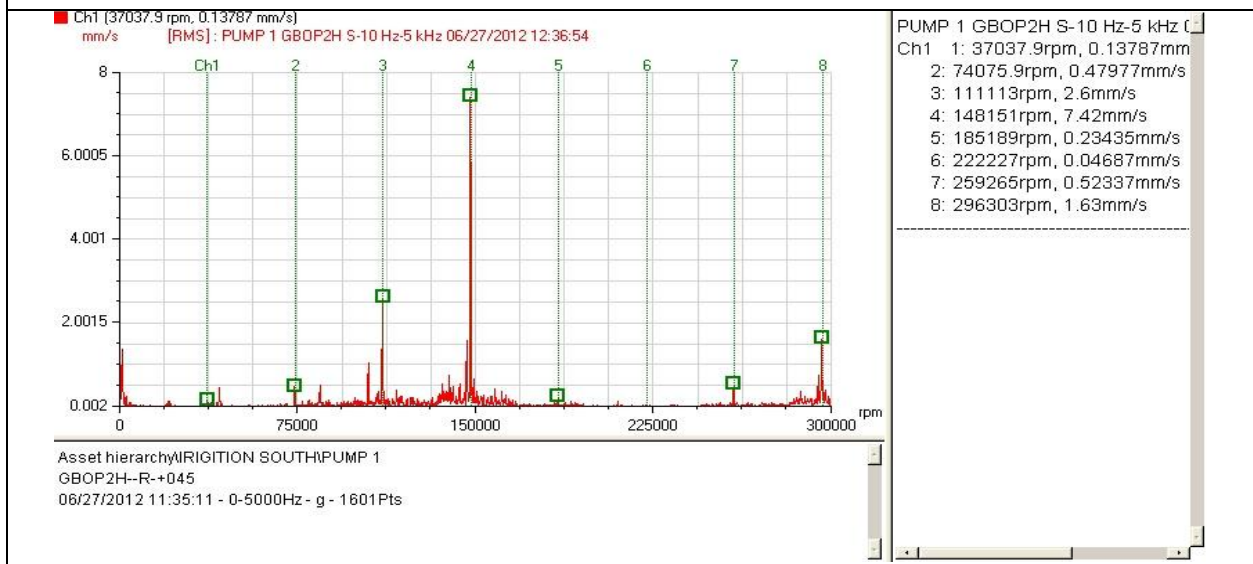
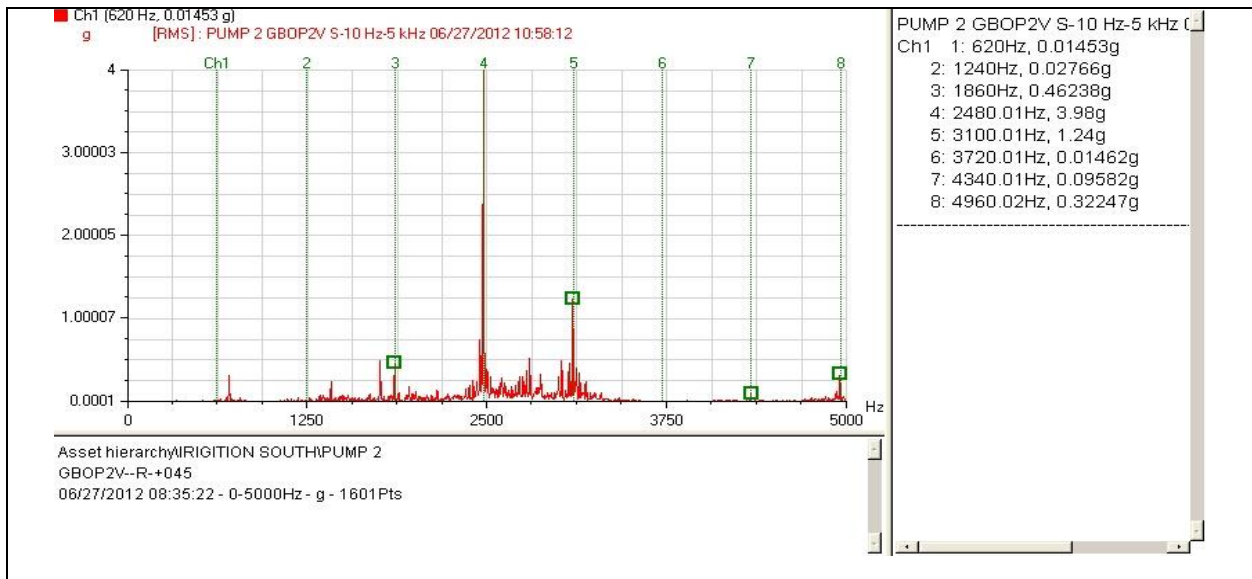
(e) Gear Box pump side horizontal

(f) Gear Box pump side vertical

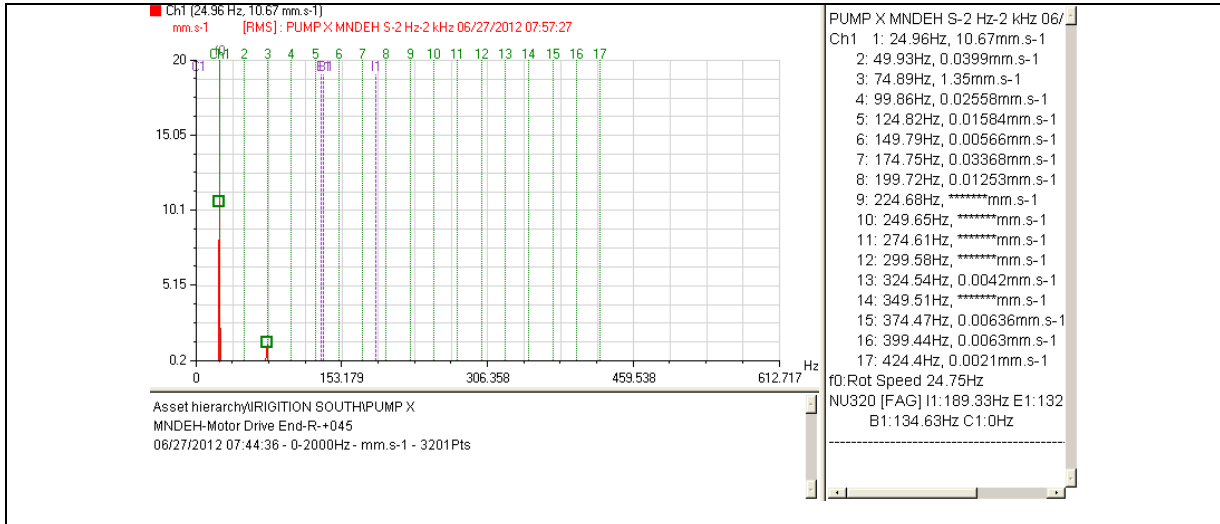
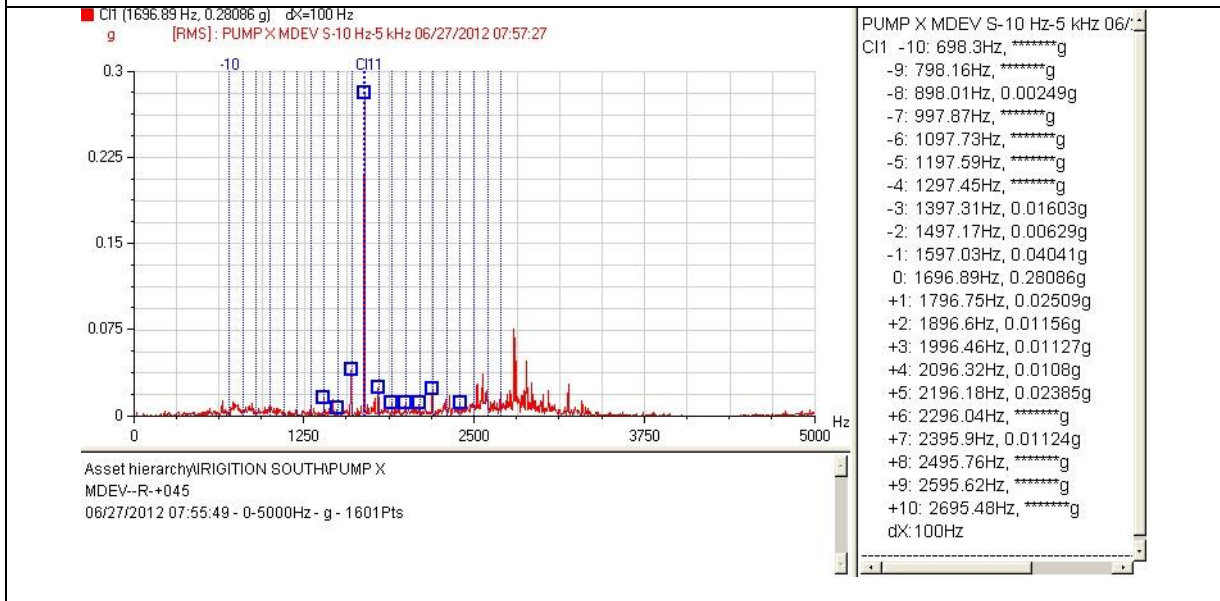
Fig. (5) Frequency analyses at no load on the motor

Results of frequency analyses that were done at the motor show that the motor misalignment problem and resonance problems could be caused by weight of the electric motor, as shown in **Figures (5-a, and 5-b)**.

(a) : motor non drive side horizontal MNDSH

(b) : motor drive side vertical MNDSV

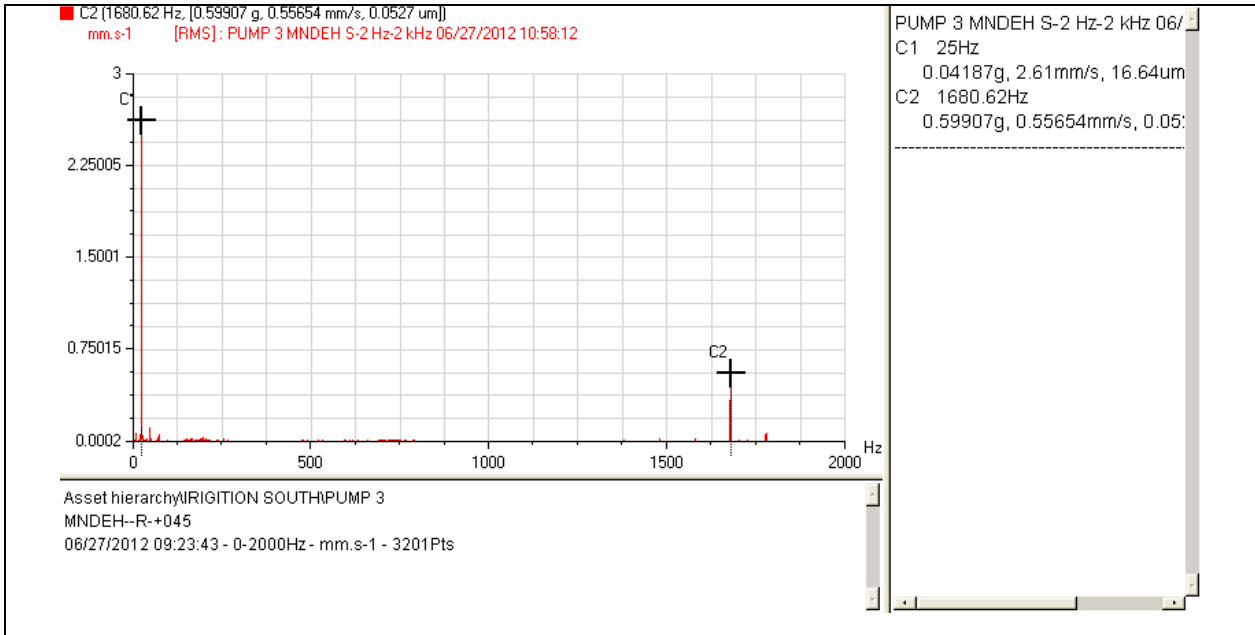
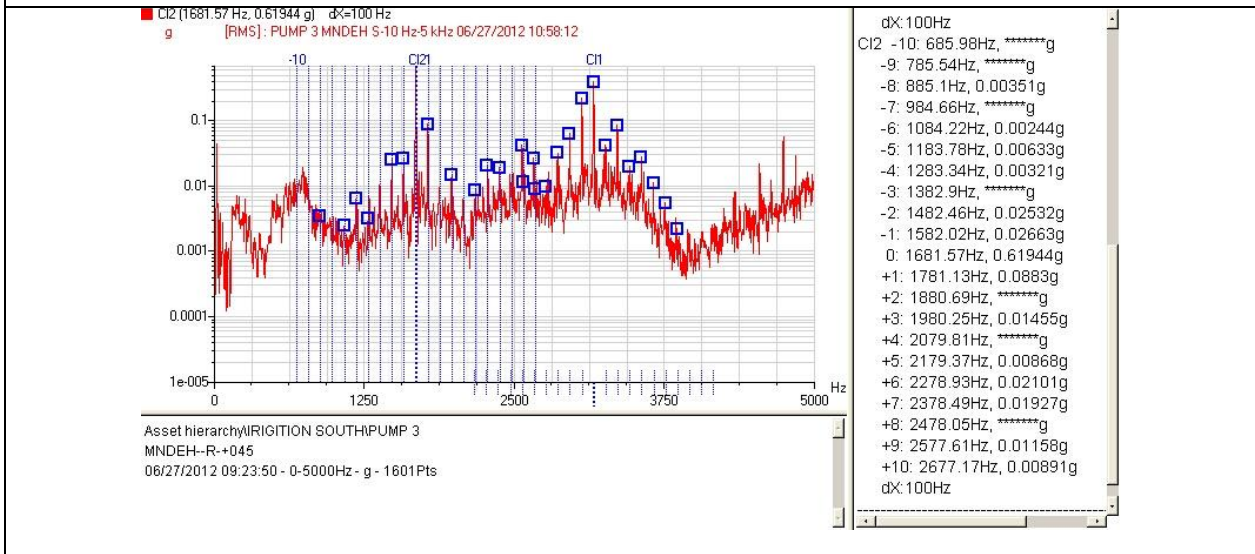
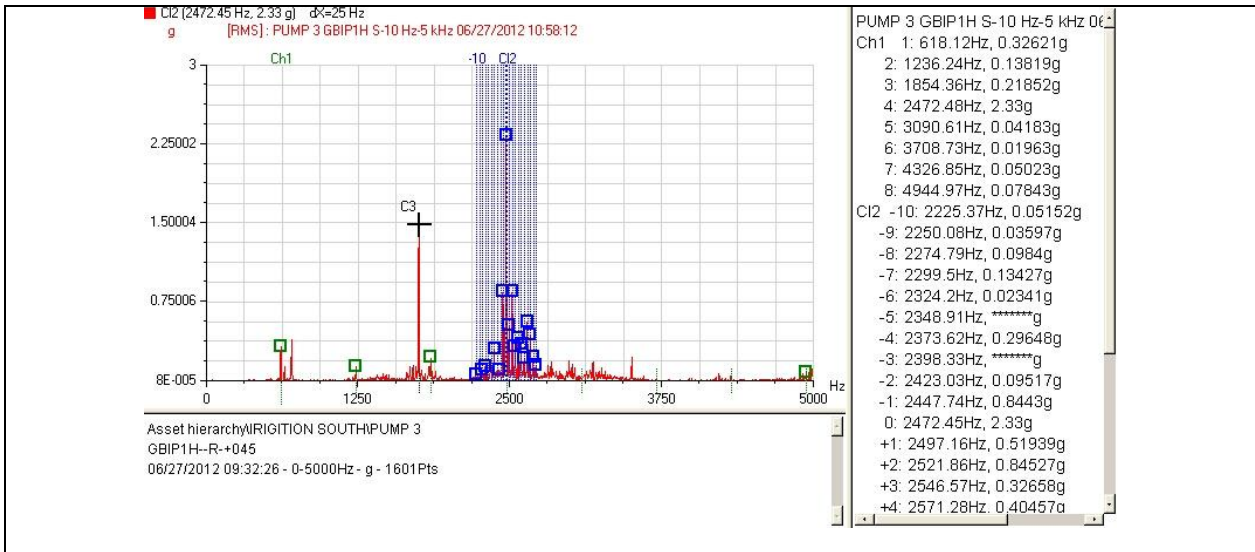
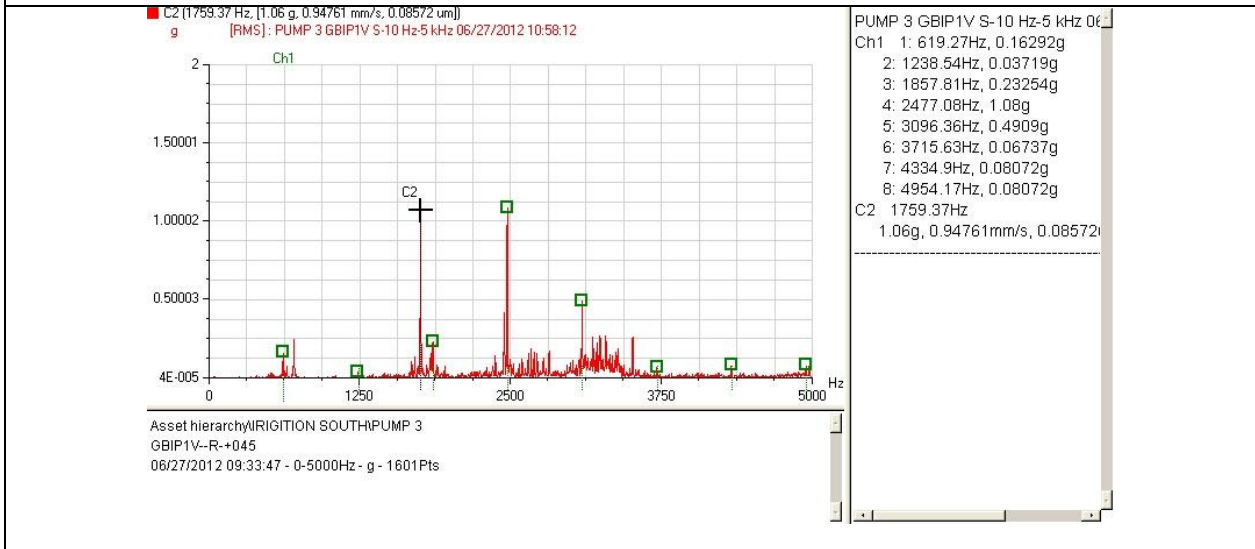
Fig. (6) Frequency analyses at full load on the motor and gearbox

From frequency analyses, there is frequency equal frequency clutch (GUF) at rotating speed and its harmonics reached to 6.66 mm /sec as shown in **Figures (6-a, 6-b, 6-c, and 6-d)**. Also, resonance problem was still found, but less than the previous, as shown in **Figure (5-a)**.

(a) motor non drive side horizontal

(b) motor drive side horizontal

(c) Gear Box motor side horizontal

(d) Gear Box motor side Axial

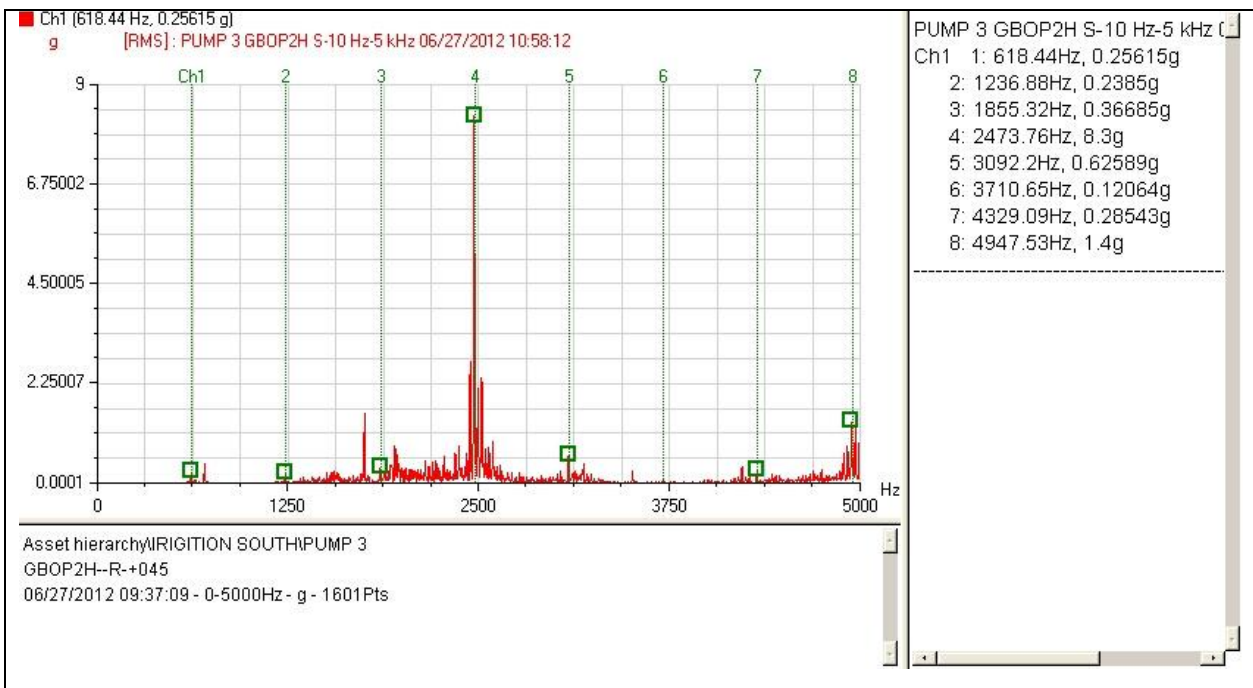
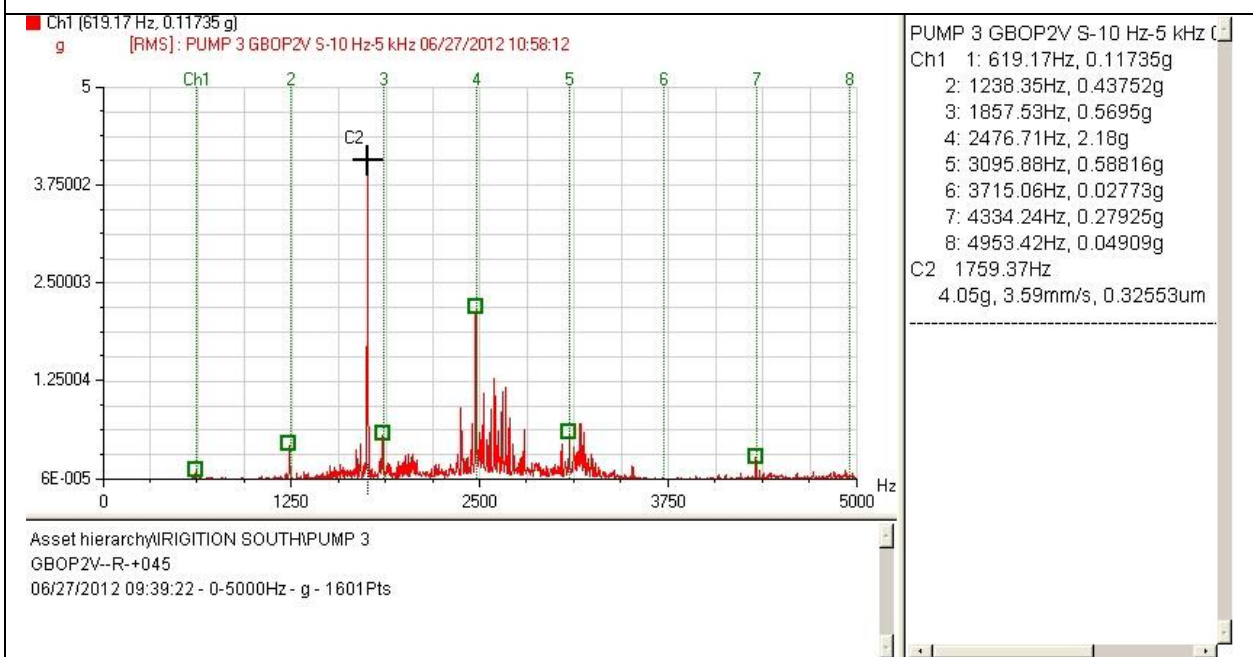
Clutch frequency values appear in the gearbox pump side in the case of full load, which indicates unbalance problem in the axial direction according to incorrect putting steel foundation under the motor over the base of concrete, as shown in **Figures (6-e and 6-f)**.

(e) Gear Box pump side horizontal

(f) Gear Box pump side vertical

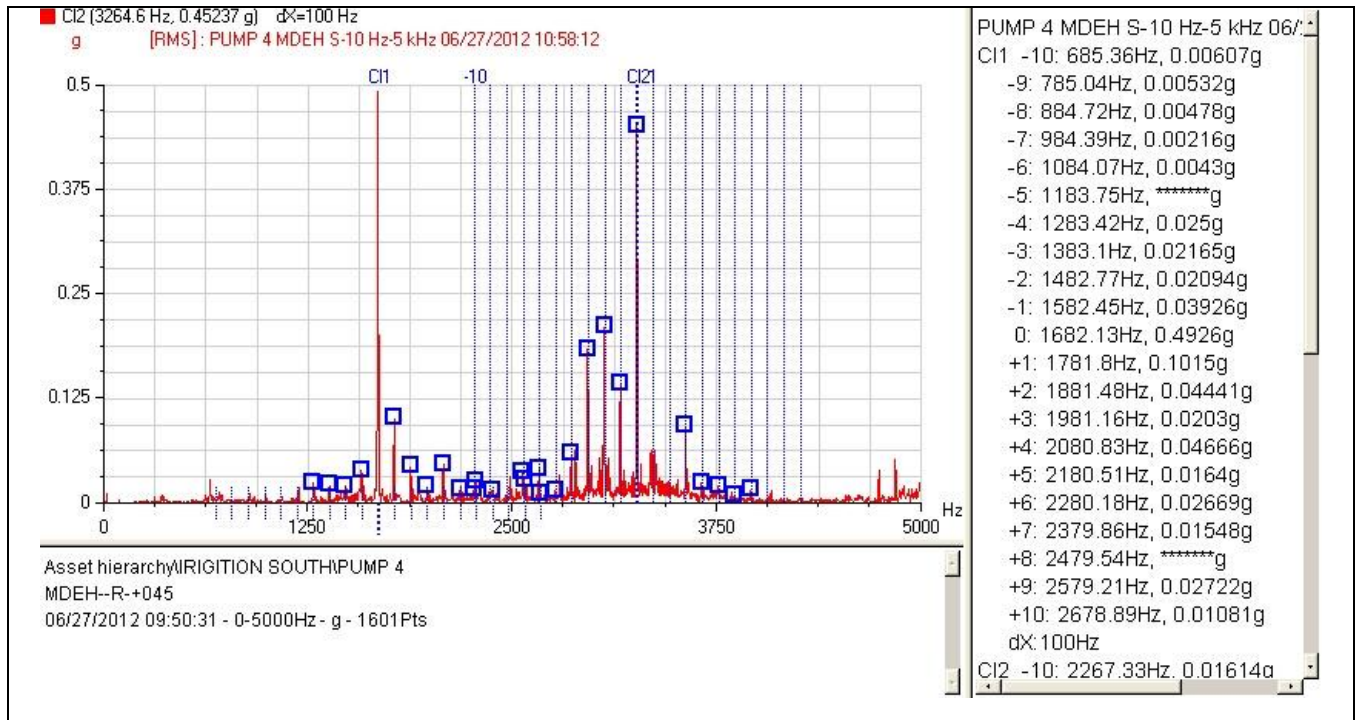
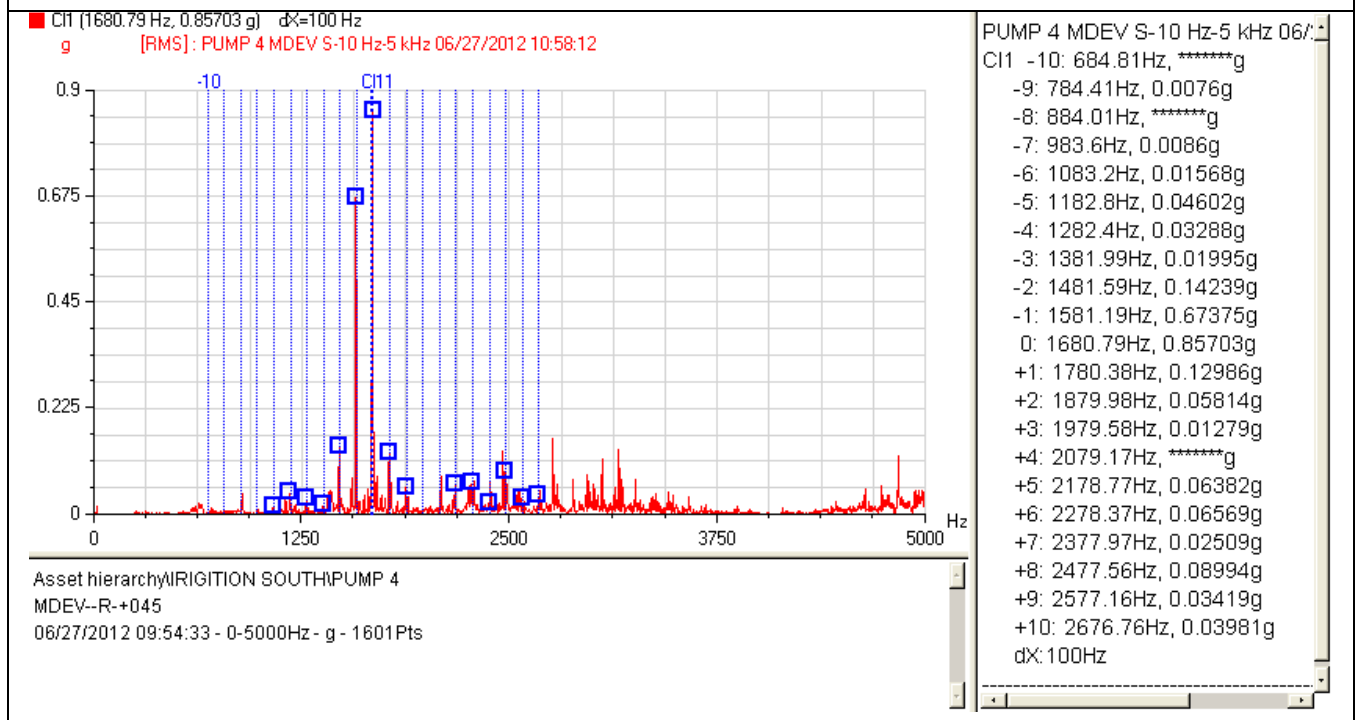
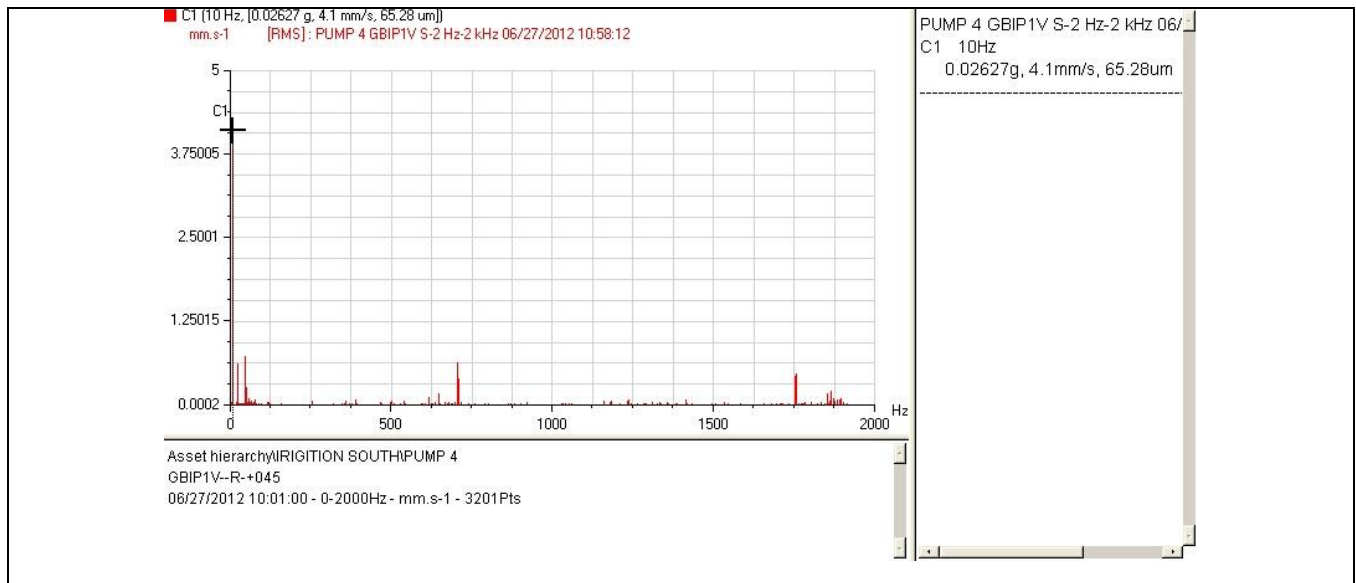
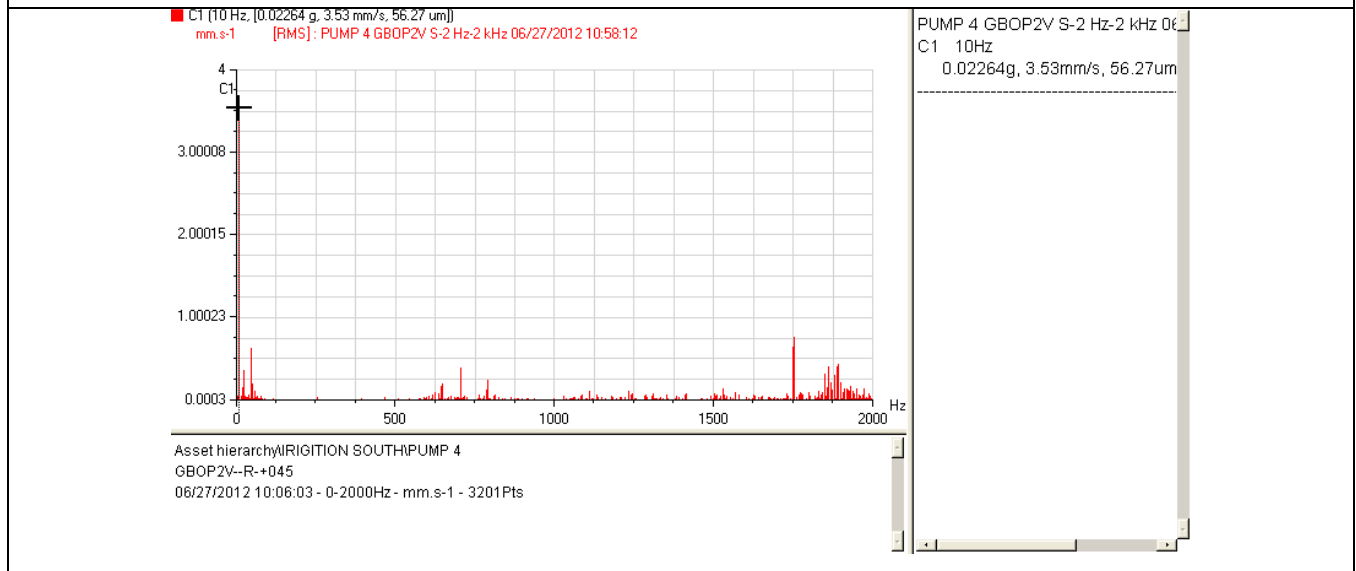
Fig. (8) Frequency analyses at full load on the motor and gearbox after increasing supports

After increasing steel supports to motor foundation stronger than the previous and adding iron base under the motor foundation so, it become hardness then vibrations decreased on the motor where it reached to 1.29 mm/sec and 1.1 mm/sec respectively, as shown in **Figures (8-a and 8-b)**. Also resonance problems disappeared and also frequency clutch and its harmonics were disappeared, as shown in **Figures (8-c and 8-d)**.

(a) motor non drive side horizontal

(b) motor drive side horizontal

(c) Gear Box pump side horizontal

(d) Gear Box pump side vertical
