EXPERIMENTAL INVESTIGATION AND FINITE ELEMENT ANALYSIS FOR SOLVING VERTICAL PUMPS STRUCTURAL WEAKNESS

Sami A. A. El-Shaikh

Mechanical & Electrical Research Institute, National Water Research Center, Ministry of Water Resources & Irrigation, Delta Barrage, Egypt

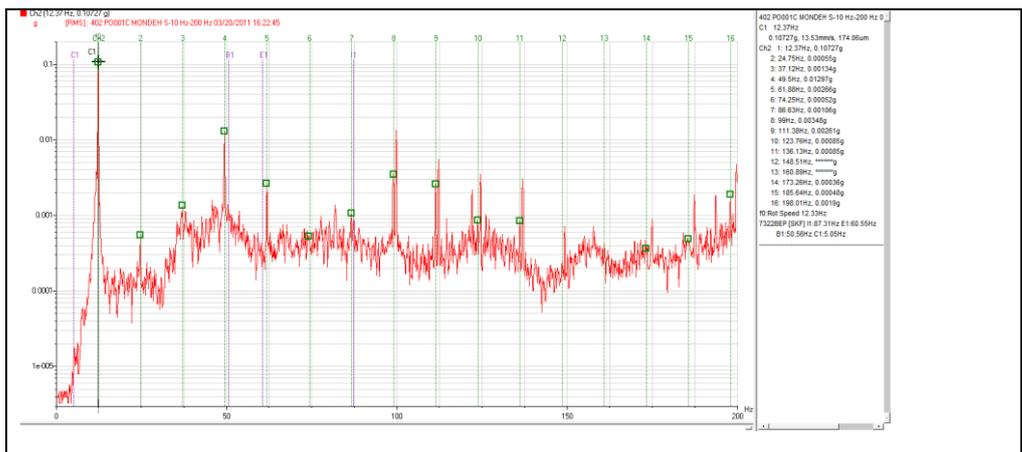
Frequency Analysis was done to determine high frequencies for each element in the pump system, and to determine problem at any frequencies. Frequency spectrum analysis indicated that there are vibration peaks at motor running speed 1x (12.4Hz) and its harmonics in the vertical and horizontal directions. It is obviously noticed that the maximum vibration amplitude reached 13.5 mm/sec at 12.5 Hz as shown in Figure (6-a), its harmonics as shown in Figure (6-b), and peaks with high amplitude at low frequency as shown in Figure (6-c). These high levels of vibration are in the not permissible zone of ISO 10816-3 indicating a resonance problem. It is not safe and dangerous to operate at this condition. The cause of this problem is due to the foundation weakness.

Figure (6-a) “FFT Domain for MNDEH“

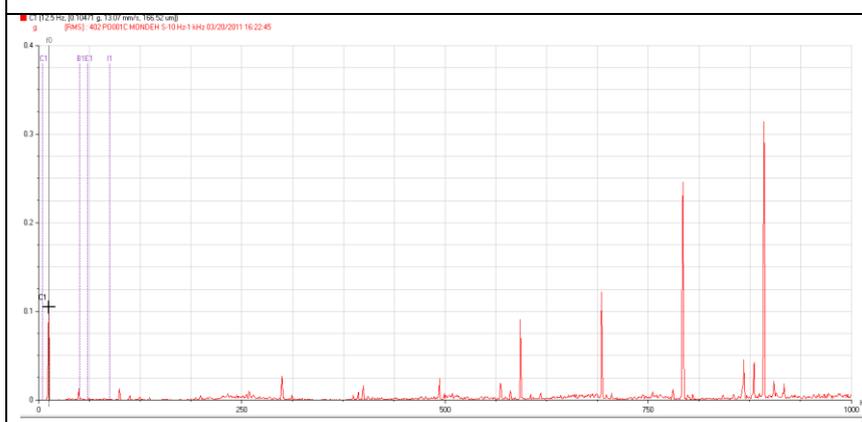
Figure (6-b) “FFT Harmonic for Resonance at MNDEH“

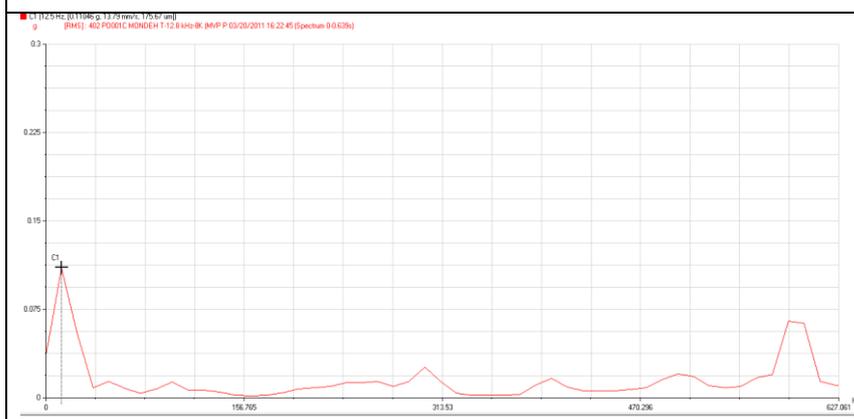
Figure (6-c) “Time domain for Peak at low frequency at MNDEH“

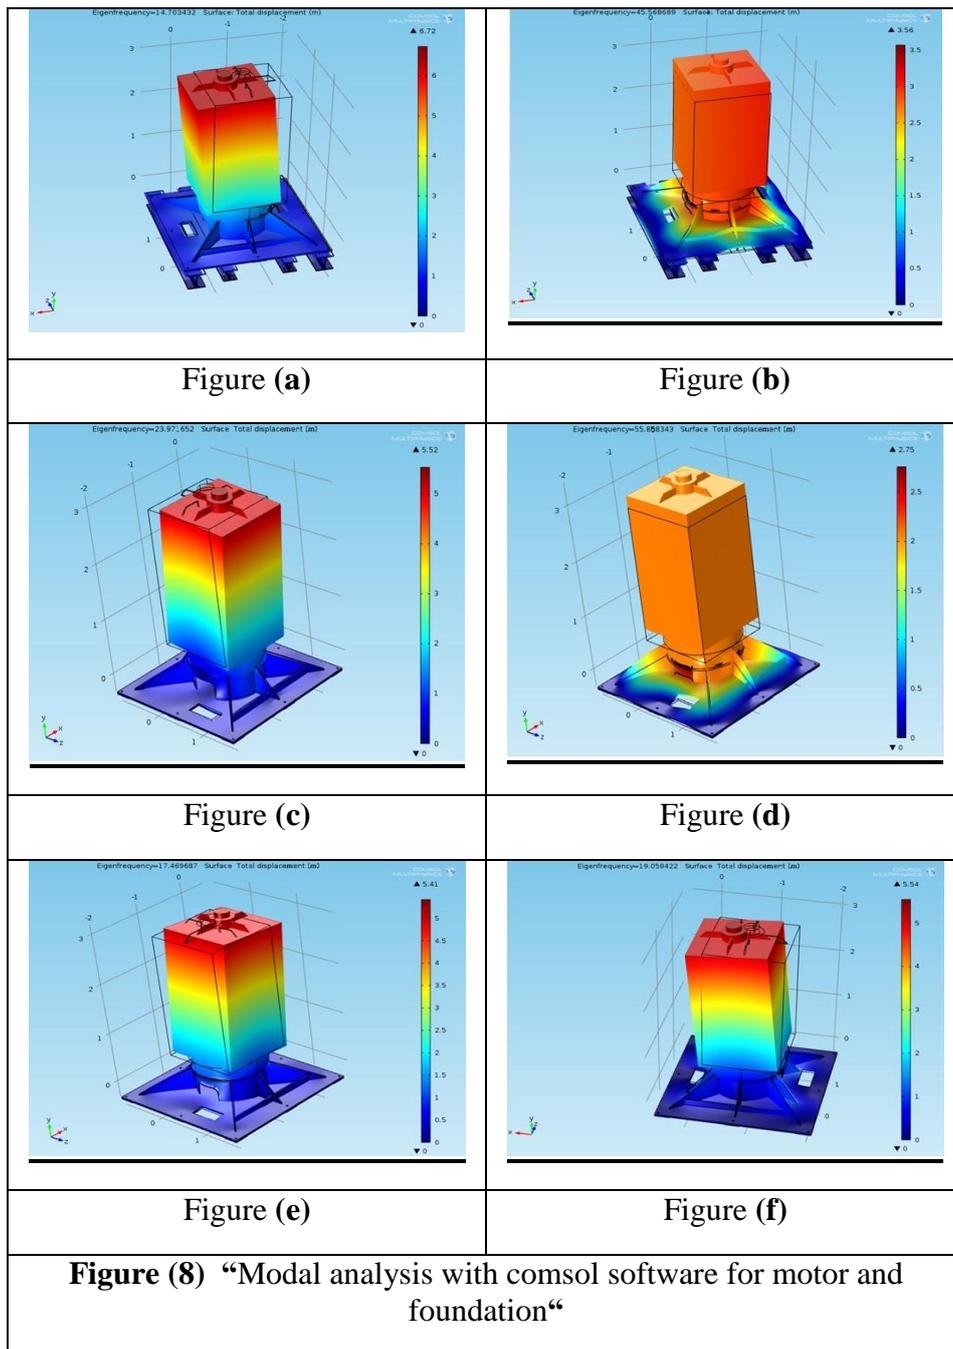
A simulation was done by the theoretical program to solve the problem that leads to decreasing the level of vibration, enhancing the characteristics of operating pumping station condition. The theoretical program indicates to add Stainless steel supports of motor foundation. Stainless steel support was manufacturer by a certain thickness and height and then, vibrations measurements was repeated again and doing analysis for the results. Modal Shape for motor, and motor foundation before adding support, are shown in **Figures (8a, 8b, 8c, 8d, 8e, and 8f)**.

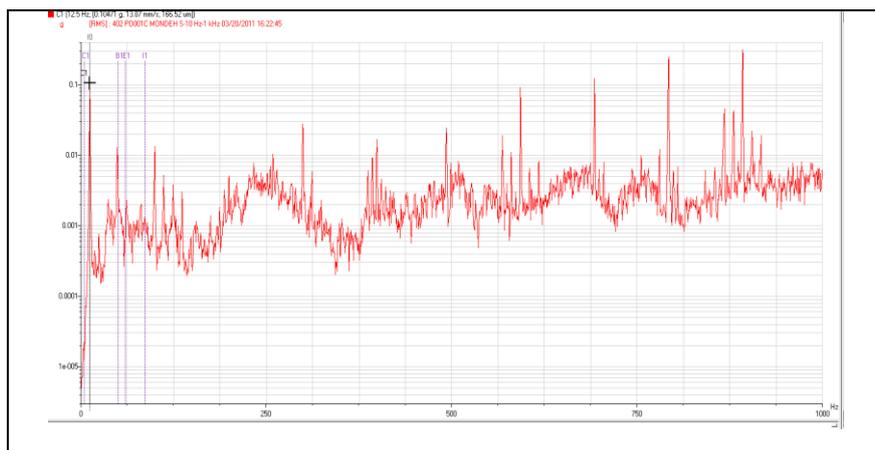
Frequency spectrum analysis indicated that still vibration peaks are found at motor running speed 1RPM (16.5 Hz, 12.5Hz) and its harmonics reached 13.07 mm/sec as shown in “Figure (9-a)”, its harmonics as shown in “Figure (9-b)”, and peaks with high amplitude at low frequency as shown in “Figure (9-c)”.

Figure (9-a) “FFT Domain for MNDEH“

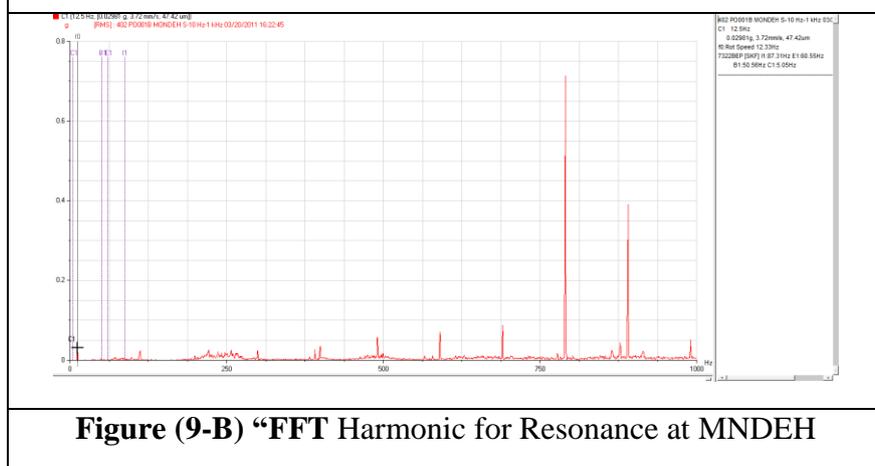
Figure (9-B) “FFT Harmonic for Resonance at MNDEH

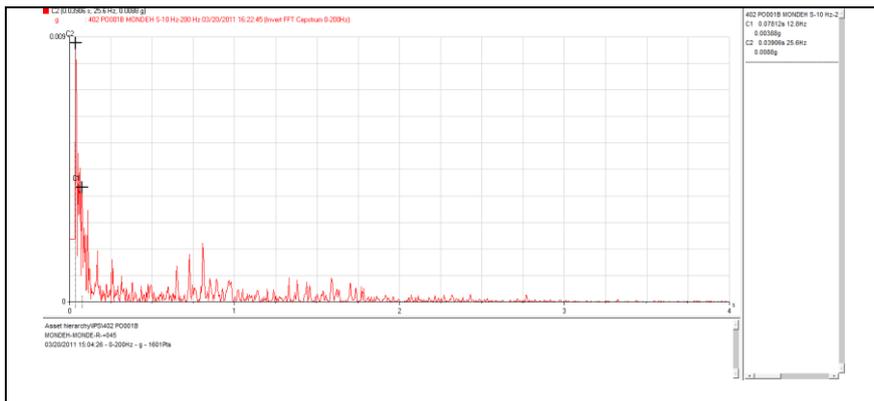
Figure (9-c) “Time domain for Peak at low frequency at MNDEH“

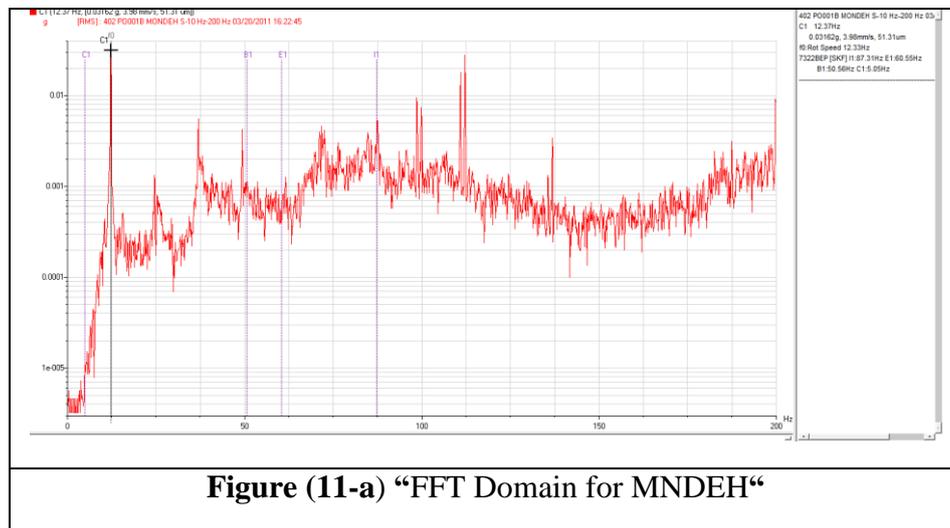
Frequency spectrum analysis indicated that no vibration peaks were found at motor running speed (1RPM, 12.5Hz, reached to 3.98 mm/sec, as shown in “**Figure (11-a)**”, no harmonics as shown in Figure (11-b), and no peaks with high amplitude at low frequency as shown in “**Figure (11-c)**”.

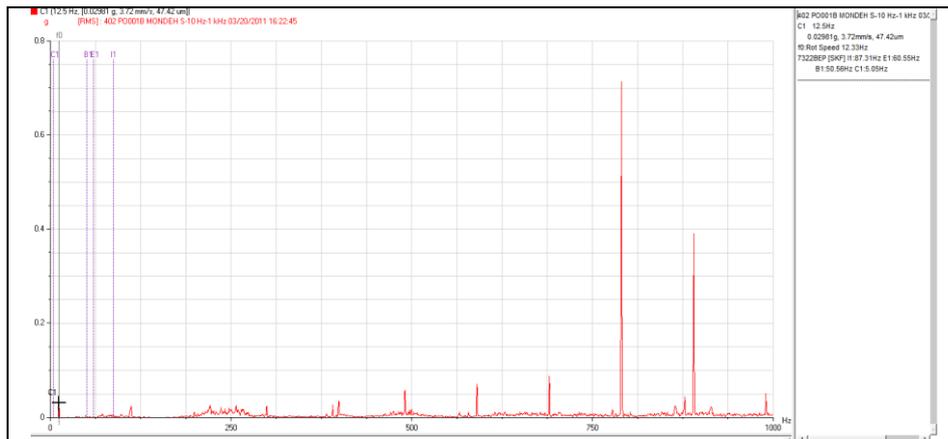
Figure “(11-B)” FFT Harmonic for Resonance at MNDEH“

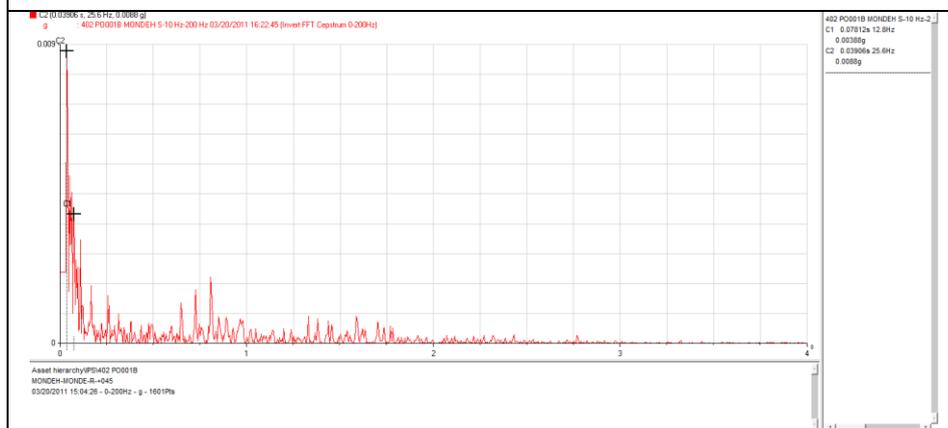
Figure (11-c) “Time domain for Peak at low frequency at MNDEH“
