MATERIAL PROPERTIES AS A MEASURE OF THE AGING EFFECTS OF EMBANKMENT DAMS

OLADEJO, O.S

Department of Civil Engineering

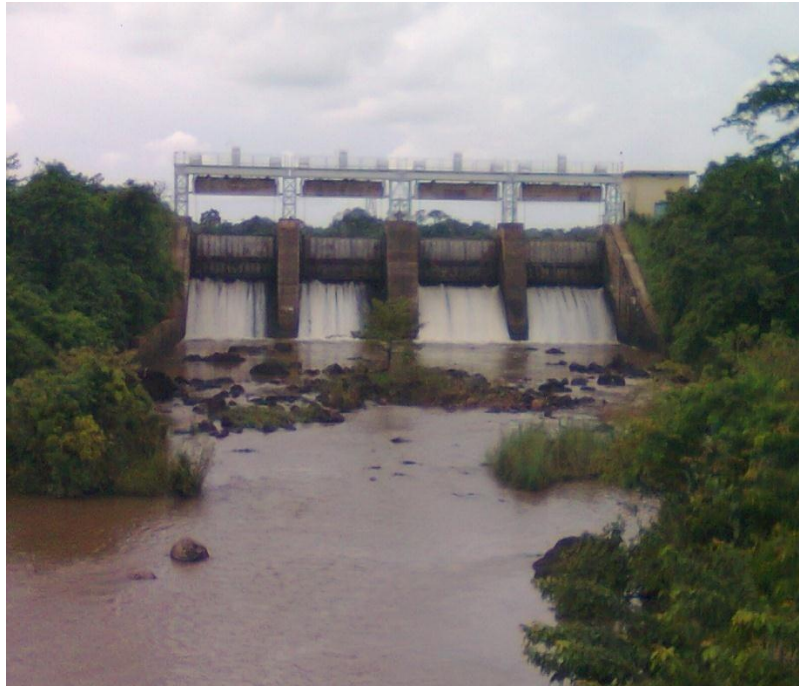
Figure 1: Downstream side of the spillway with fractured floor

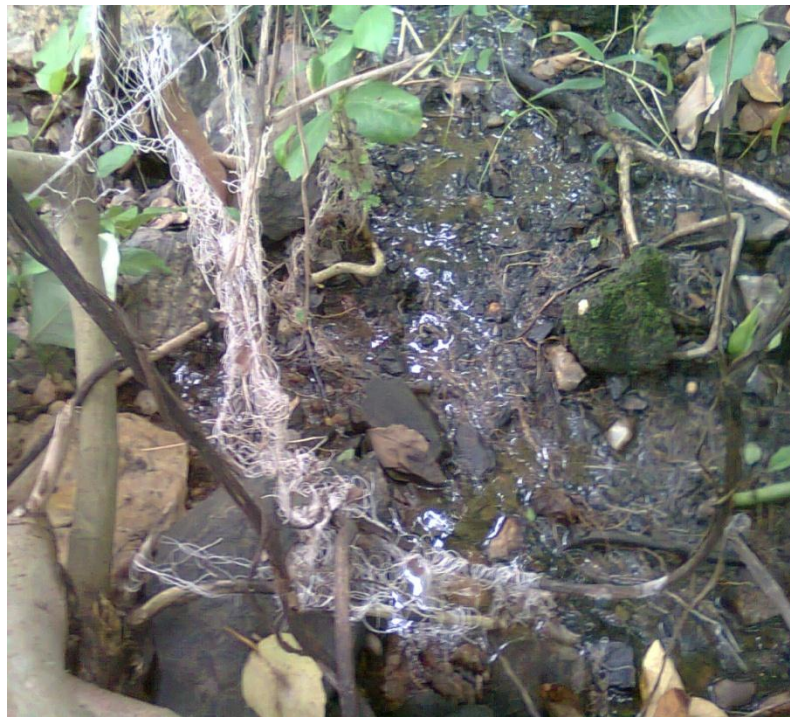
Figure 2: Seepage water flowing out at downstream toe

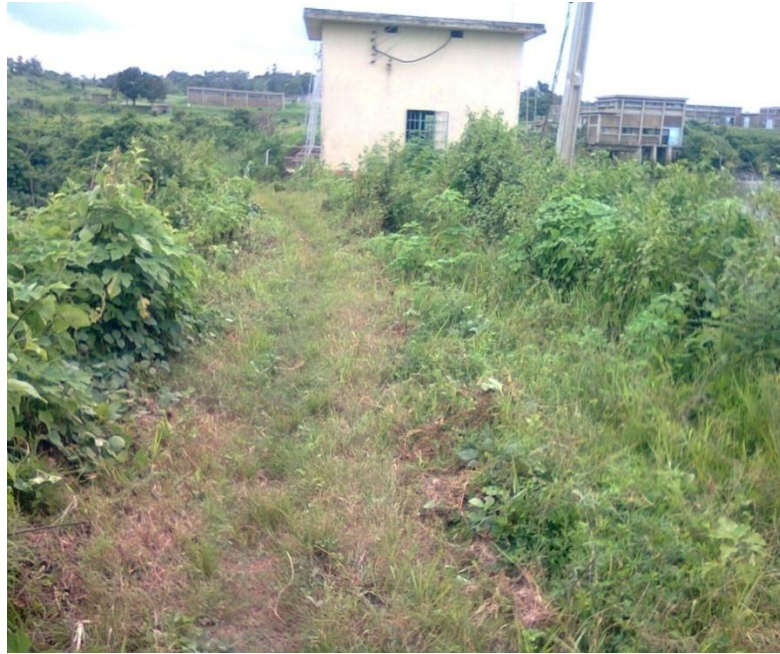
Figure 3: The Crest of the dam covered with vegetation

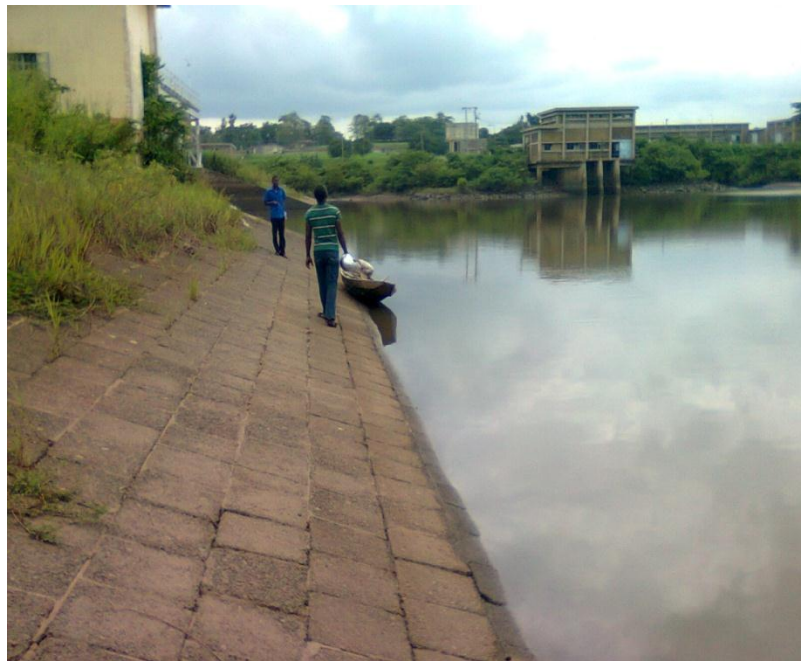
Figure 4: Disjointed concrete slabs at upstream face

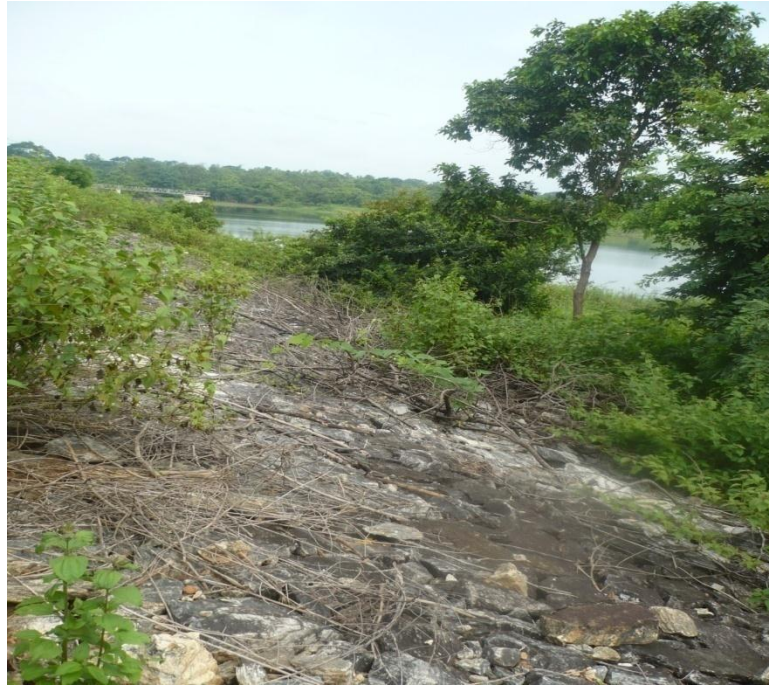
Figure 5: Dislocated stone riprap with tree vegetation at upstream side

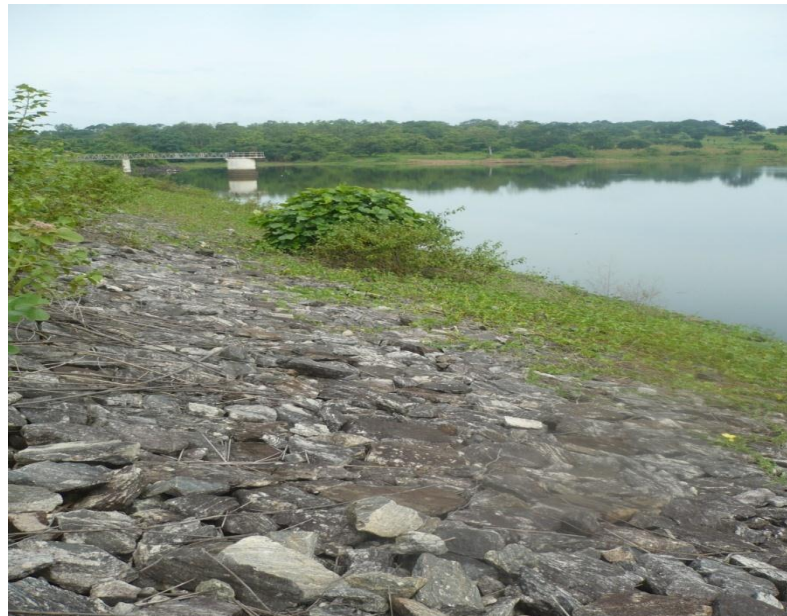
Figure 6: Disjointed stone riprap at upstream side
