# VIBRATION ANALYSIS AND INFRARED THERMOGRAPHY TECHNIQUE FOR EVALUATING MISALIGNMENT PROBLEM

**Dalia. M.El-Gazzar and Mofreh. A. Hashim**

*Mechanical and Electrical Research Institute, National Water Research Center, Ministry of  
Water Resources and Irrigation, Egypt, Email: [dalia\\_erngdalia@yahoo.com](mailto:dalia_erngdalia@yahoo.com)*

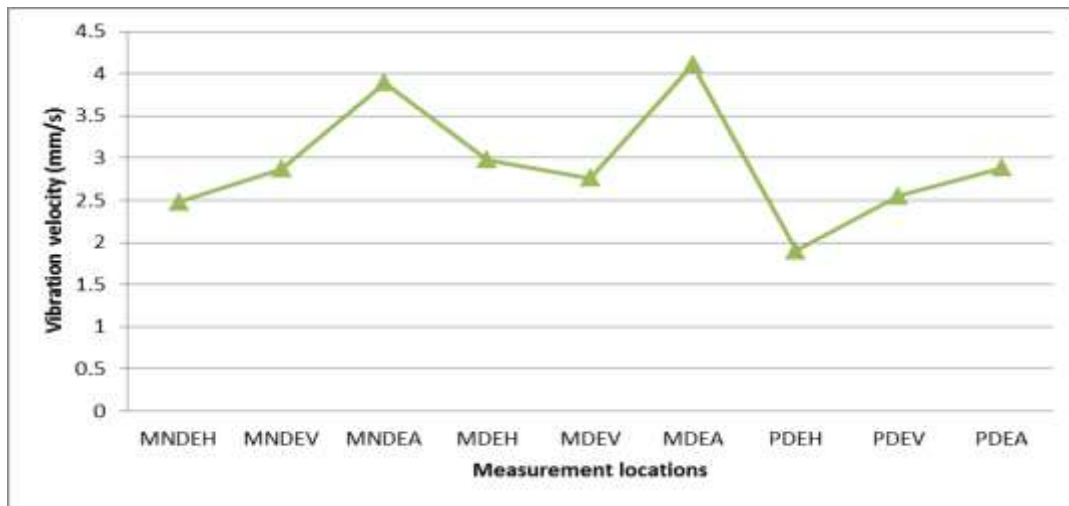
Overall vibration velocities measured at the measurement locations of the test rig are shown in Figure 3. Measurements at the motor non drive end (MNDE) showed that the maximum vibration velocity reached 3.89 mm/s and 2.95 mm/s in the axial and vertical directions respectively. These levels exceed the permissible levels by 38% and 5%. On the other hand, the measurements on the motor drive end (MDE) showed that the maximum maximum vibration velocity reached reached 4.11 mm/s and 3.00 mm/s in the axial and vertical directions respectively. These levels exceed the permissible levels by 46% and 7%. Maximum vibration velocity reached 2.88 mm/s on the pump drive end (PDE) in the axial direction. The overall vibration level of the motor drive and non drive ends is falling within the unacceptable range.

Figure 3. Overall vibration level velocity measured at different locations.

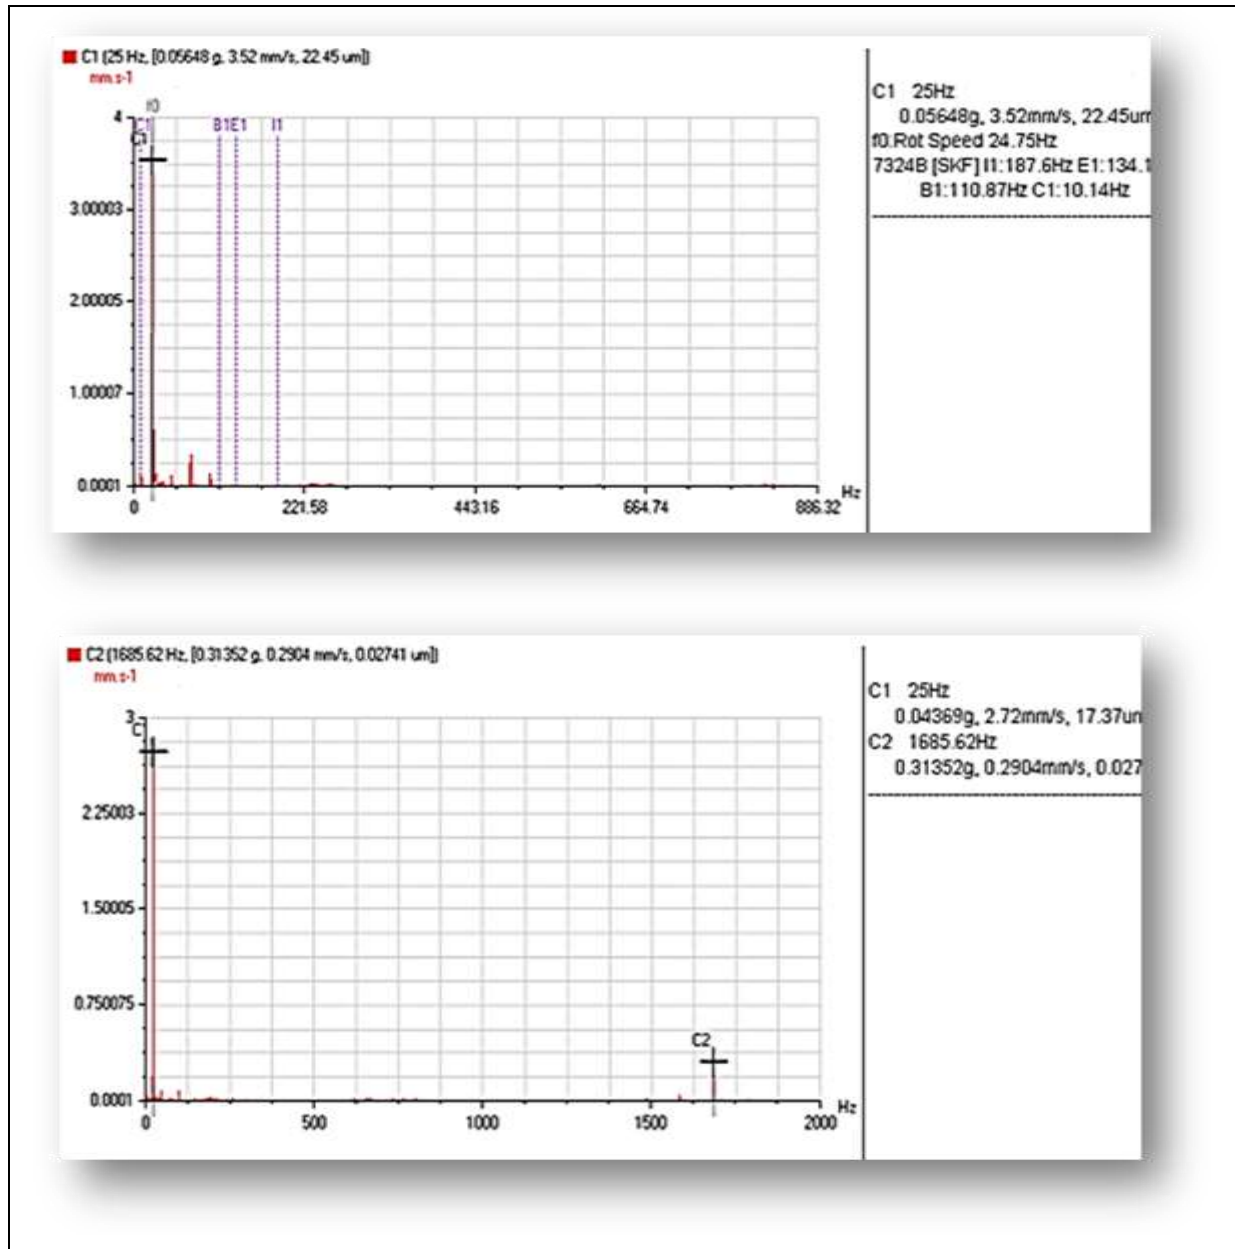
The FFT spectrum analysis that has been recorded indicates that, there are vibration peaks founded at motor running speed (1RPM, 25Hz) in the axial and vertical directions of the motor drive and non drive ends. Vibration amplitude reached 3.52 mm/s, and 2.72 mm/s at the motor drive no drive end in the axial and vertical direction respectively as shown in Figure 4. On the other hand, vibration amplitude measured at the motor drive end reached 4.06 mm/s and 2.23mm/s in the axial and vertical direction as shown in Figure 5. These high levels of vibration are unacceptable. The results indicated that the amplitude changed with directions. Also the amplitude in the axial direction is about 50 percent of the highest radial amplitude. Depending on all these remarks, it is obvious that there is a misalignment problem. Misalignment causes an overload on bearings and results in shortening bearing life. This reduction depends on the degree of misalignment. Bearing defect factor is a value that gives proof on the bearing statues if it operates within good conditions or not. The bearing defect factor level is within the alarm range at the motor drive end and pump drive end sides. Maximum overall bearing defect factor reached 8.61 on the motor drive end in the vertical direction, and 7.67 on motor drive end in the vertical direction.

Figure 4. Vibration spectrum measured at motor non drive end in axial & vertical directions.

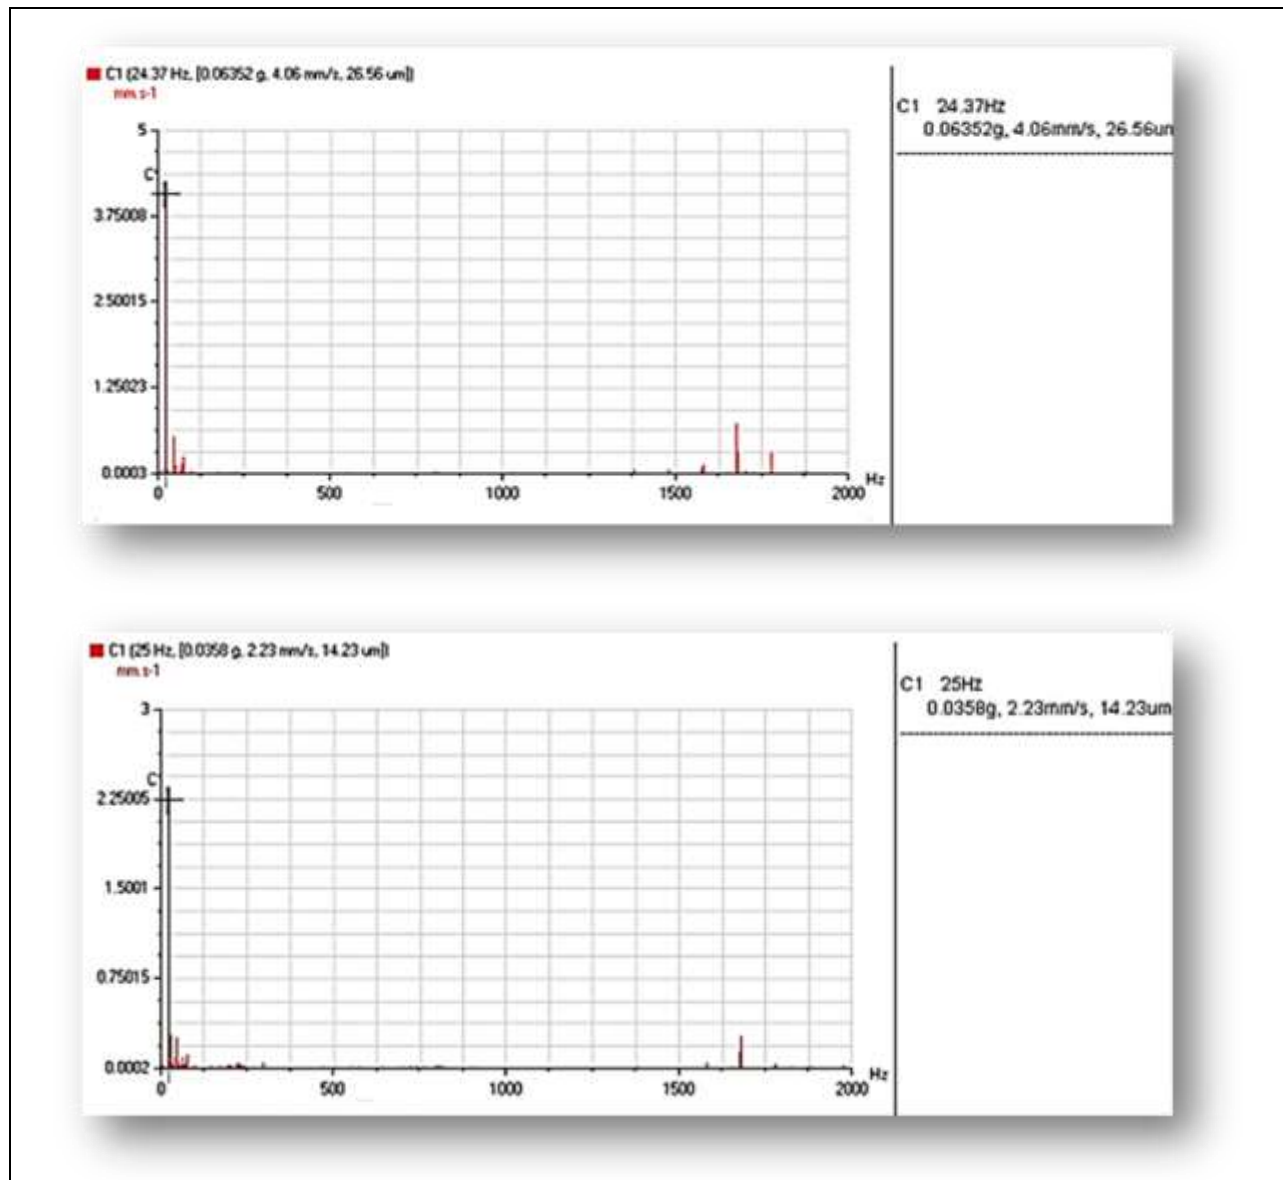
Figure 5. Vibration spectrum measured on motor drive end in axial & vertical directions.

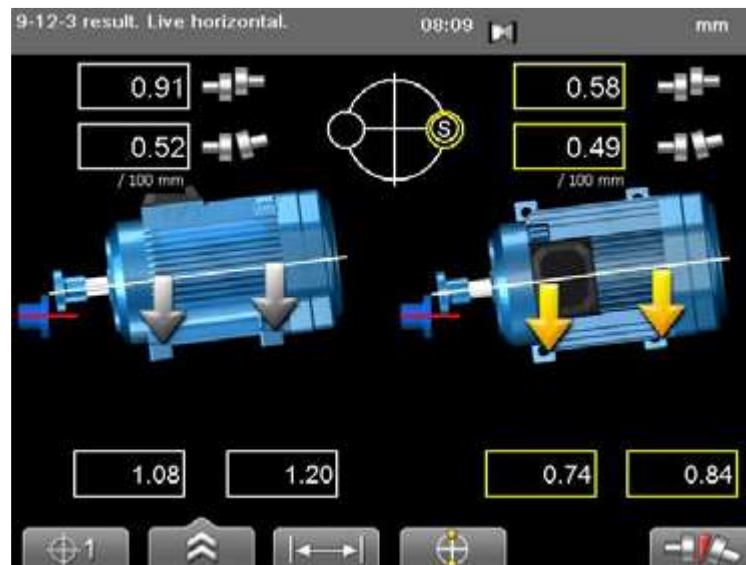
The laser system can calculate from the shaft movement how much each foot has raised as shown in Figure 6. Correct machine dimensions must be input into a laser alignment system for correct calculations. Once foot movements have been established, the results need to be interpreted and translated into shim thicknesses needed to correct any soft foot situation. In this case the offset alignment reached 0.310 mm while the angular alignment value reached 0.366 mm. These values are dangerous, so it must be but shims under the motor and move it to be within acceptable tolerance. After applying alignment procedure, the offset alignment decreased to 0.035mm while the angular alignment decreased to 0.013mm and these values are within the acceptable range according to device limit.

Figure 6. The laser system calculation for how much each foot has been raised.

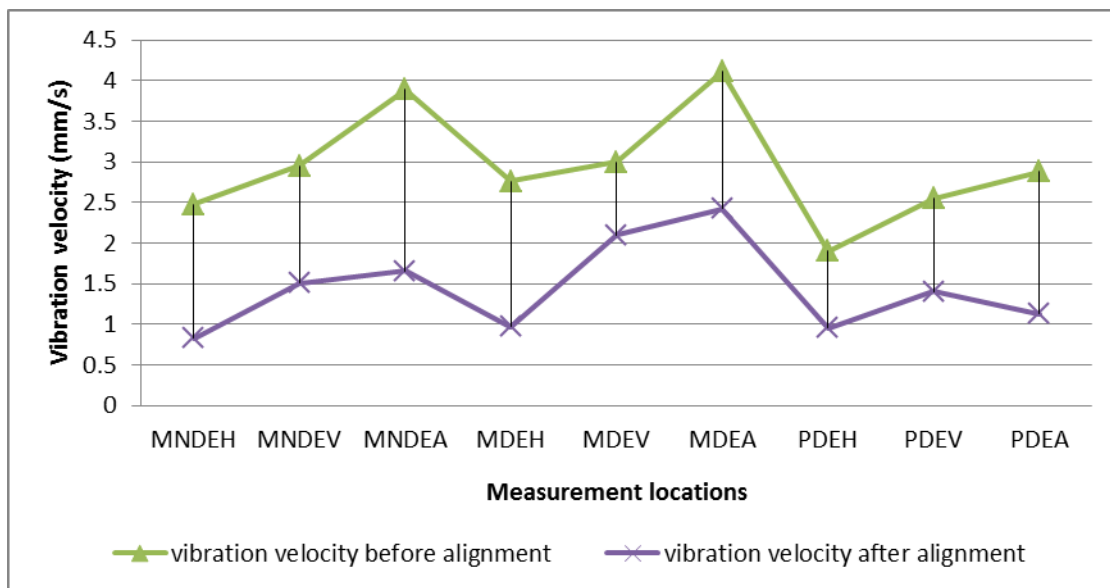
After applying alignment process between motor and pump, the results indicated that vibration Levels are within the acceptable range according to ISO 10816 -3. The measurements showed that the maximum overall vibration level measured reached 1.6 mm/s and 1.51 mm/s on the motor non drive end. Vibration levels decreased to 57% and 48% in the axial and vertical direction respectively. On the other hand measurements showed that the maximum overall

vibration level measured reached 1.82 mm/s and 1.24 mm/s at the motor drive end. Vibration levels decreased to 41% and 29% in the axial and vertical direction respectively. Comparison between vibration levels before and after applying the alignment procedure is shown in Figure 7. The FFT spectrum analysis indicates that the maximum vibration amplitude reached 0.4083 mm/s, and 0.9067 mm/s at the motor drive non drive end respectively in the axial and vertical direction as shown in Figure 8. Maximum vibration amplitude measured at the motor drive end reached 0.8729 mm/s and 1.22 mm/s in the axial and vertical direction as shown in Figure 9. The analysis result confirmed that the vibration level became within acceptable healthy condition after correcting misalignment problem. Therefore this will help to prolong machine life through the application of proactive maintenance strategies.

Figure 7. Comparison between vibration levels before and after applying alignment procedure.

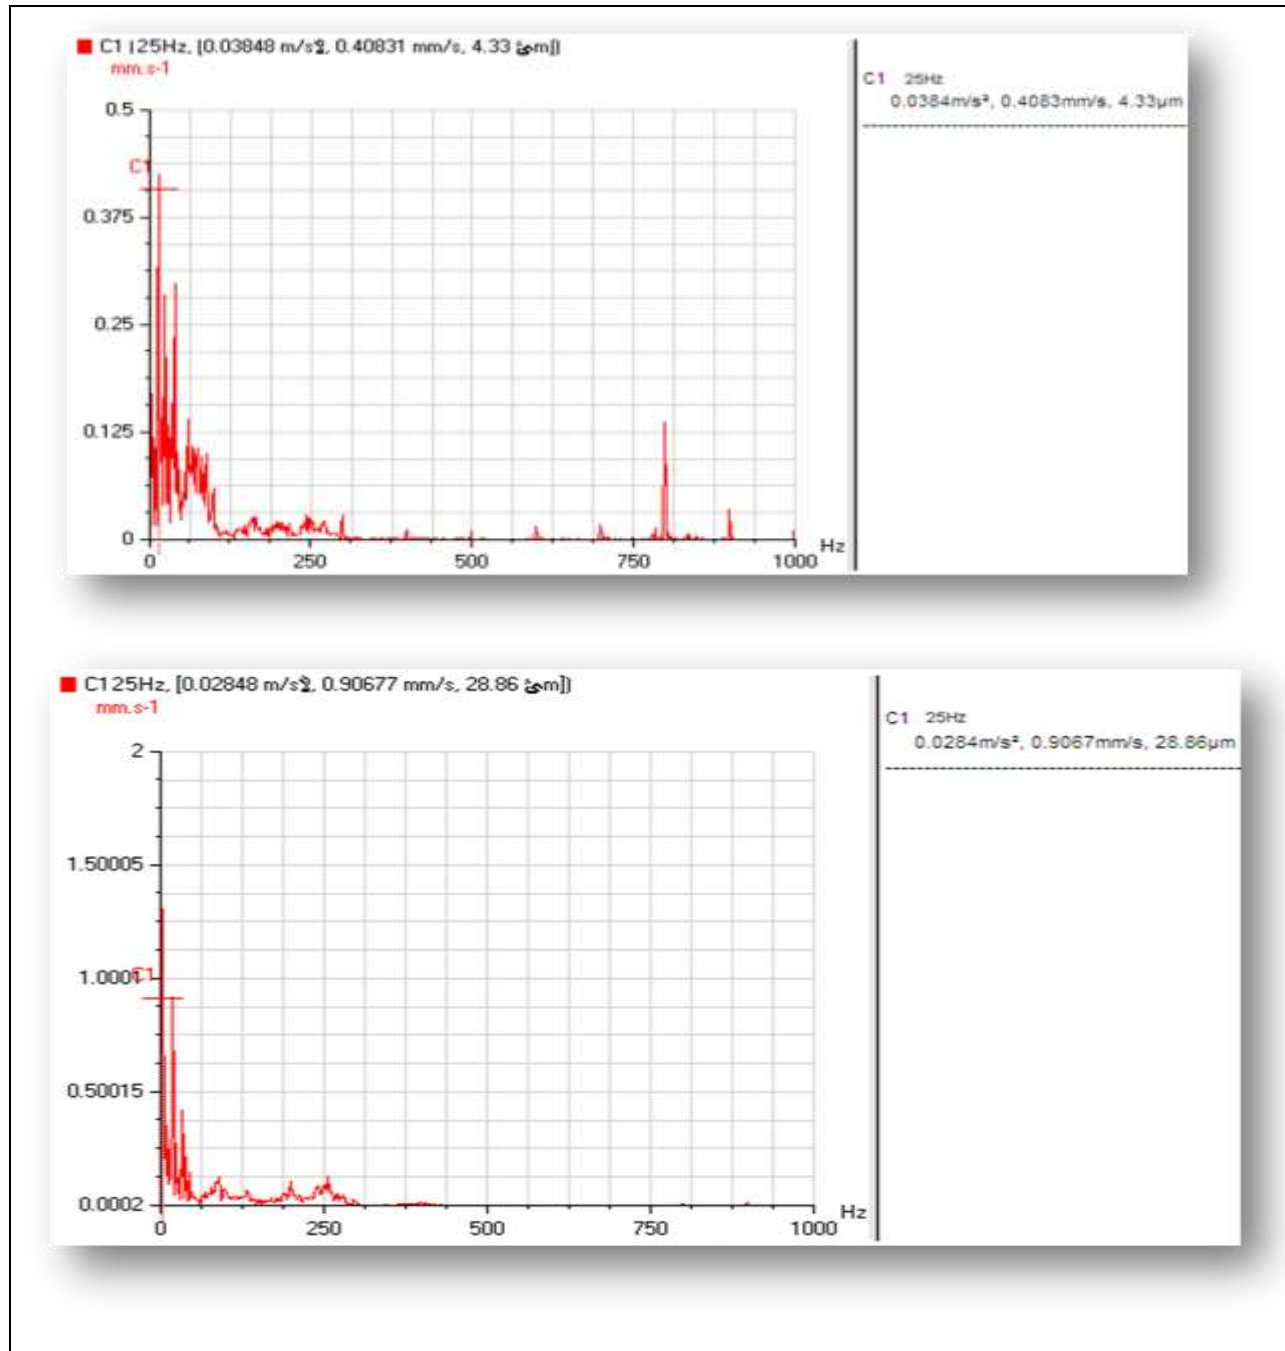
Figure 8. Vibration spectrum measured at motor non drive end in axial & vertical directions.

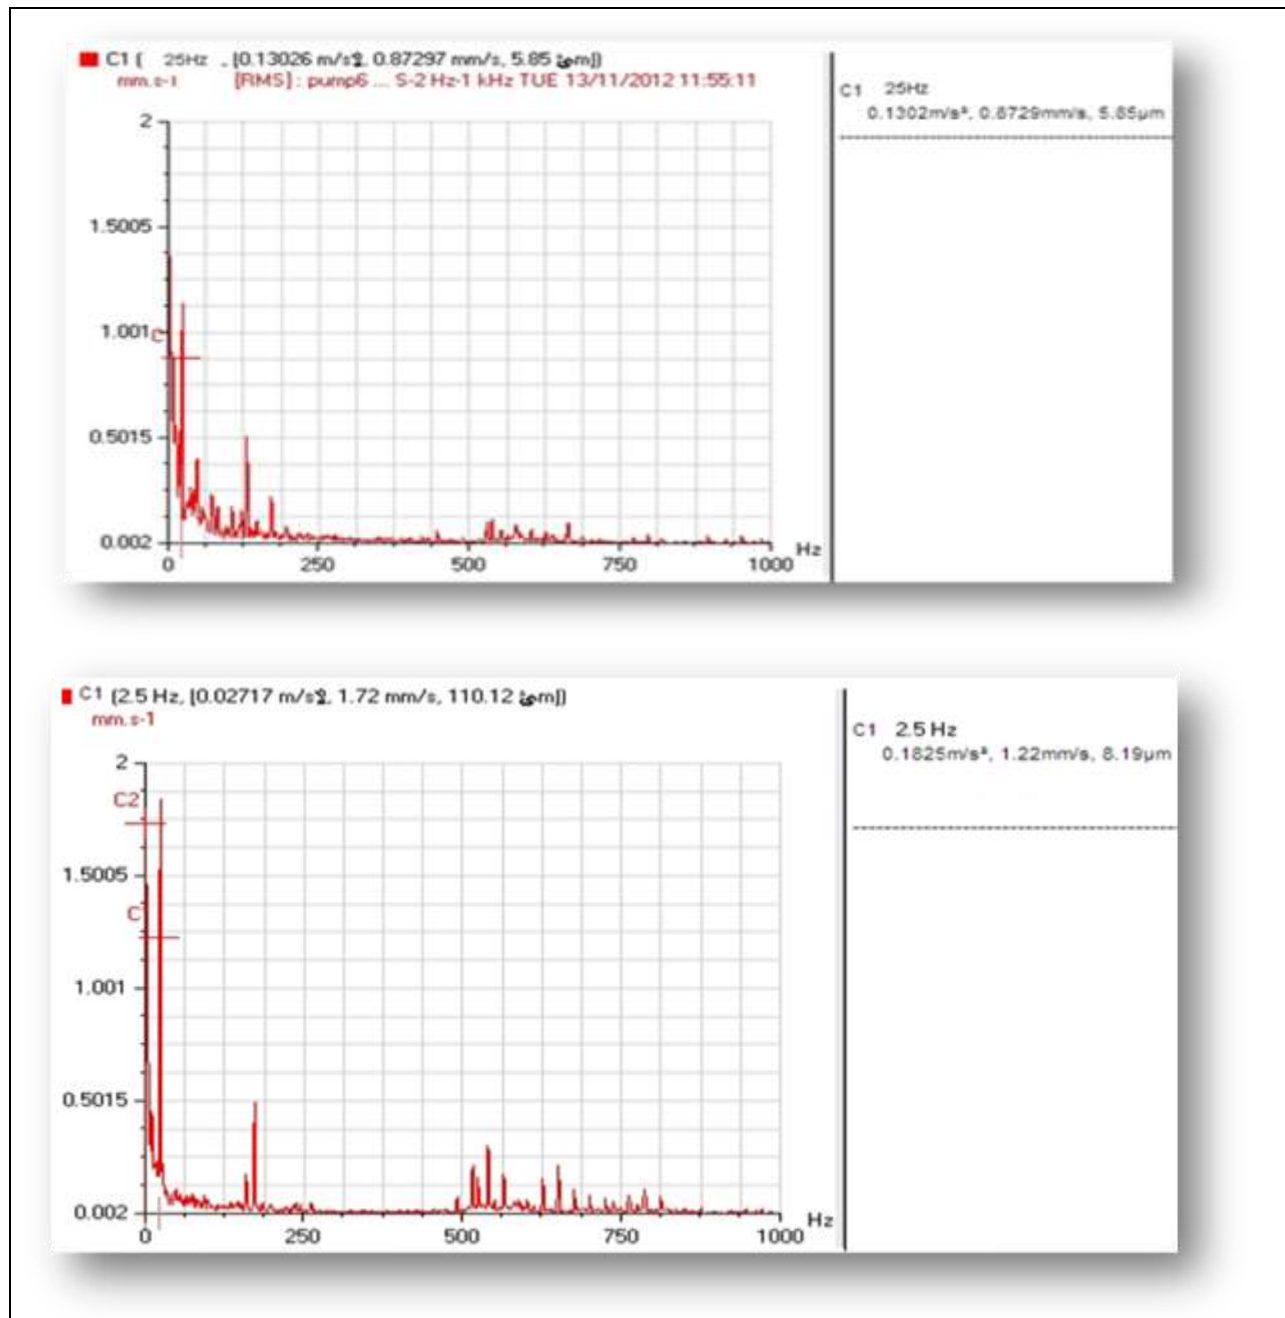
Figure 9. Vibration spectrum measured at the motor drive end in axial & vertical directions.

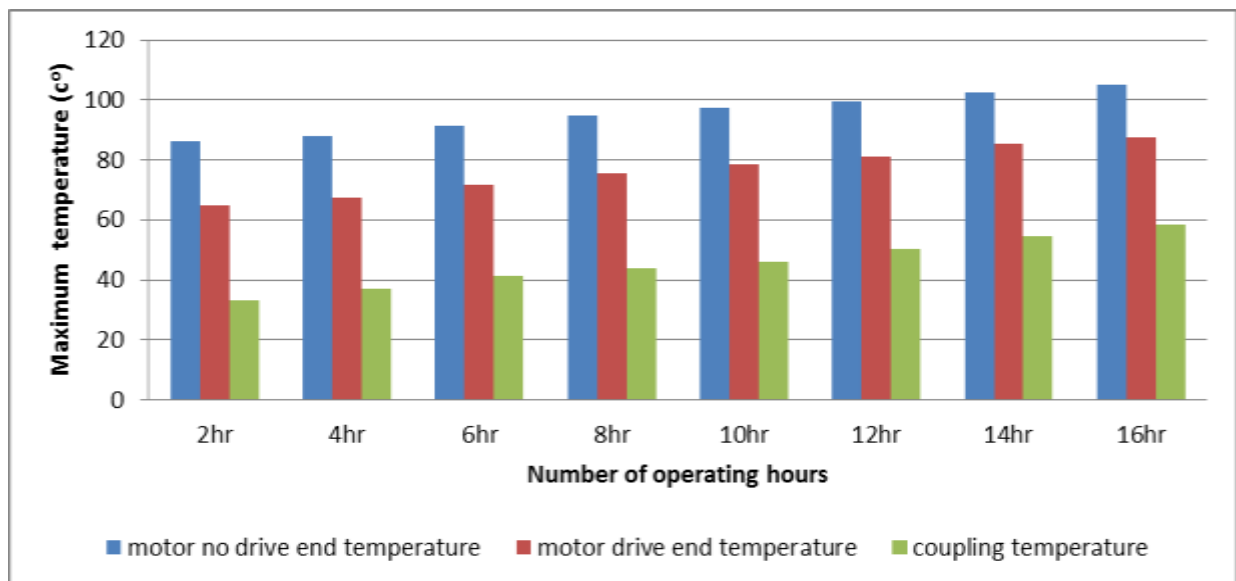
The measured temperature was acquired by a fixed thermo graphic camera. The test rig worked continuously for 16 hour to indicate the effect of the misalignment problem with increasing temperature. Temperature measurements were processed and recorded every two hours. Shaft misalignment evaluation at a region of interest is selected to determine the maximum component temperature. Varying misalignment conditions were achieved by using different thickness stainless steel shims which were placed under machine foot. Infrared thermography analysis was achieved before and after applying alignment process. Figure 10 shows the variation of maximum temperature during different operating hours at bearings and coupling. The variation of maximum temperature with different misalignment values at bearings and coupling is shown in Figure 11. It could be noticed that as the misalignment value increased the equivalent temperature of the part increased. This could be due to friction losses or energy losses.

Fig. 10 Variations of maximum temperature during different operating hours.

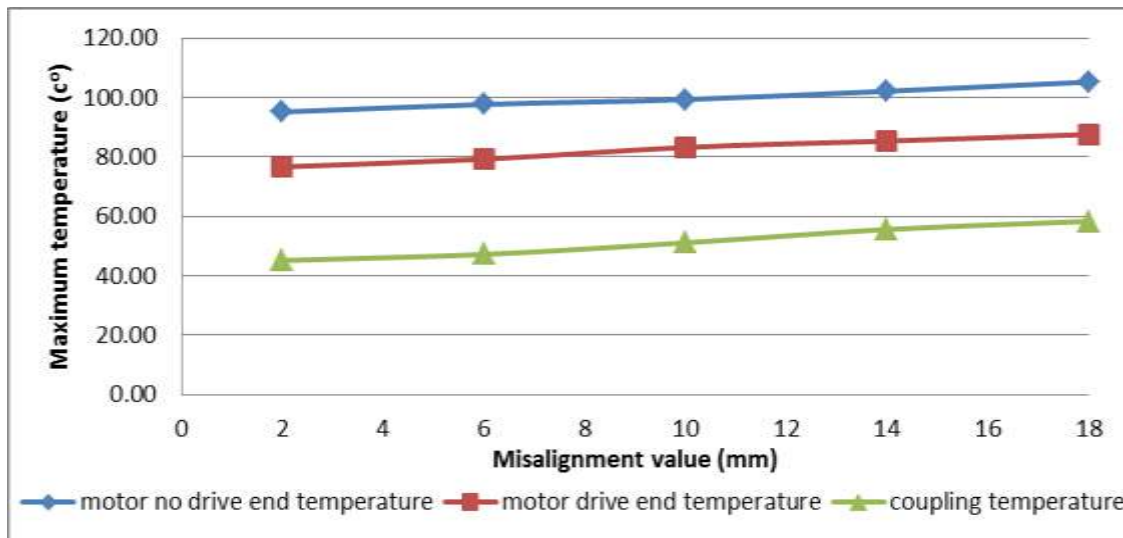
Fig. 11 Variations of maximum temperature value for different misalignment values.

Due to coupling helps in connecting driving shaft with driving shaft, so any deviation in the centerline of shafts can result in increasing in temperature of coupling. It could be noticed that the effect of the misalignment rise at the non-drive end bearing is more than its effect on drive end bearing and coupling.

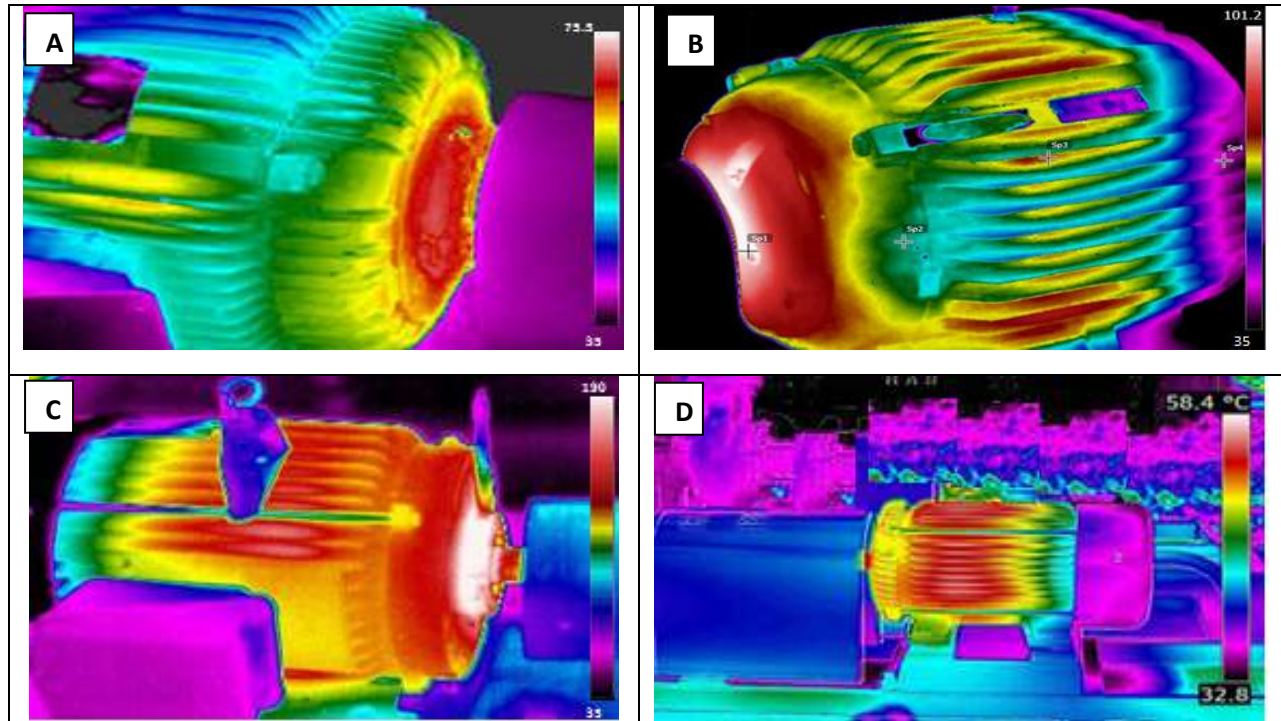
The thermal images shown in Figure 12 indicated that, as the misalignment develops, the temperature increases due to increasing friction. The first image (A) demonstrates the distribution of heat at the beginning of the operation. This image shows that the temperature of the bearing has started to increase. The entire end cover of the motor is also starting to increase in temperature. The second image (B) indicates that the temperatures changed to be higher as the load increased. The bearing housing is also affected by the heat energy generated from misalignment and even the shaft coupling is affected. The temperature of the entire end casing of the motor has increased to 101°C. The third image (C) clearly shows that the energy wasted in overcoming the forces produced by misalignment is significant. The temperature increased to be 190 °C.

All of this heat energy passes into the bearing and subsequently into the lubricant. The resulting head and forces accelerate wear of bearing. Left unchecked, this problem will first cause the bearing to wear, followed by the seal and finally the coupling. The fourth image (D) was taken

with the machine correctly aligned. The heat distribution after applying misalignment indicates that the temperature decreased to be 58.4 C°.

Fig. 12 Distribution of heat change on the test rig before & after alignment process.
