**DIAGNOSIS PUMP PROBLEMS USING VIBRATION ANALYSIS****Sami A. A. El-Shaikh**

Mechanical &amp; Electrical Research Institute, National Water Research Center, Ministry of Water Resources &amp; Irrigation, Delta Barrage, Egypt

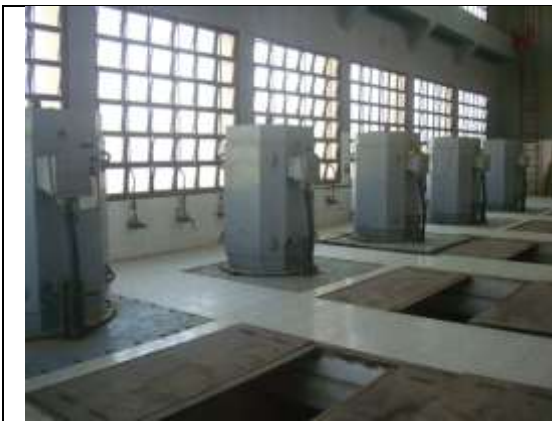
**Figure (1)** Photograph for Marashda (1) P. S.

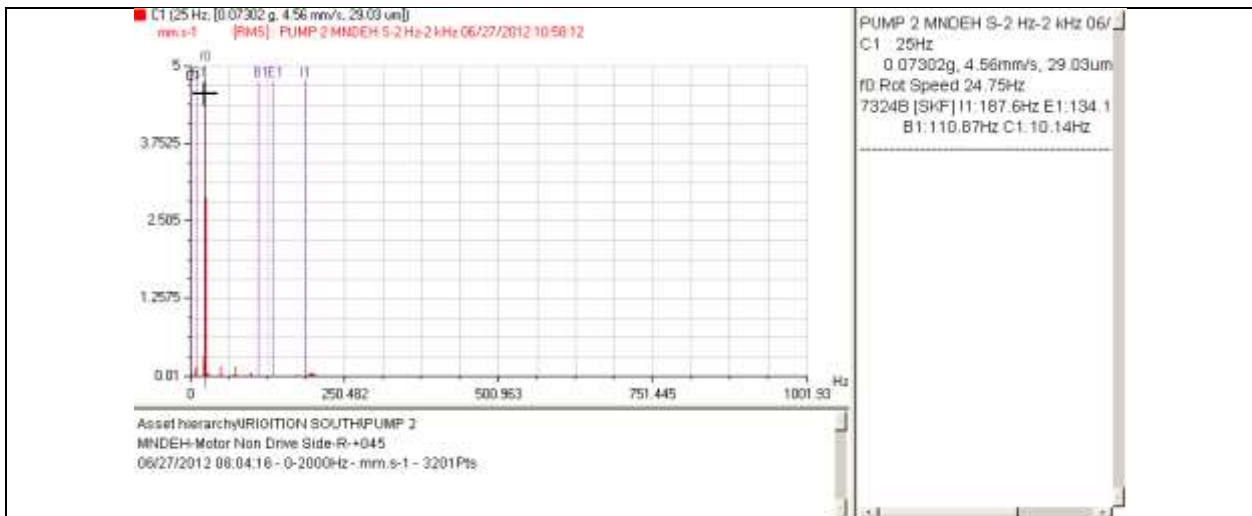
(a) motor non drive side horizontal

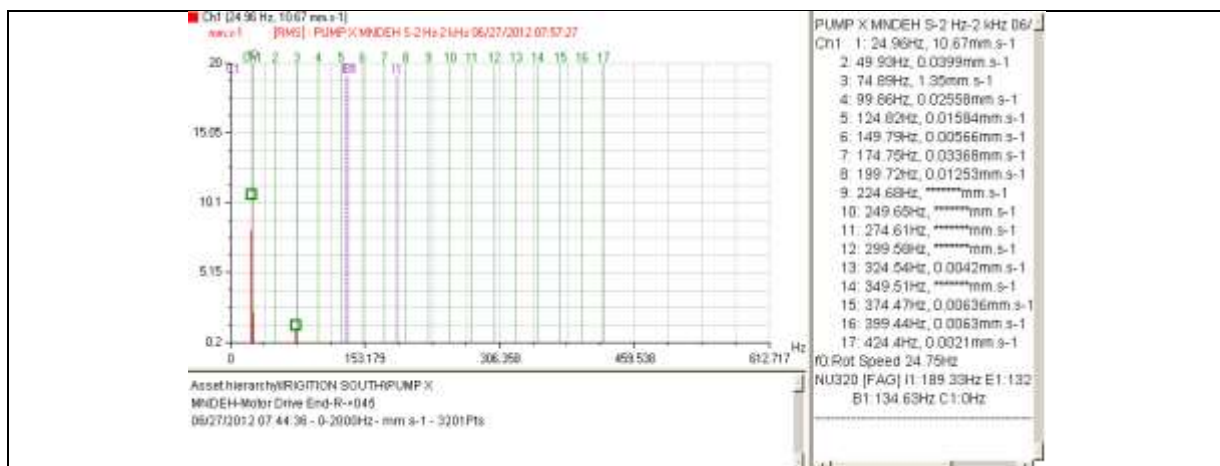
(a) : motor non drive side horizontal MNDSH

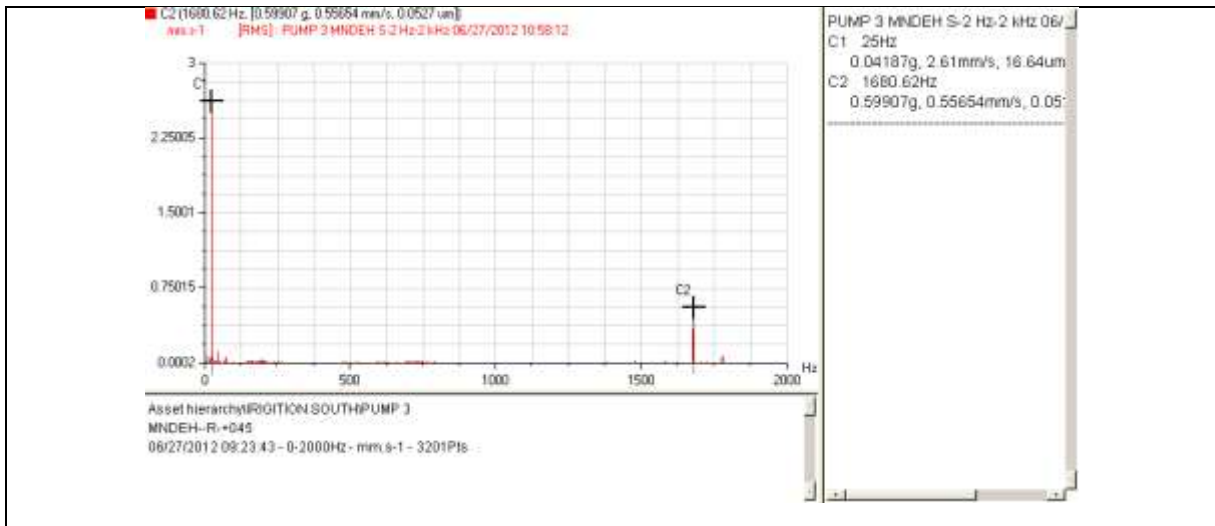
(a) motor non drive side horizontal

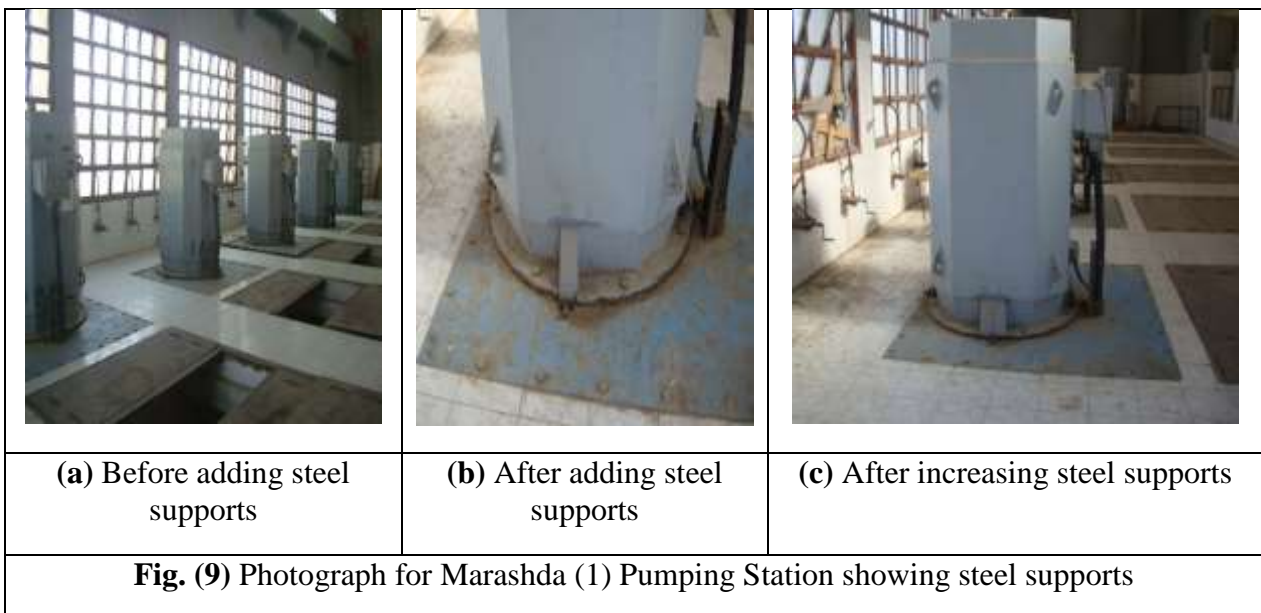
Overall Vibration Velocity, acceleration, and BDF were done after increasing steel supports to motor foundation.

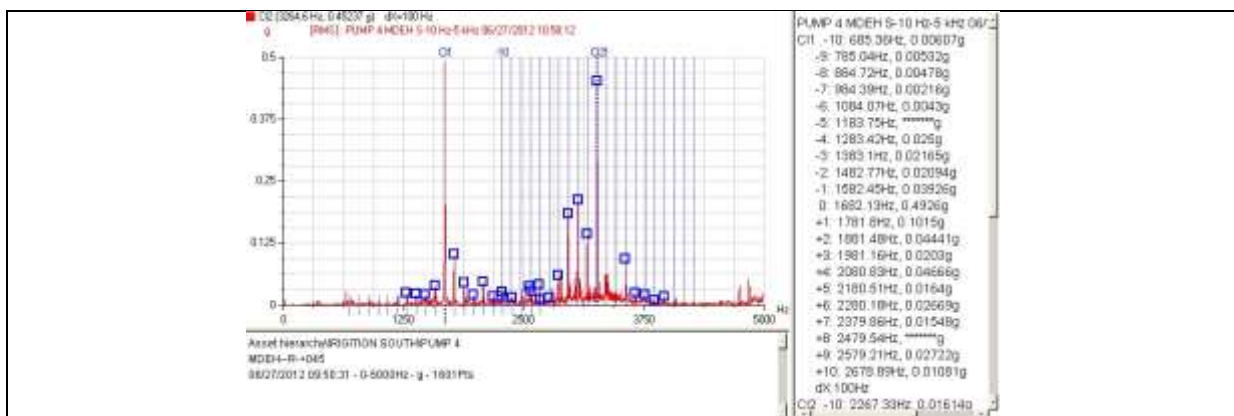
(a) motor non drive side horizontal

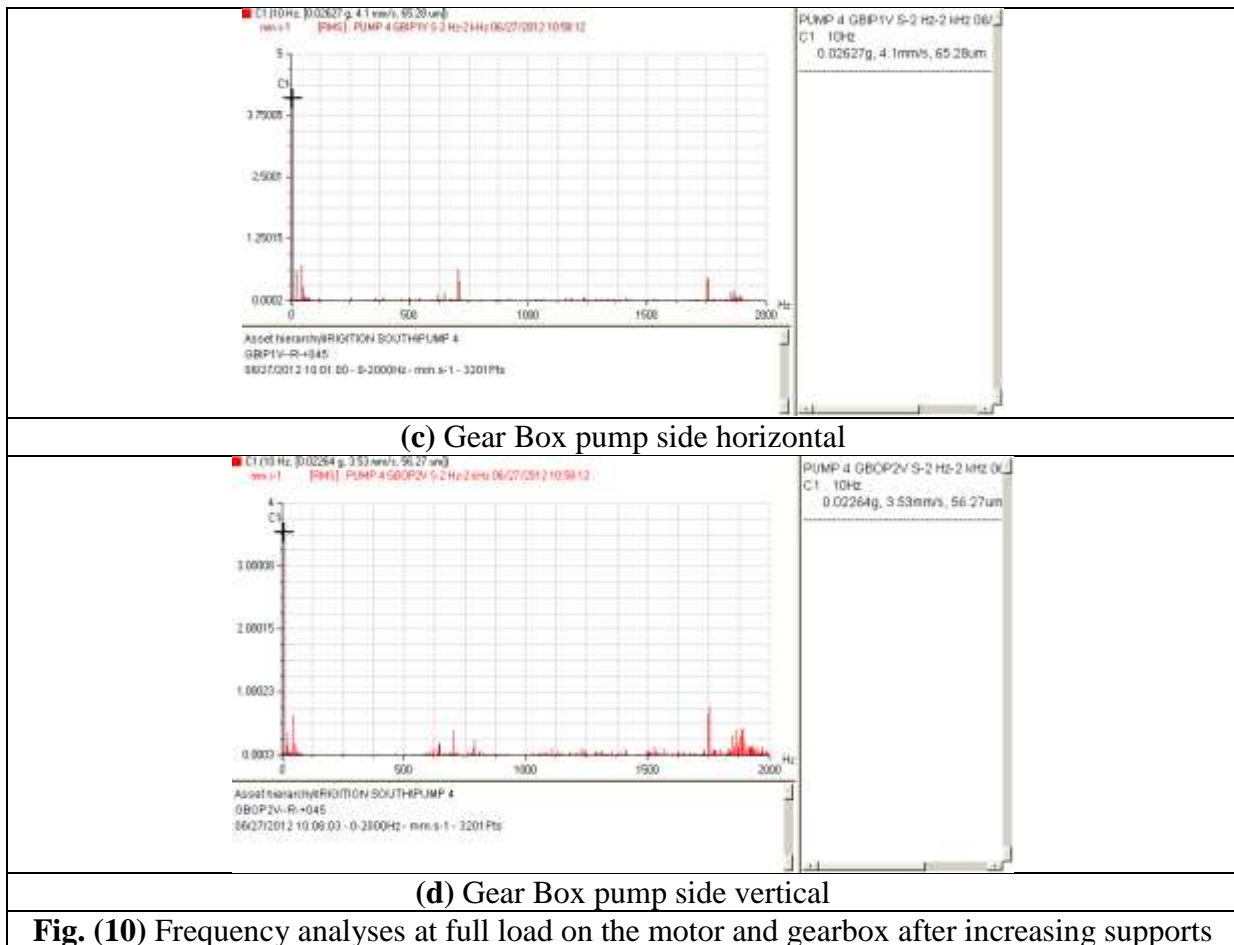
## CONCLUSIONS & RECOMMENDATIONS
