DIAGNOSIS OF PUMP PROBLEMS USING VIBRATION ANALYSIS**Sami A. A. El-Shaikh**

Mechanical and Electrical Research Institute, National Water Research Center, Ministry of Water Resources and Irrigation, Delta Barrage, Egypt.

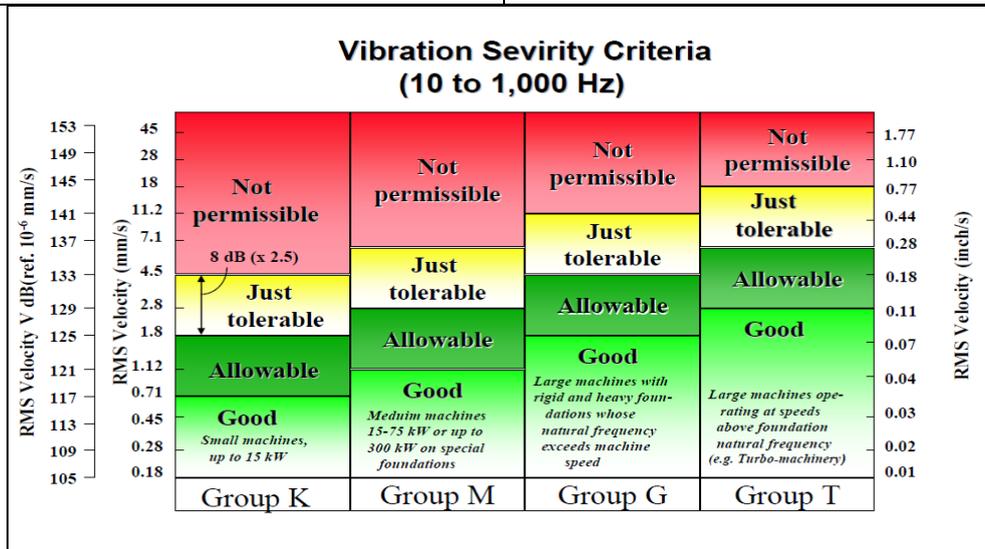
Figure (3) ISO standard for vibration

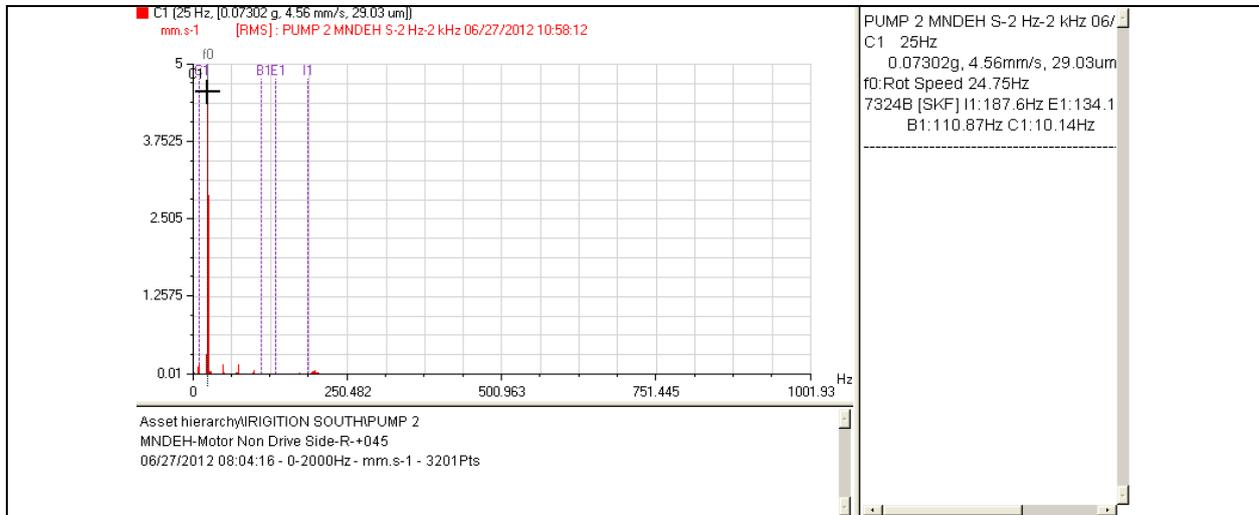
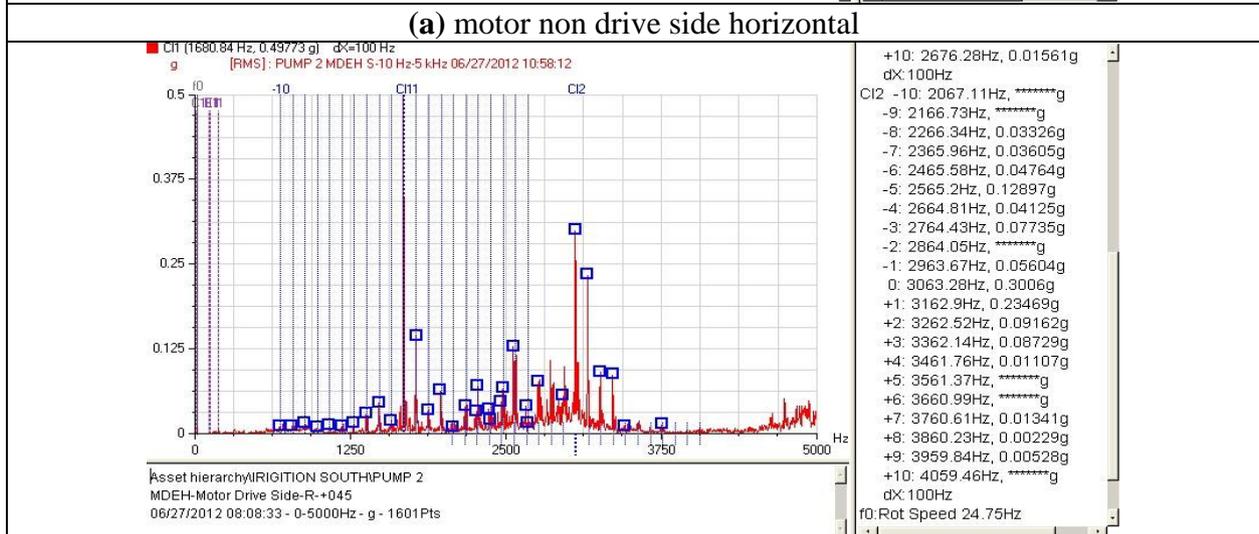
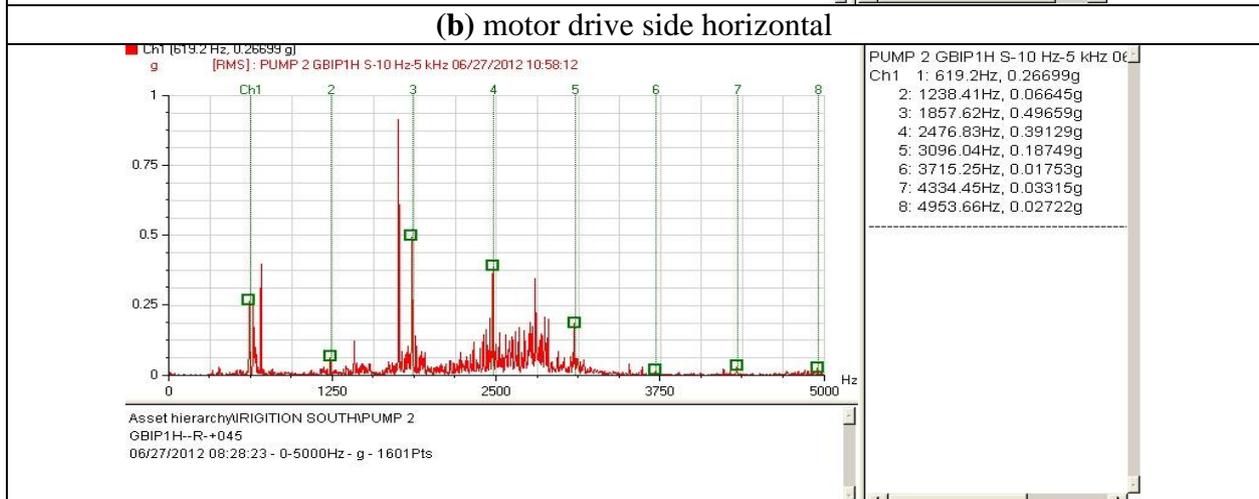
measurement at pump side showed a looseness problem in the gears as shown in **Figures (4-e, and 4-f)**

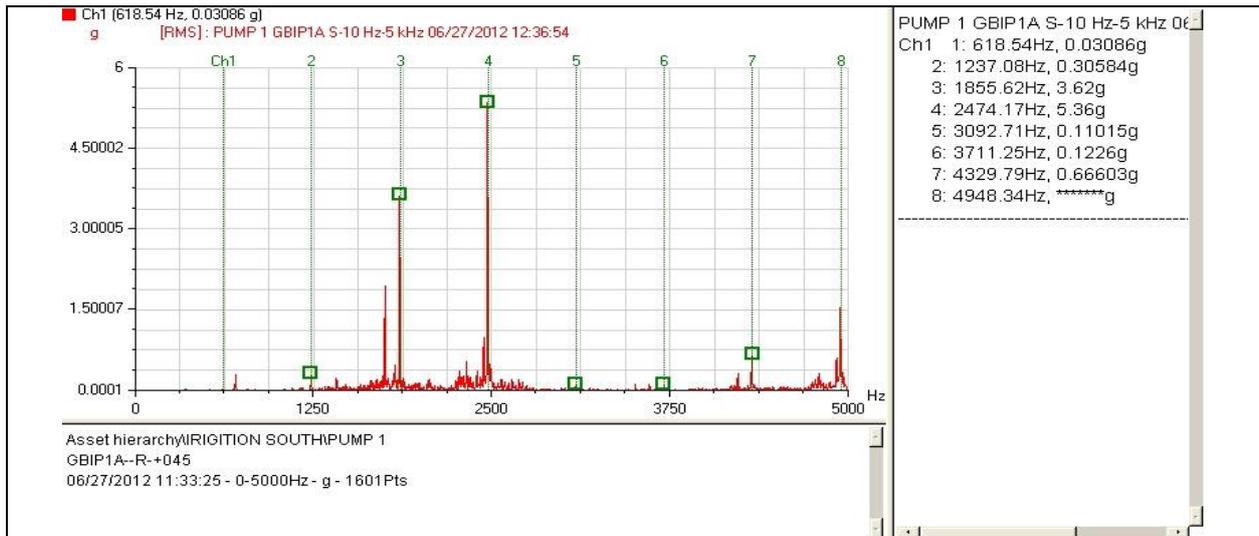
(d) Gear Box motor side Axial

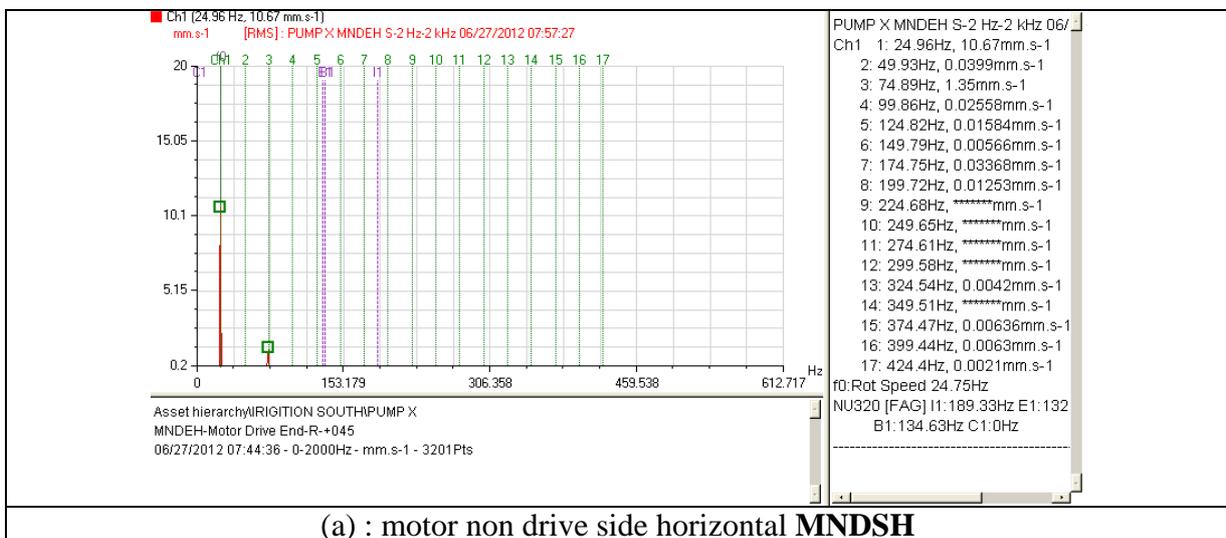
(a) : motor non drive side horizontal MNDSH

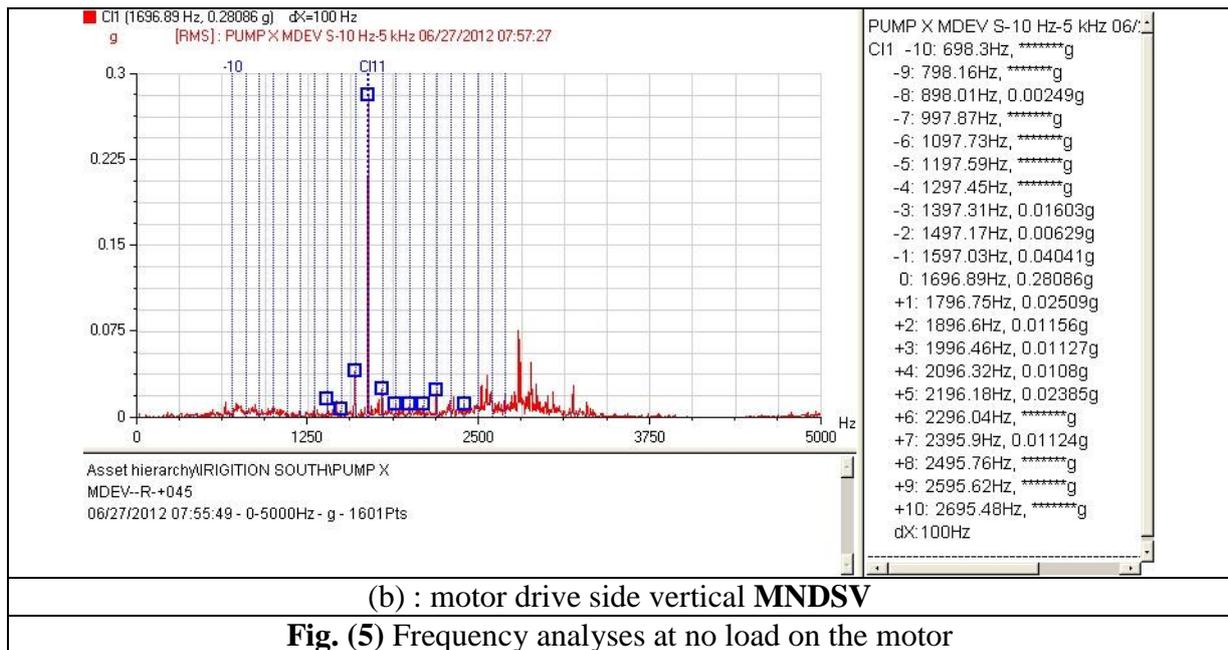
RESULTS AND DISCUSSIONS AFTER ADDING STEEL SUPPORTS

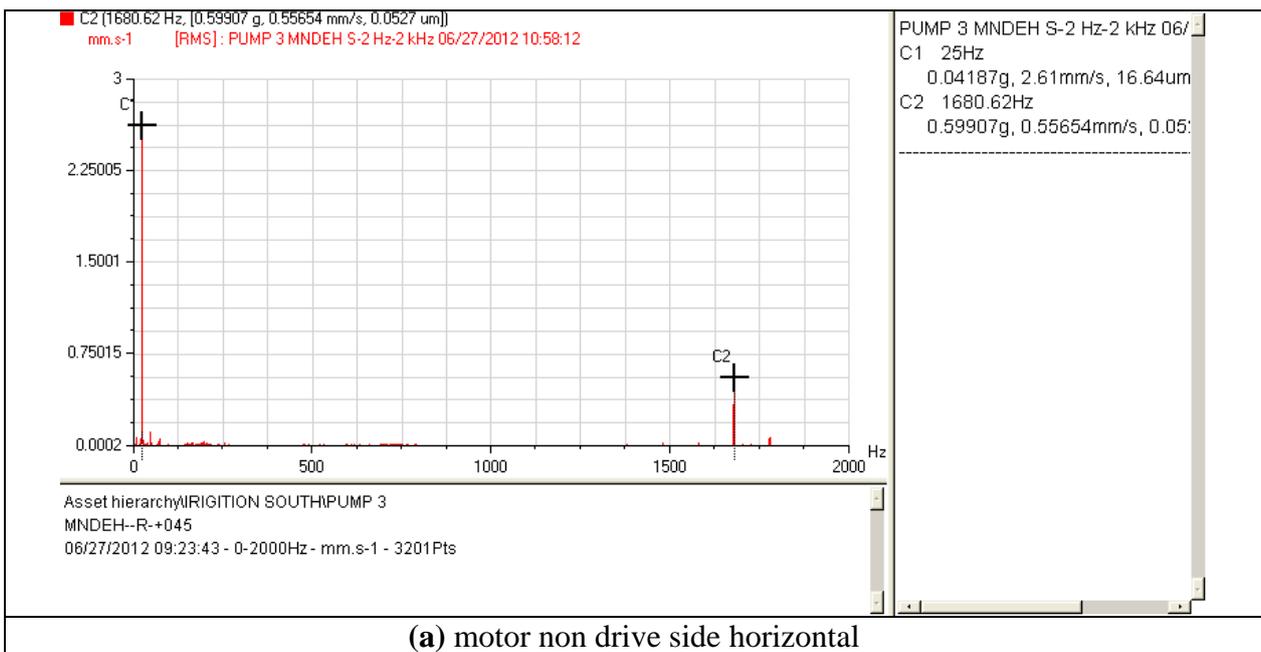
Clutch frequency values appear in the gearbox pump side in the case of full load, which indicates unbalance problem in the axial direction according to incorrect putting steel foundation under the motor over the base of concrete, as shown in **Figures (6-e and 6-f)**.

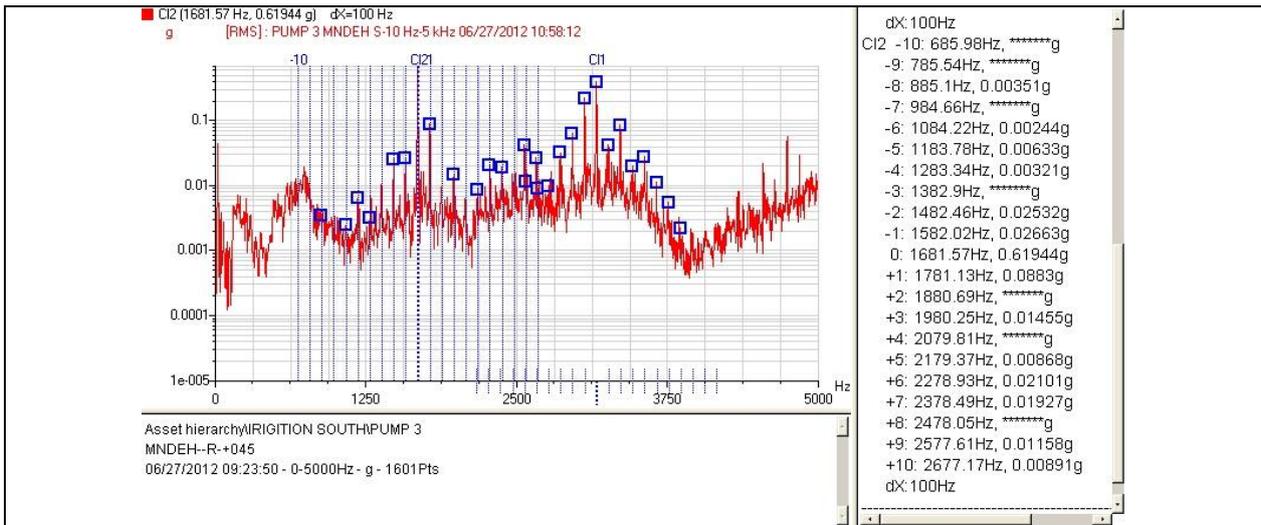
(b) motor drive side horizontal

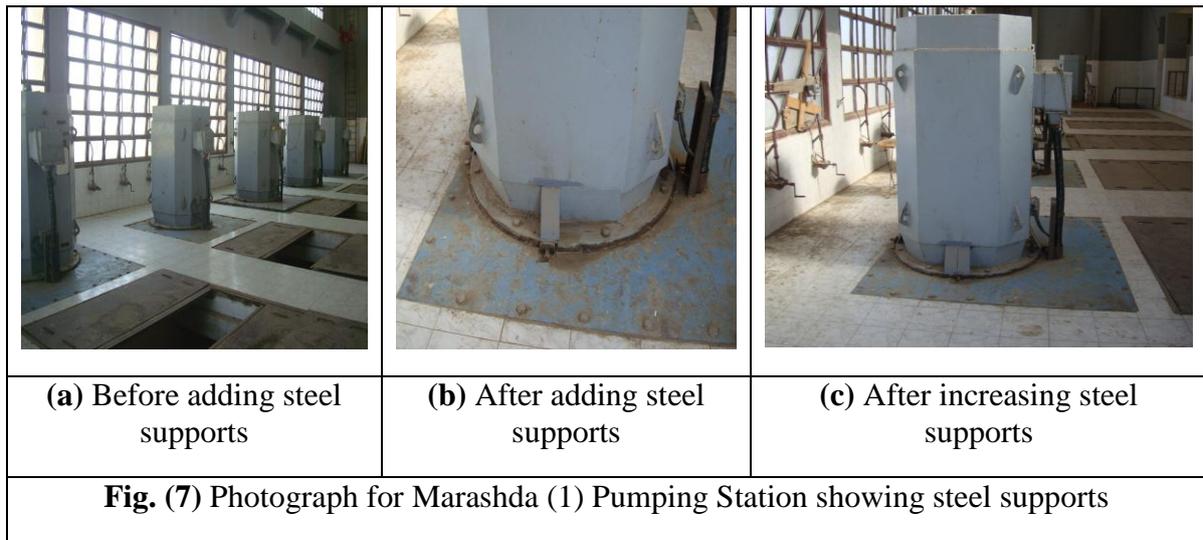
Case 4: results and discussions after increasing steel supports for pump (1) at full load

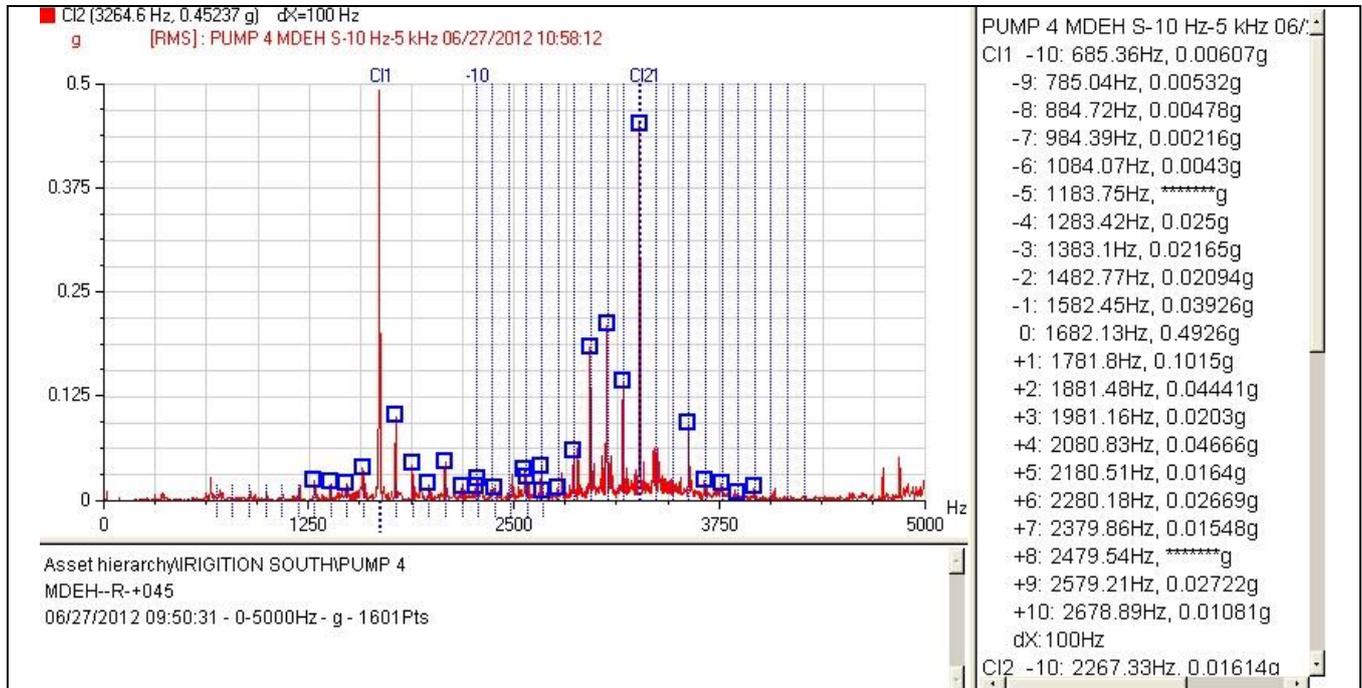
(a) motor non drive side horizontal
