FRACTOGRAPHY OF FAILED AUTOMOBILE ABSORBER SPRINGS

¹Peter Odesanmi Ojo, and ²Olanrewaju Retime Bodede ^{1,2}Department of Mechanical Engineering Technology Rufus Giwa Polytechnic, Owo. Ondo State.

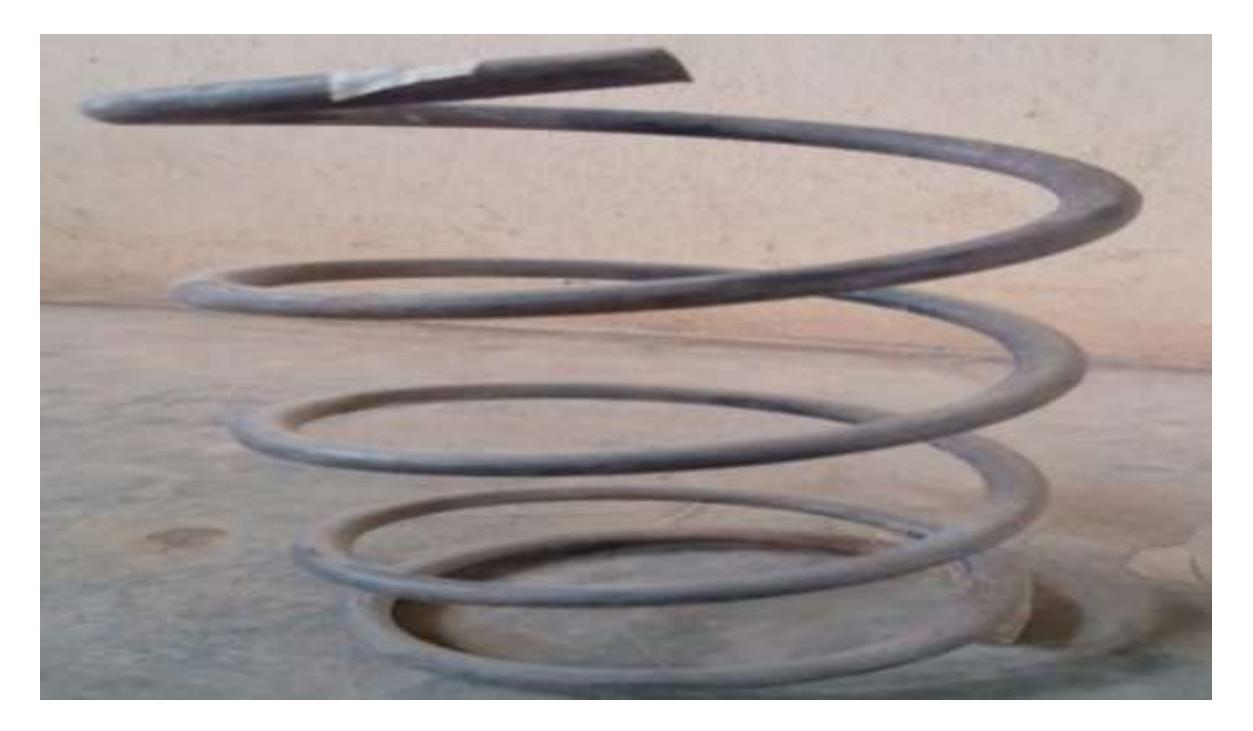
Plate 1: Sample of Failed absorber Spring

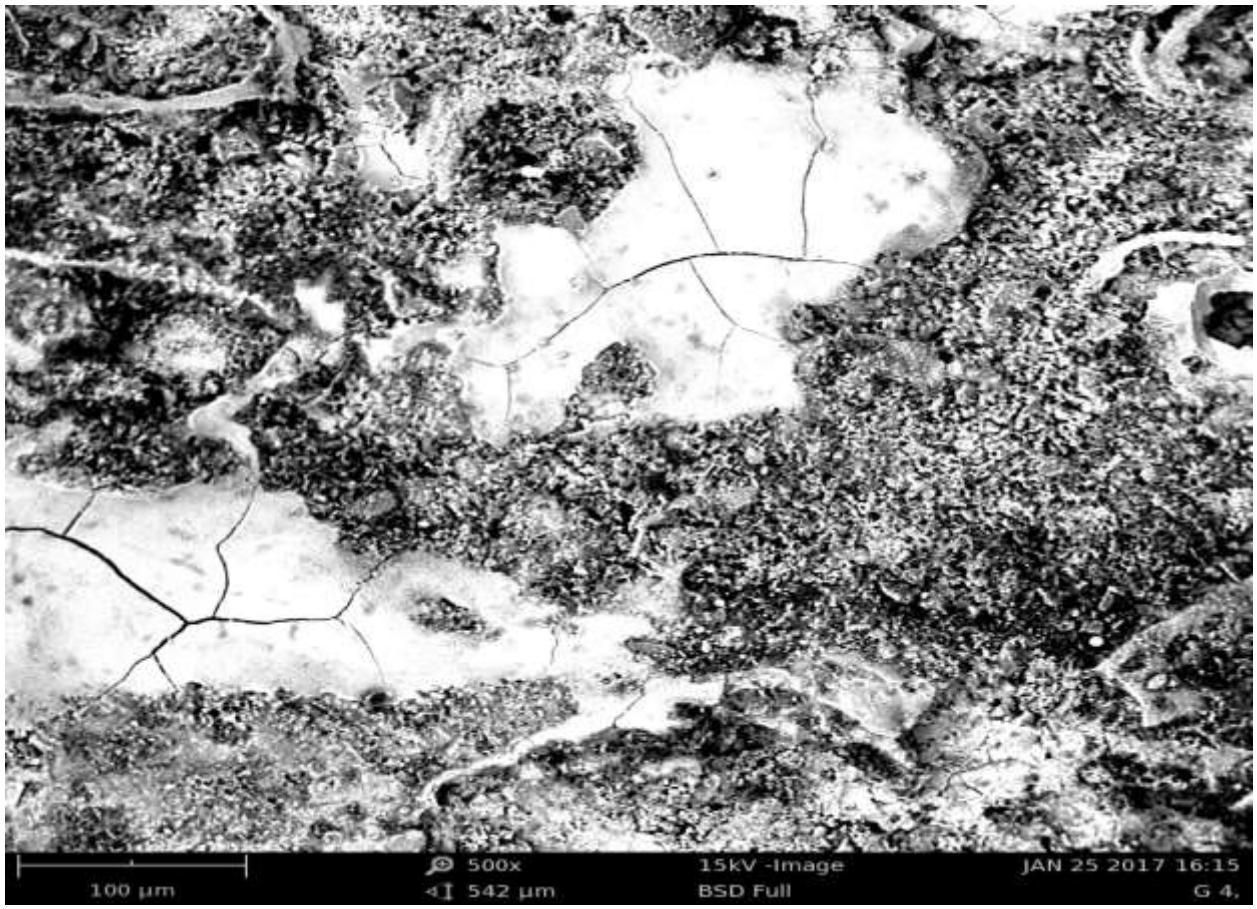
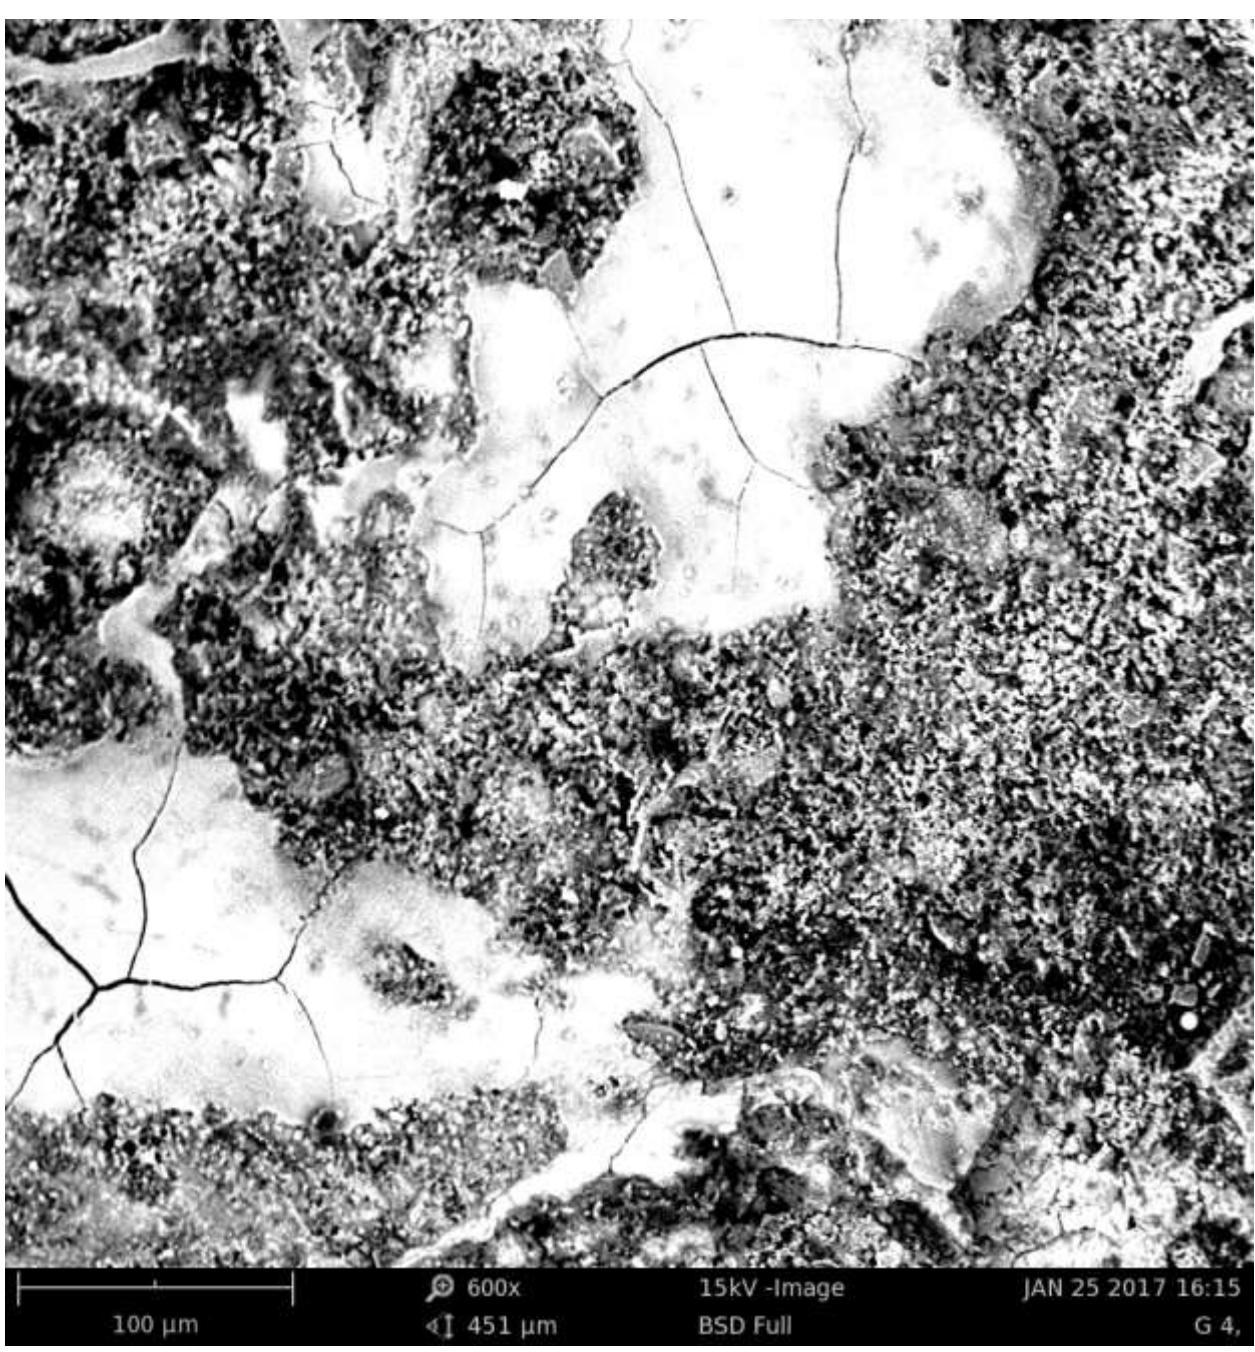
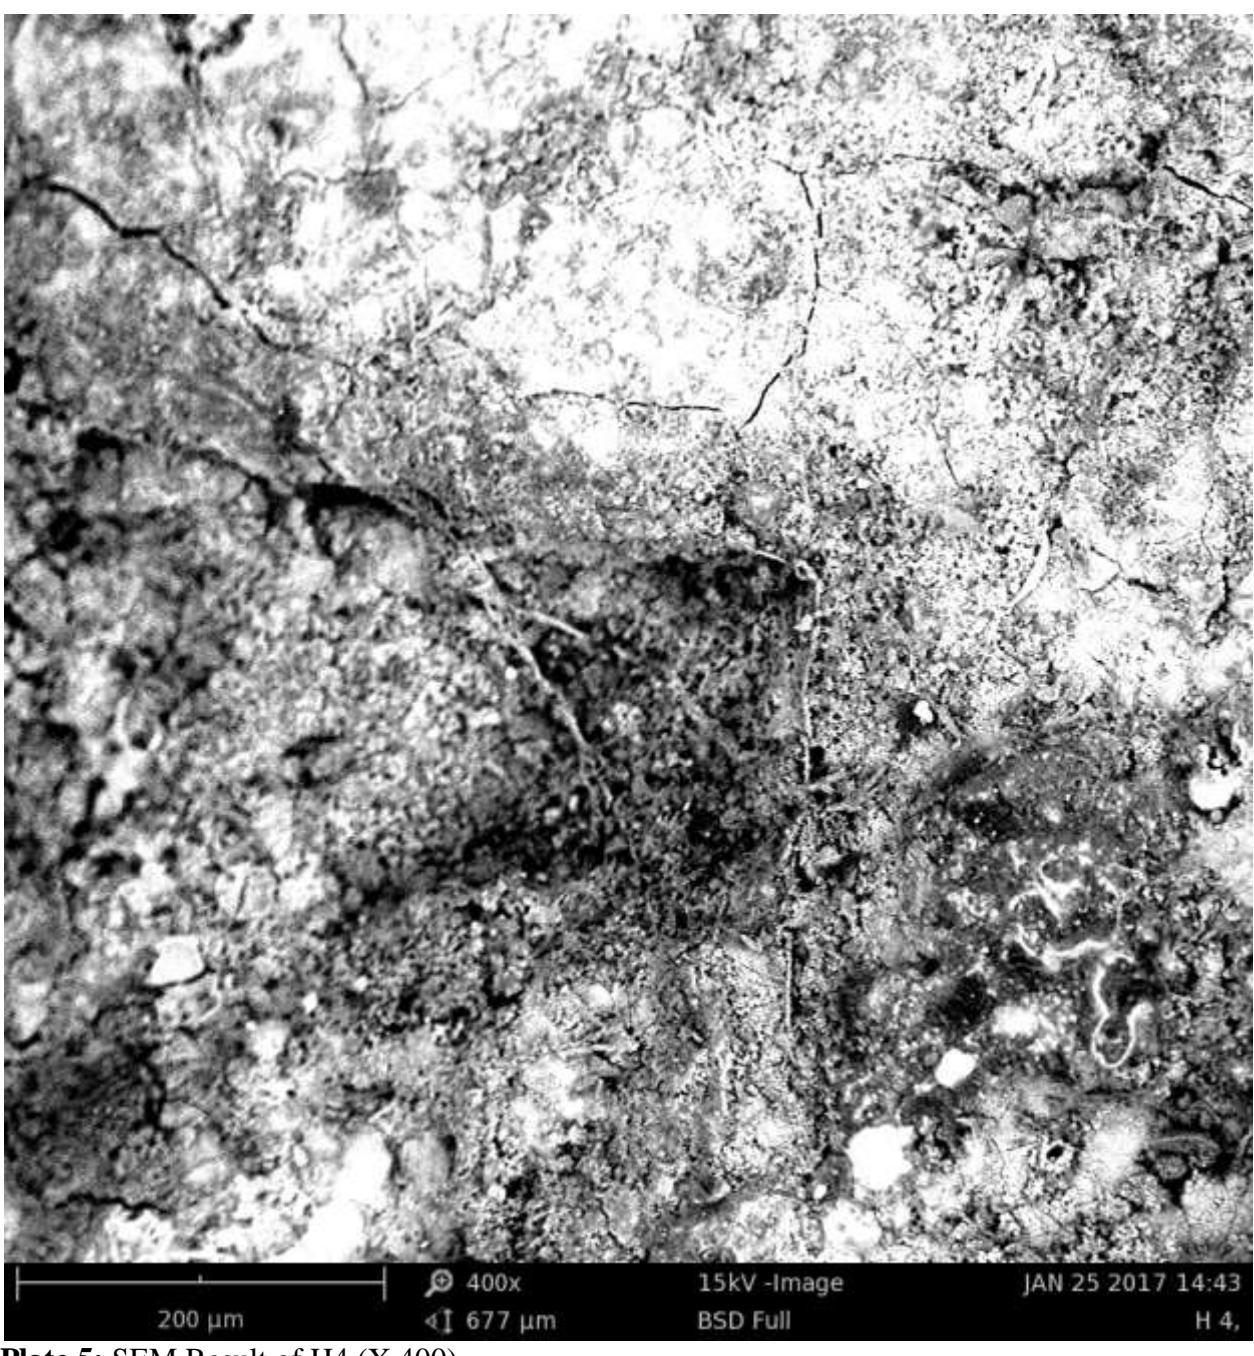
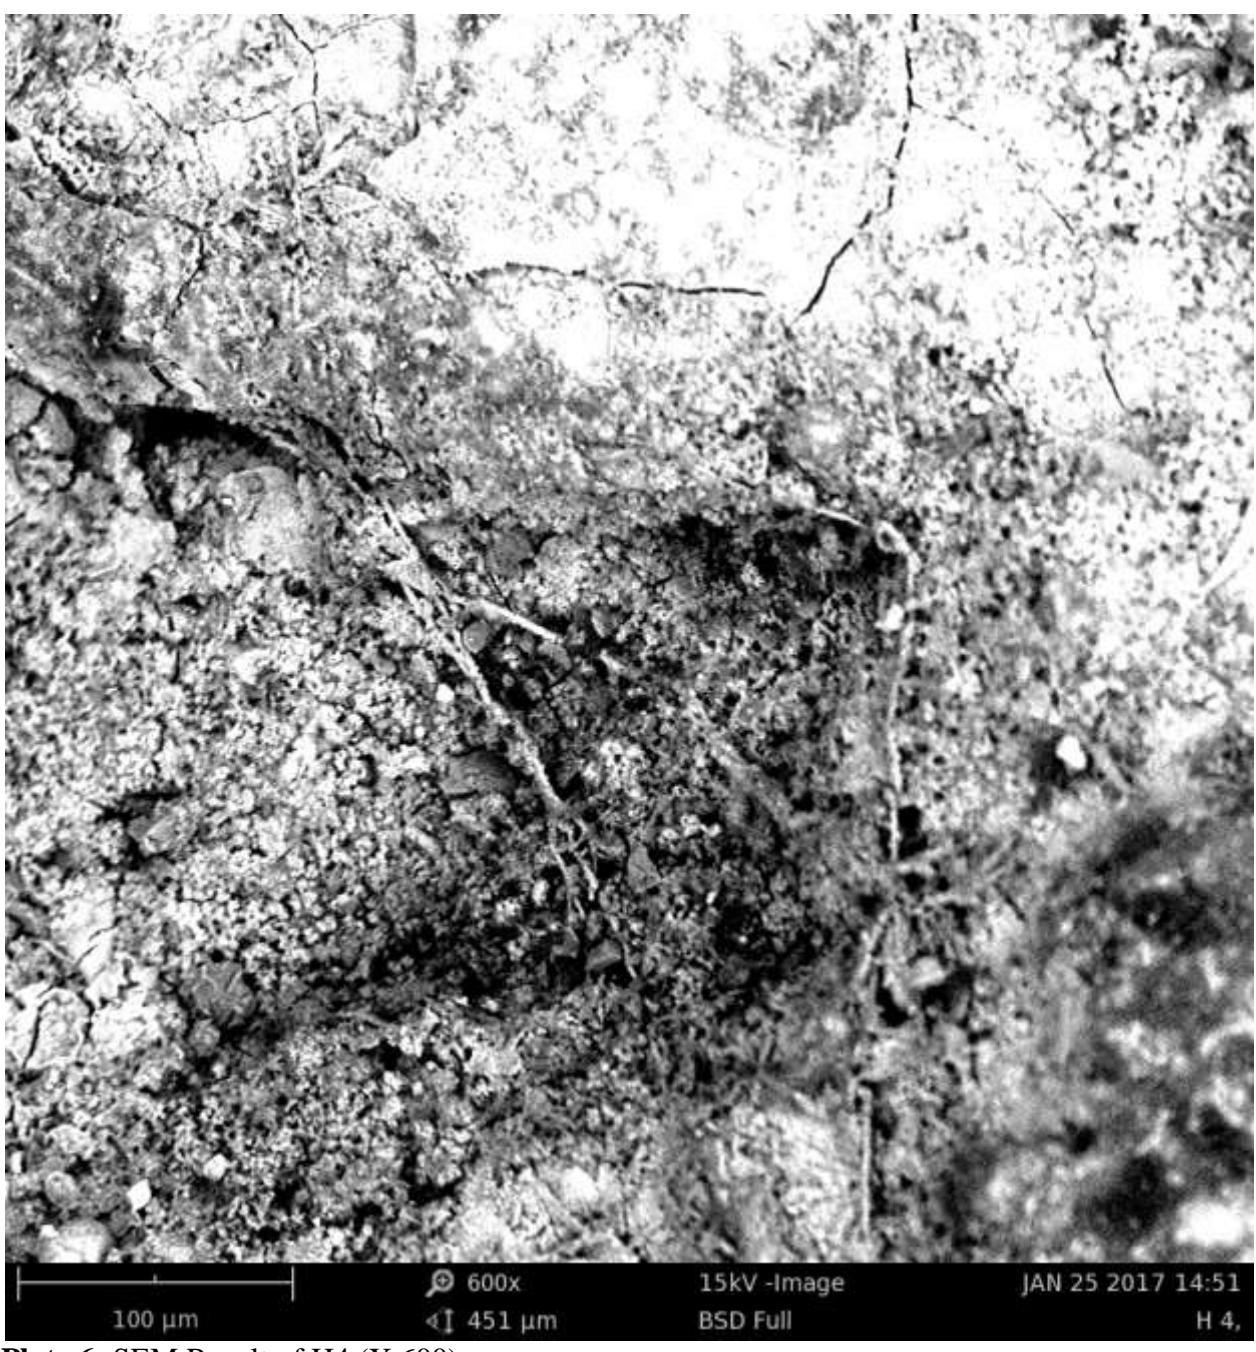
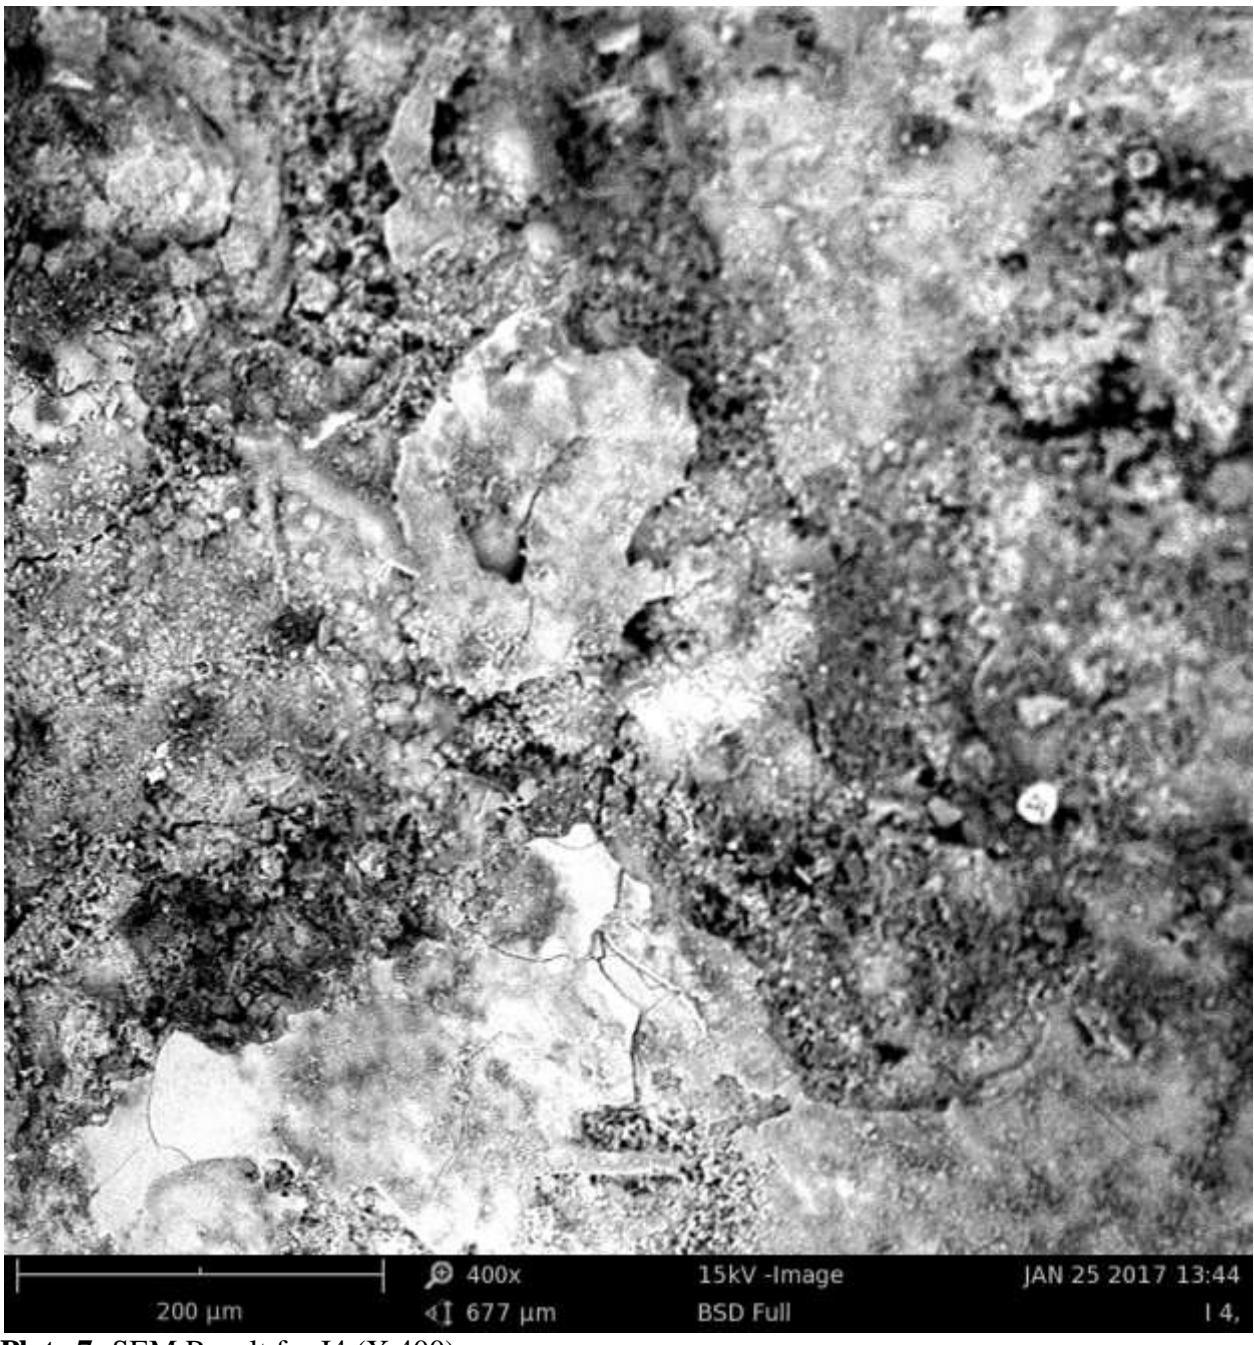
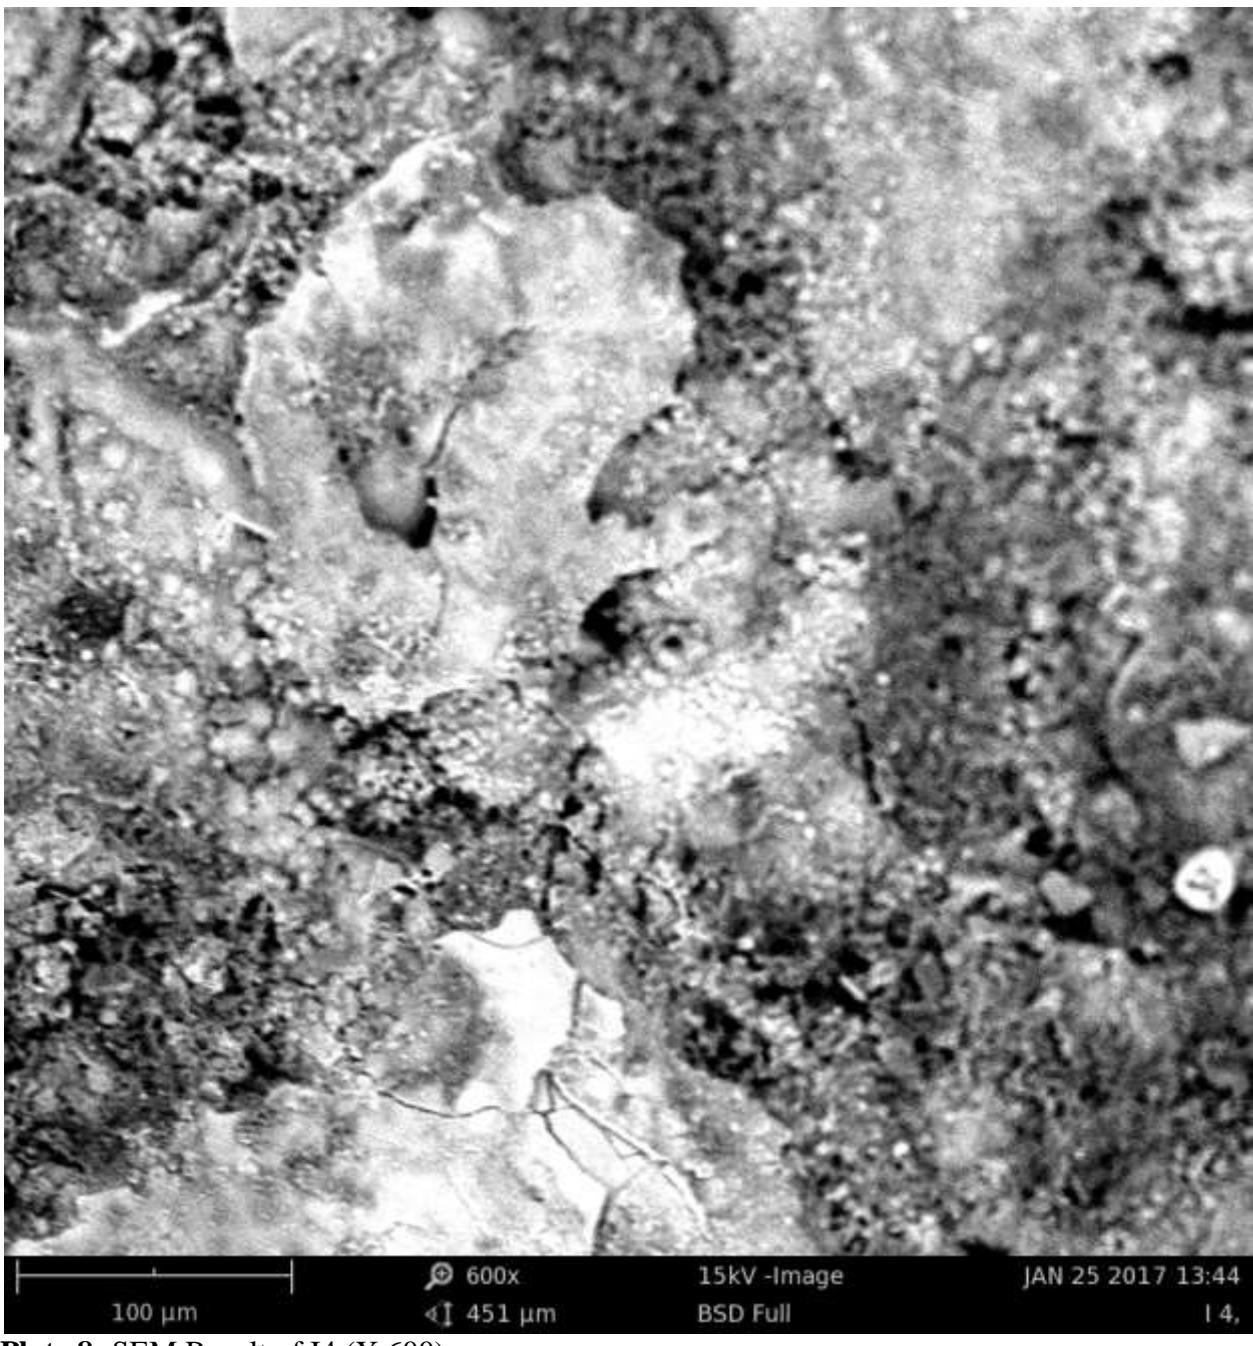
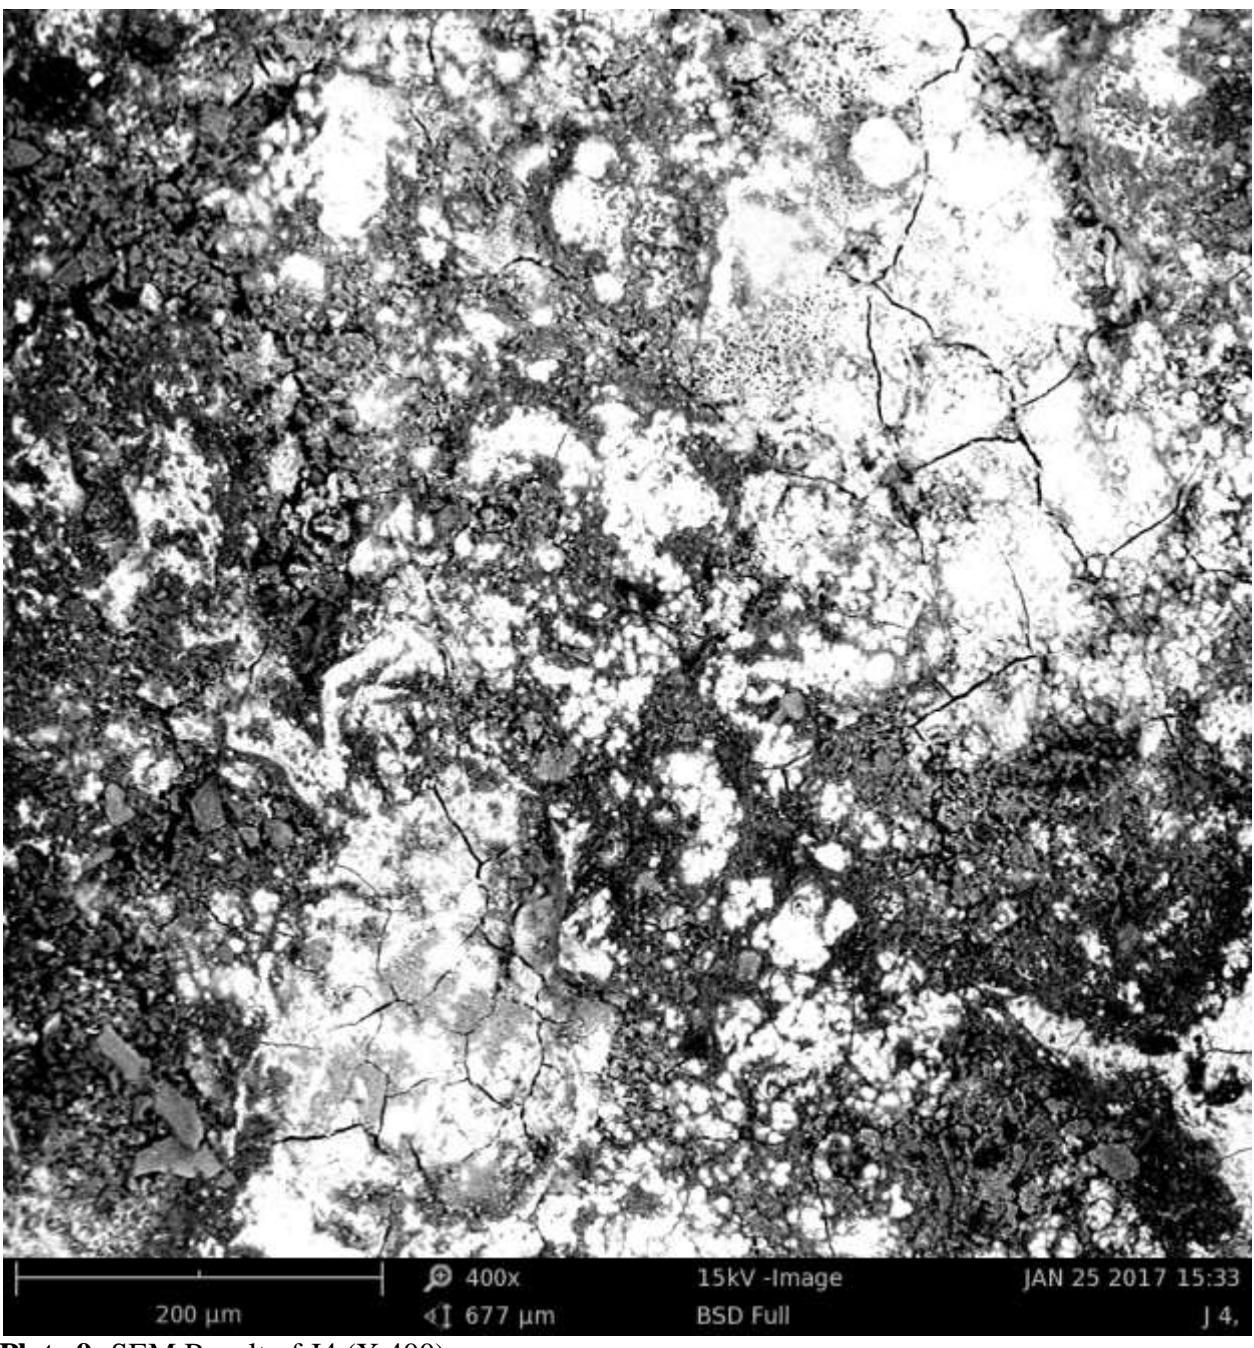
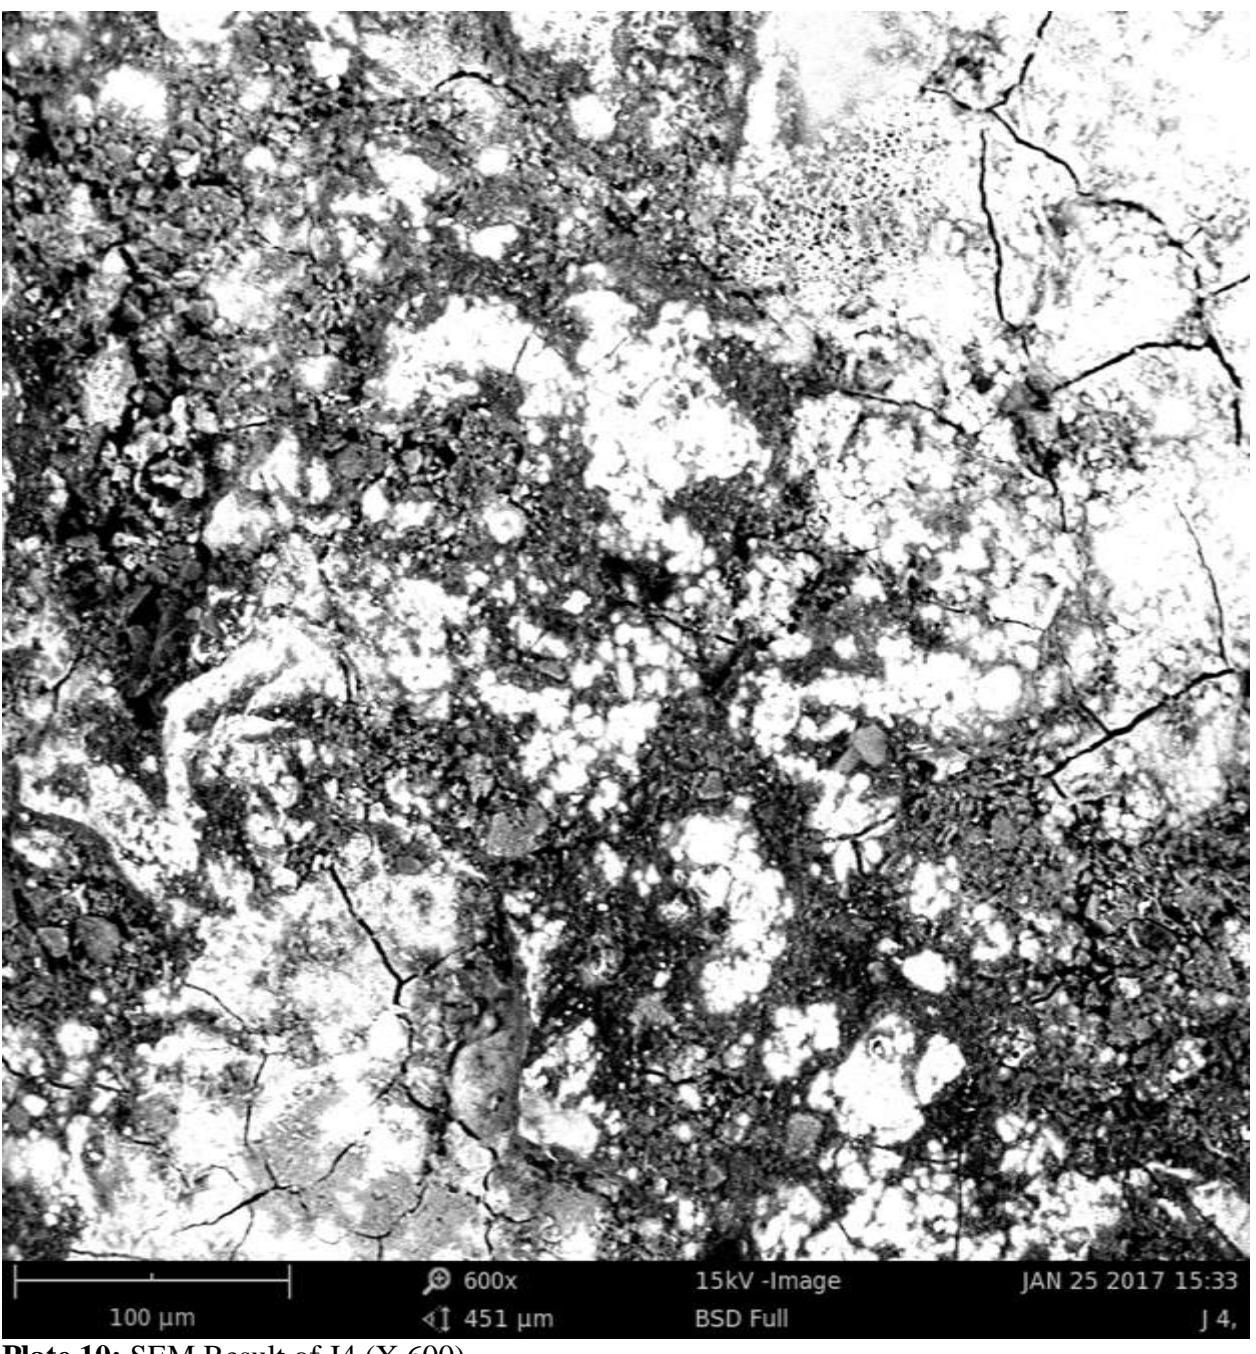
The elemental composition of the steel making up the spring as determined by the SEM with EDS is presented in Table 1, the result of the hardness testing is presented in Table 2 while the electron microscopy results are presented in Plates 3 - 10. Plates 11 - 20 show the micrographs of the samples after. It was observed that the protective layers on the surfaces of the failed springs were damaged the combination of corrosion and fatigue led to the fracture of the samples. From the fractured surface, crack gradually propagated due to the combination of corrosion attack and cyclic loading during motion.
