FRACTOGRAPHY OF FAILED AUTOMOBILE ABSORBER SPRINGS

¹Peter Odesanmi Ojo, and ²Olanrewaju Retime Bodede ^{1,2}Department of Mechanical Engineering Technology Rufus Giwa Polytechnic, Owo. Ondo State.

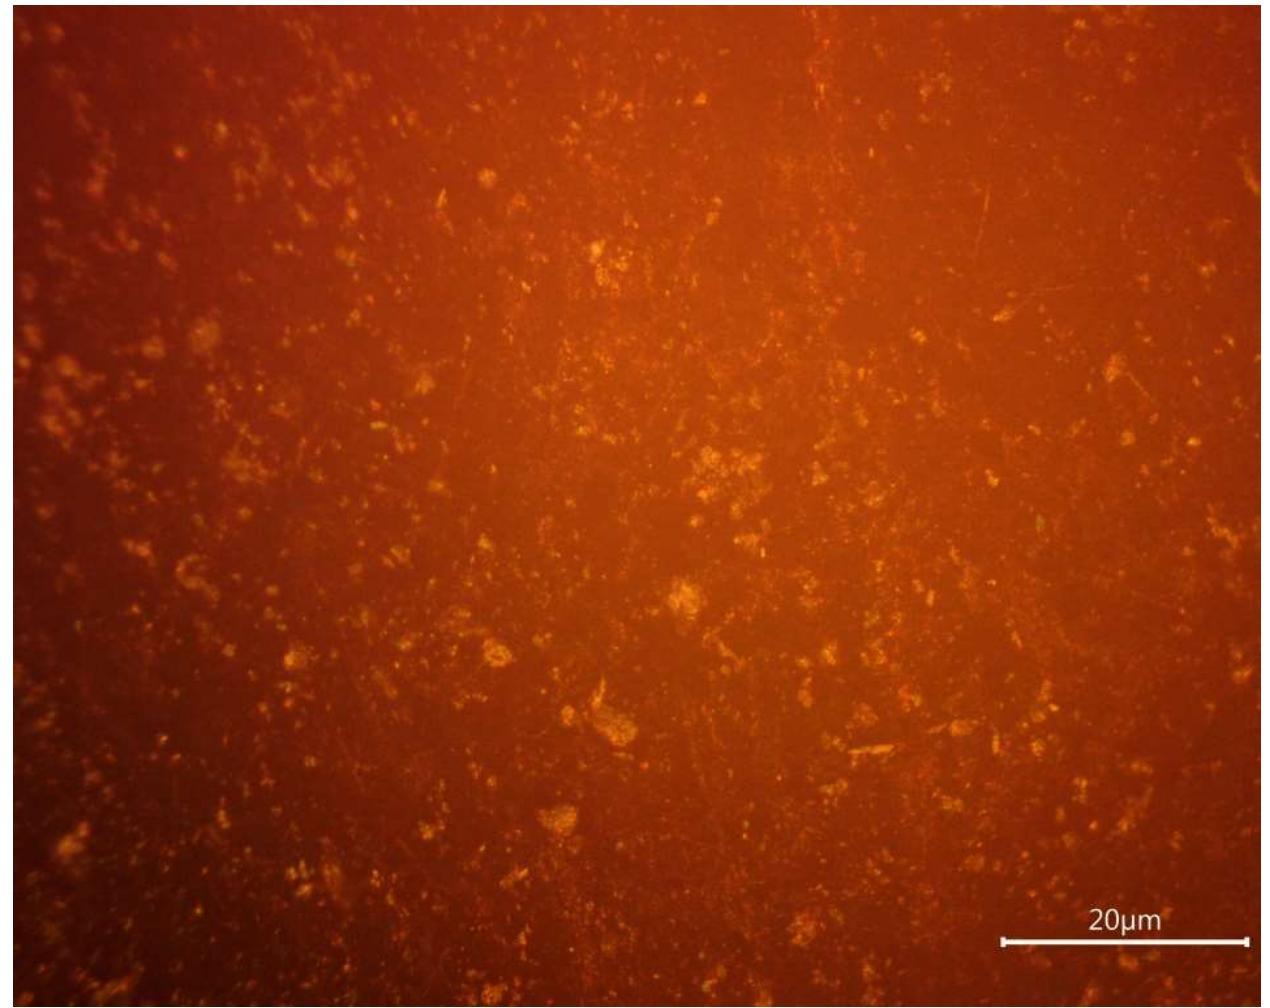
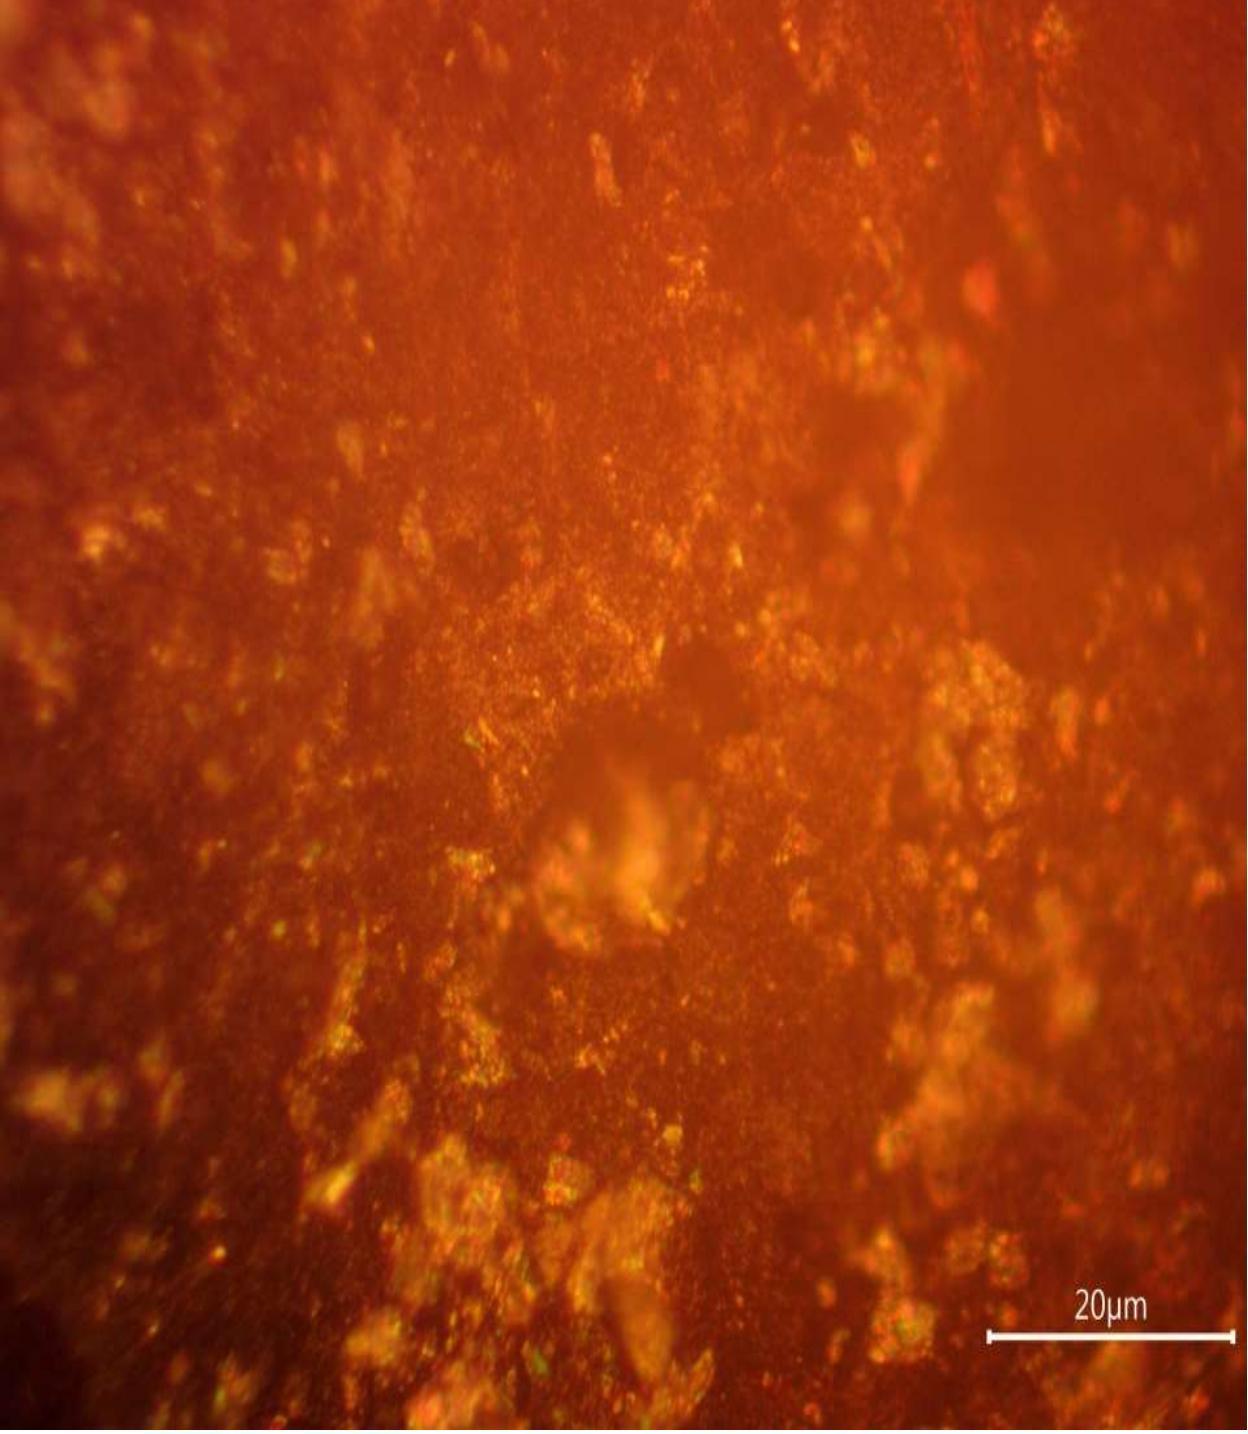
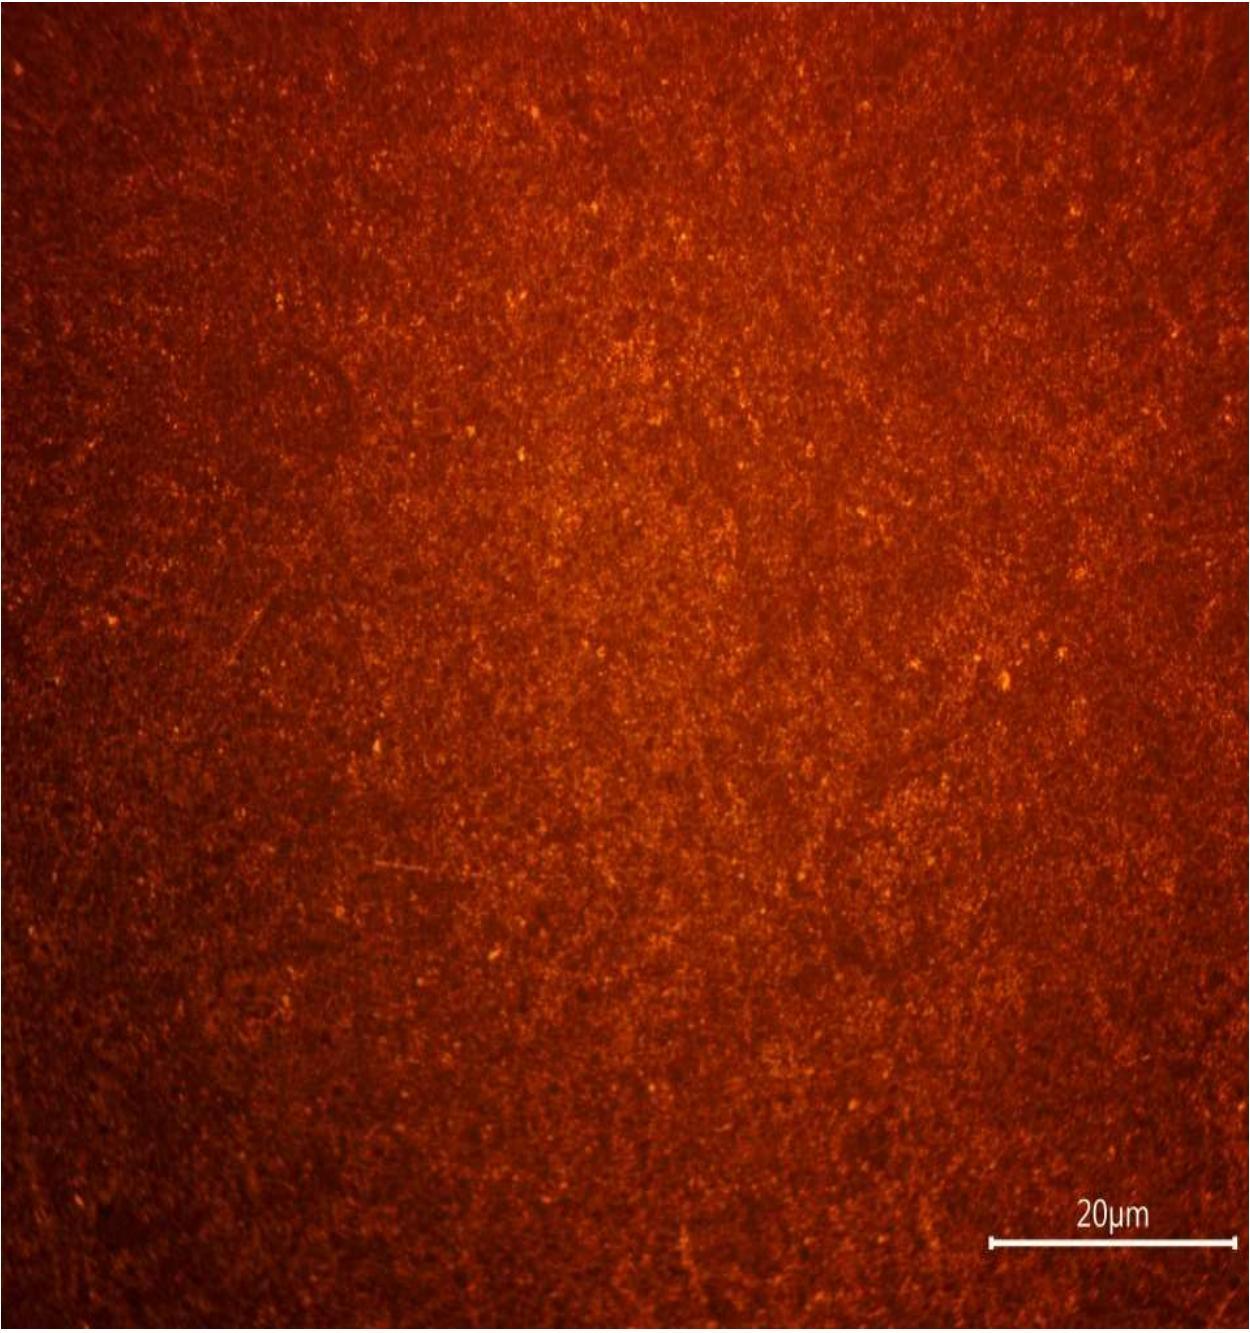
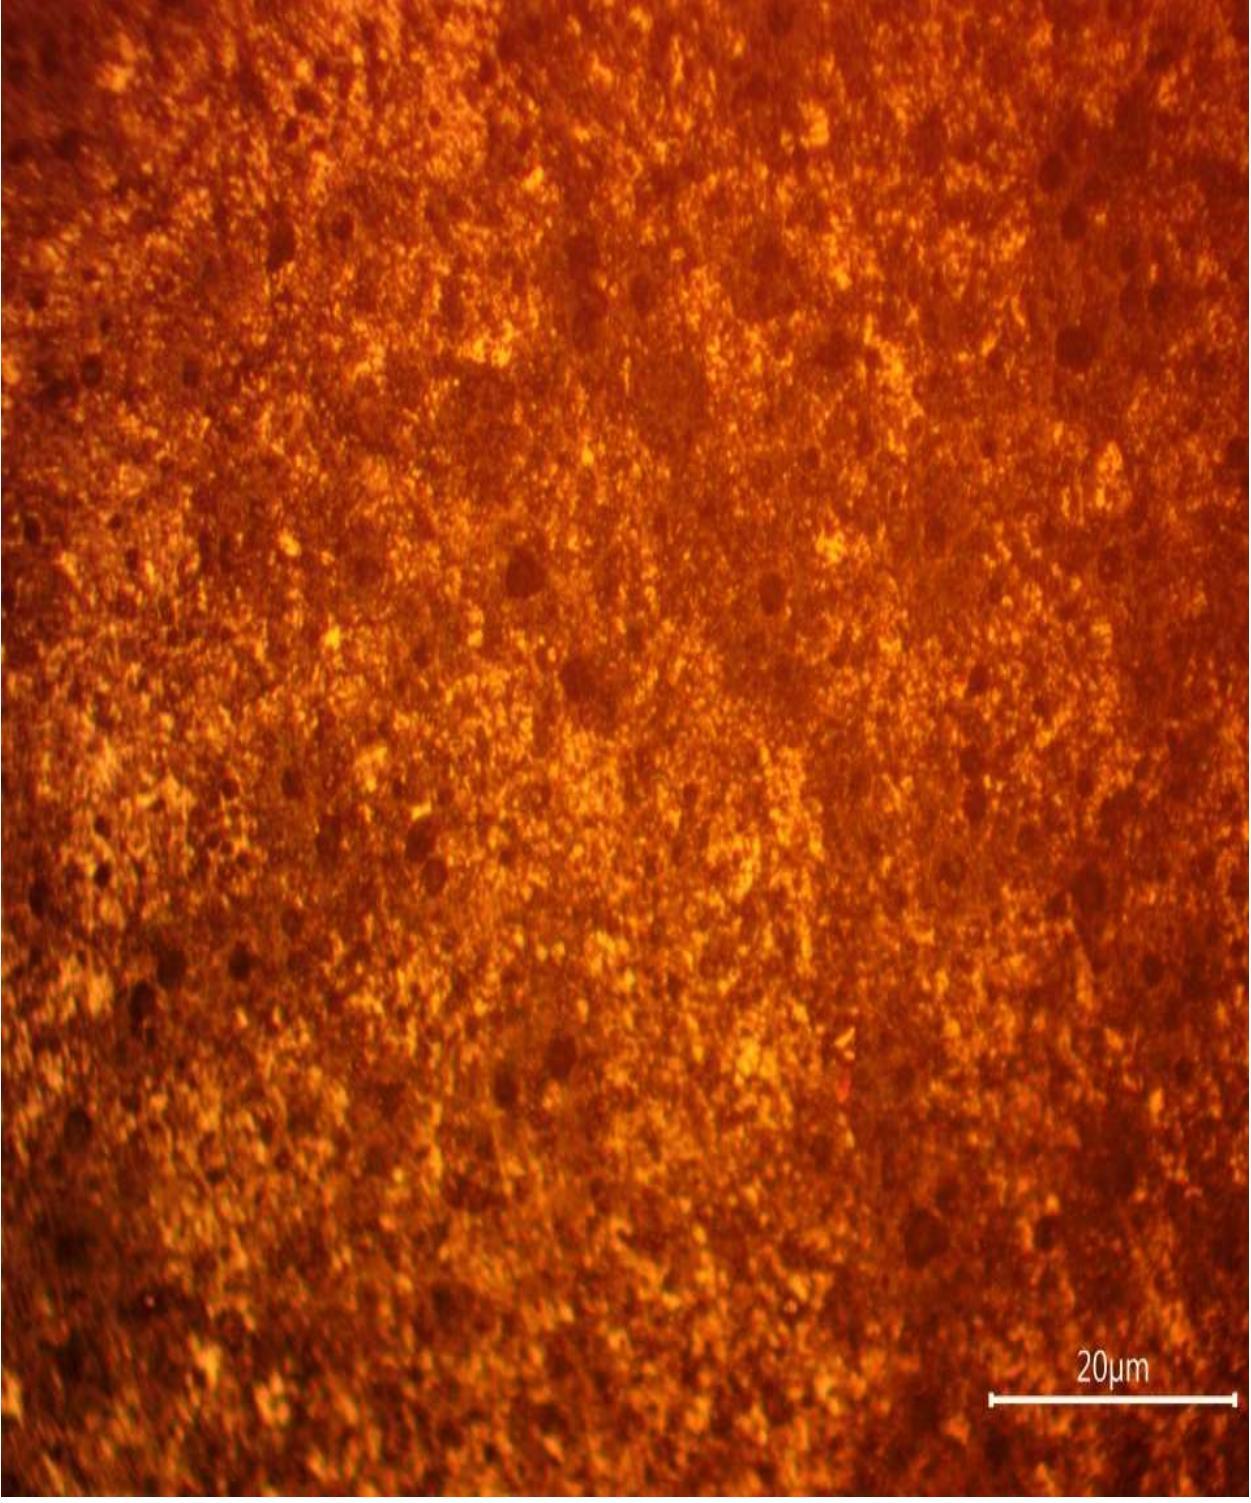
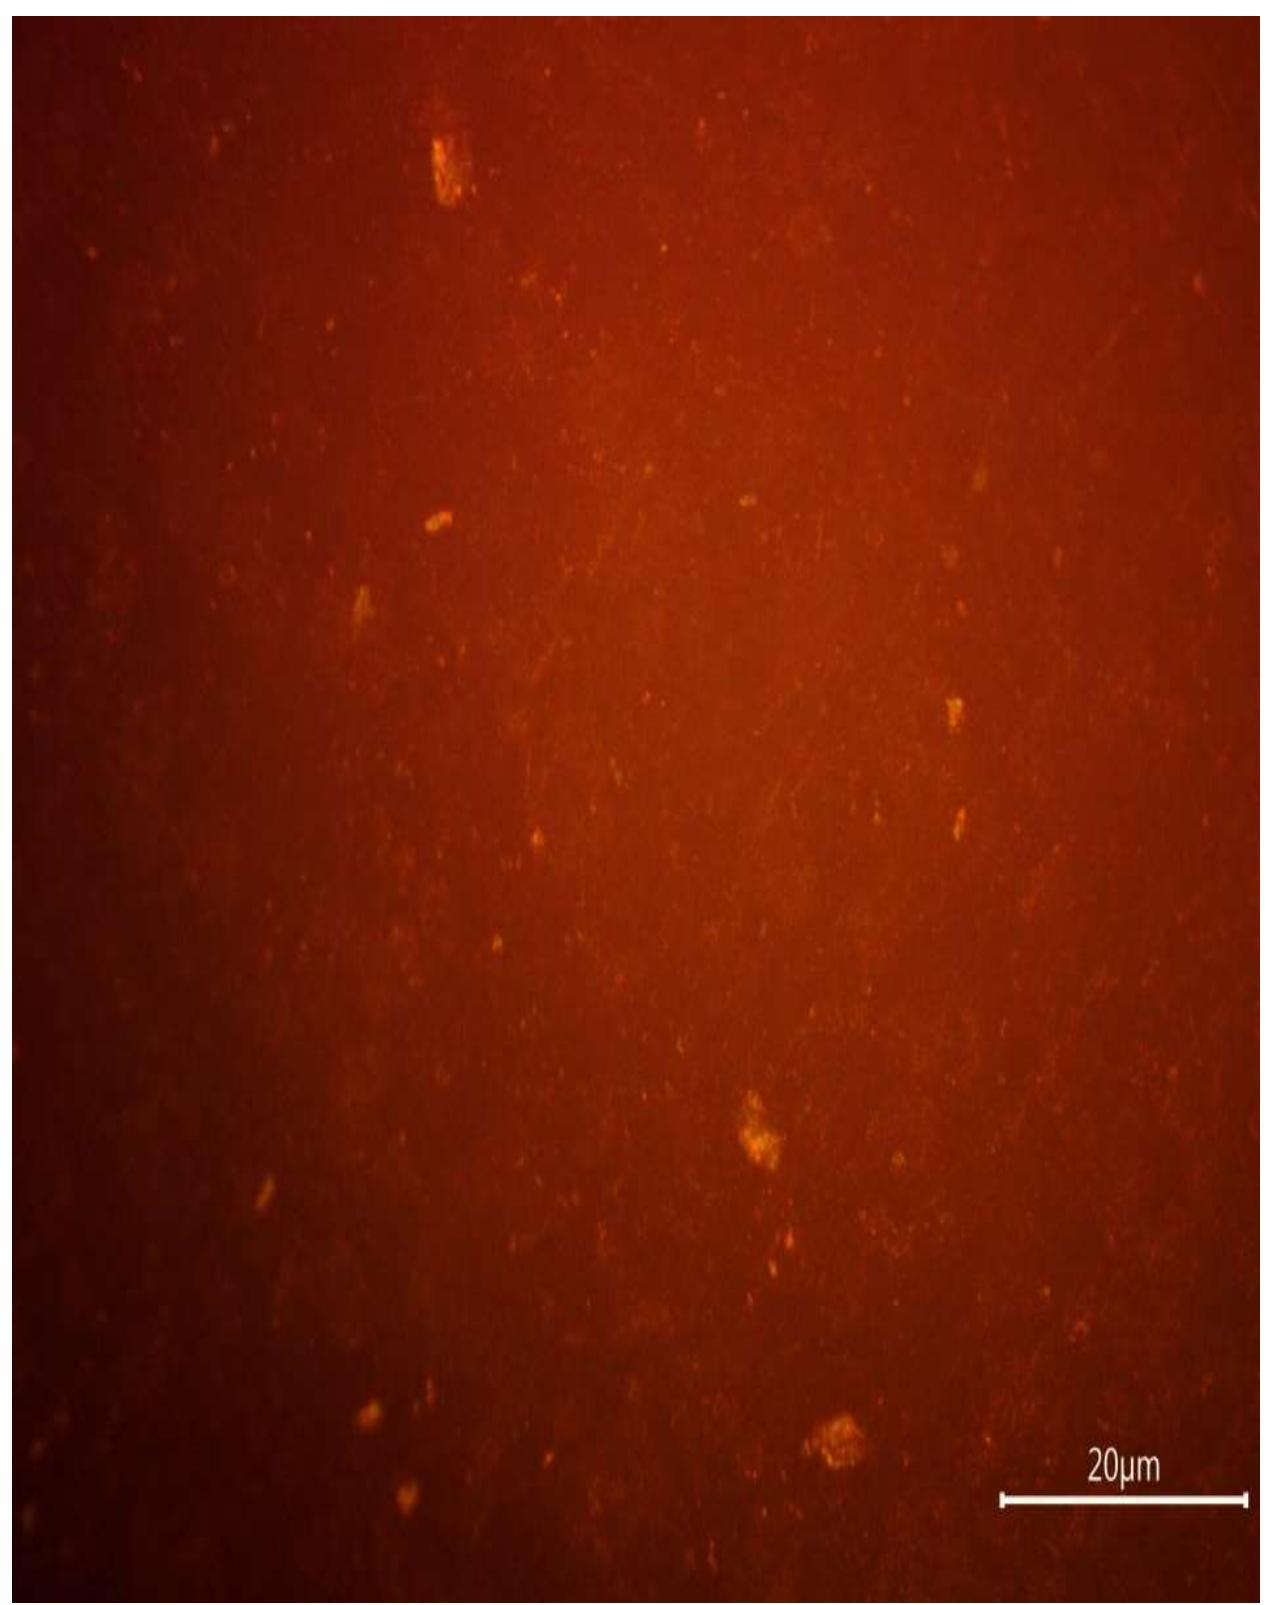
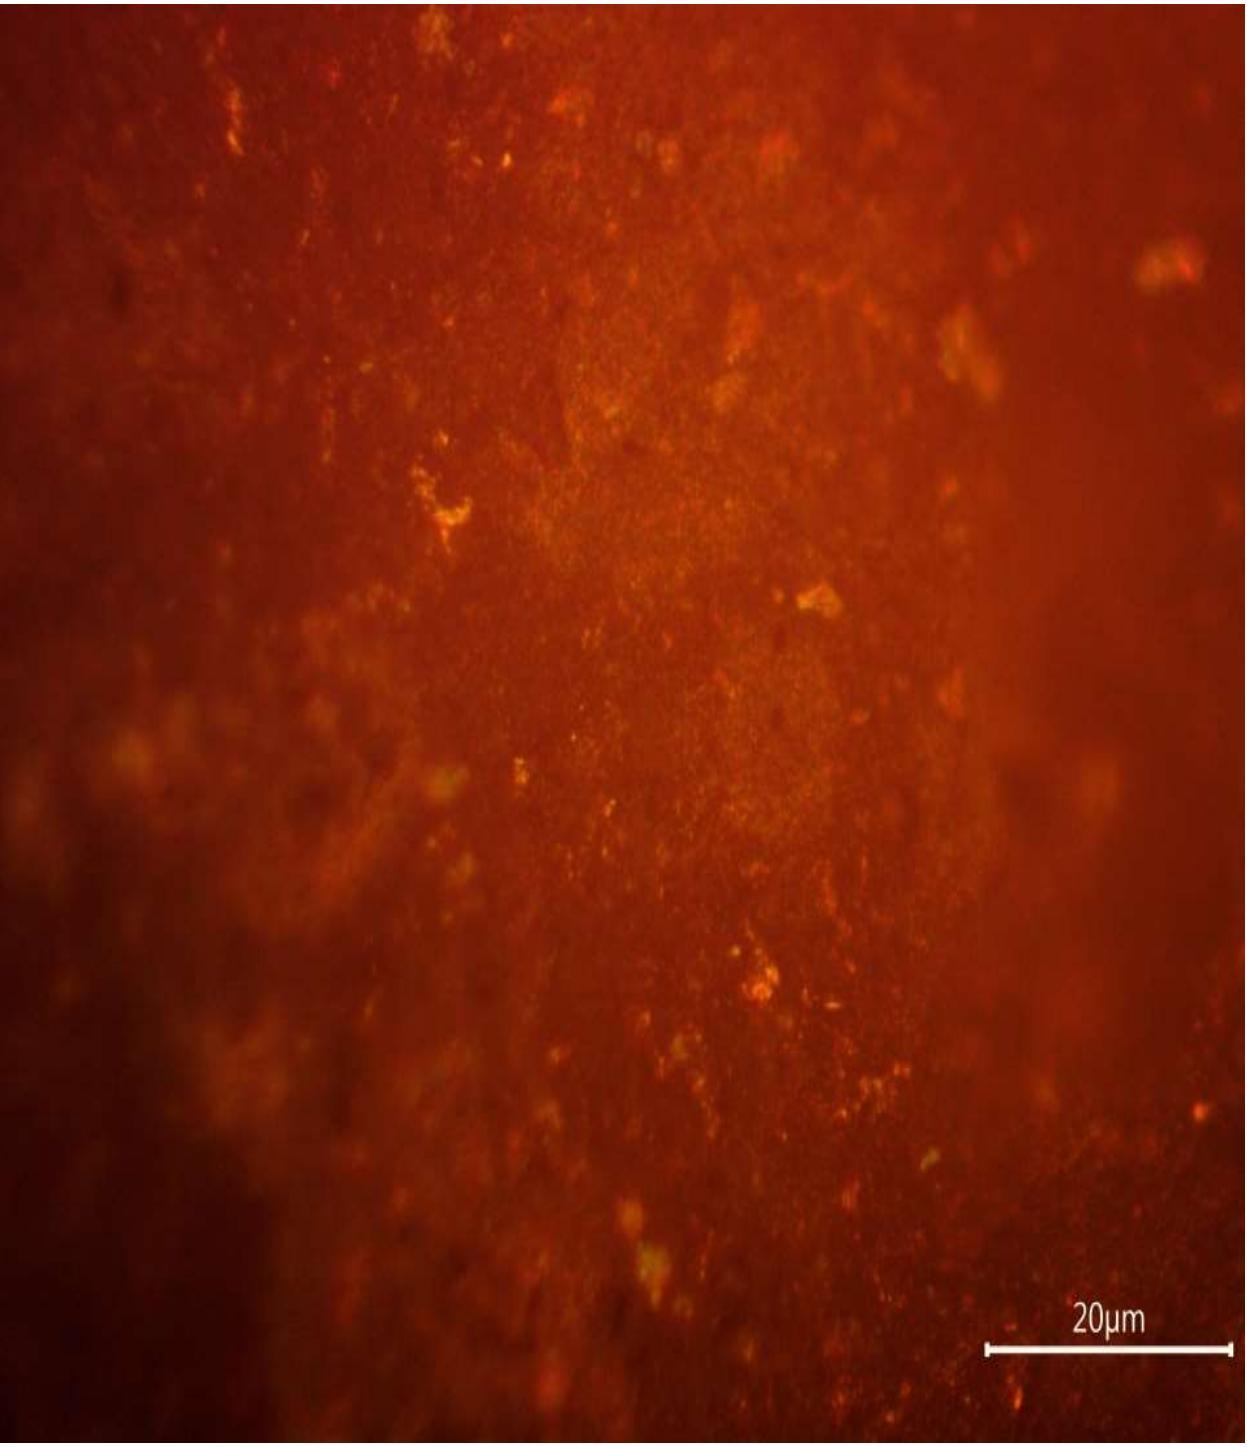
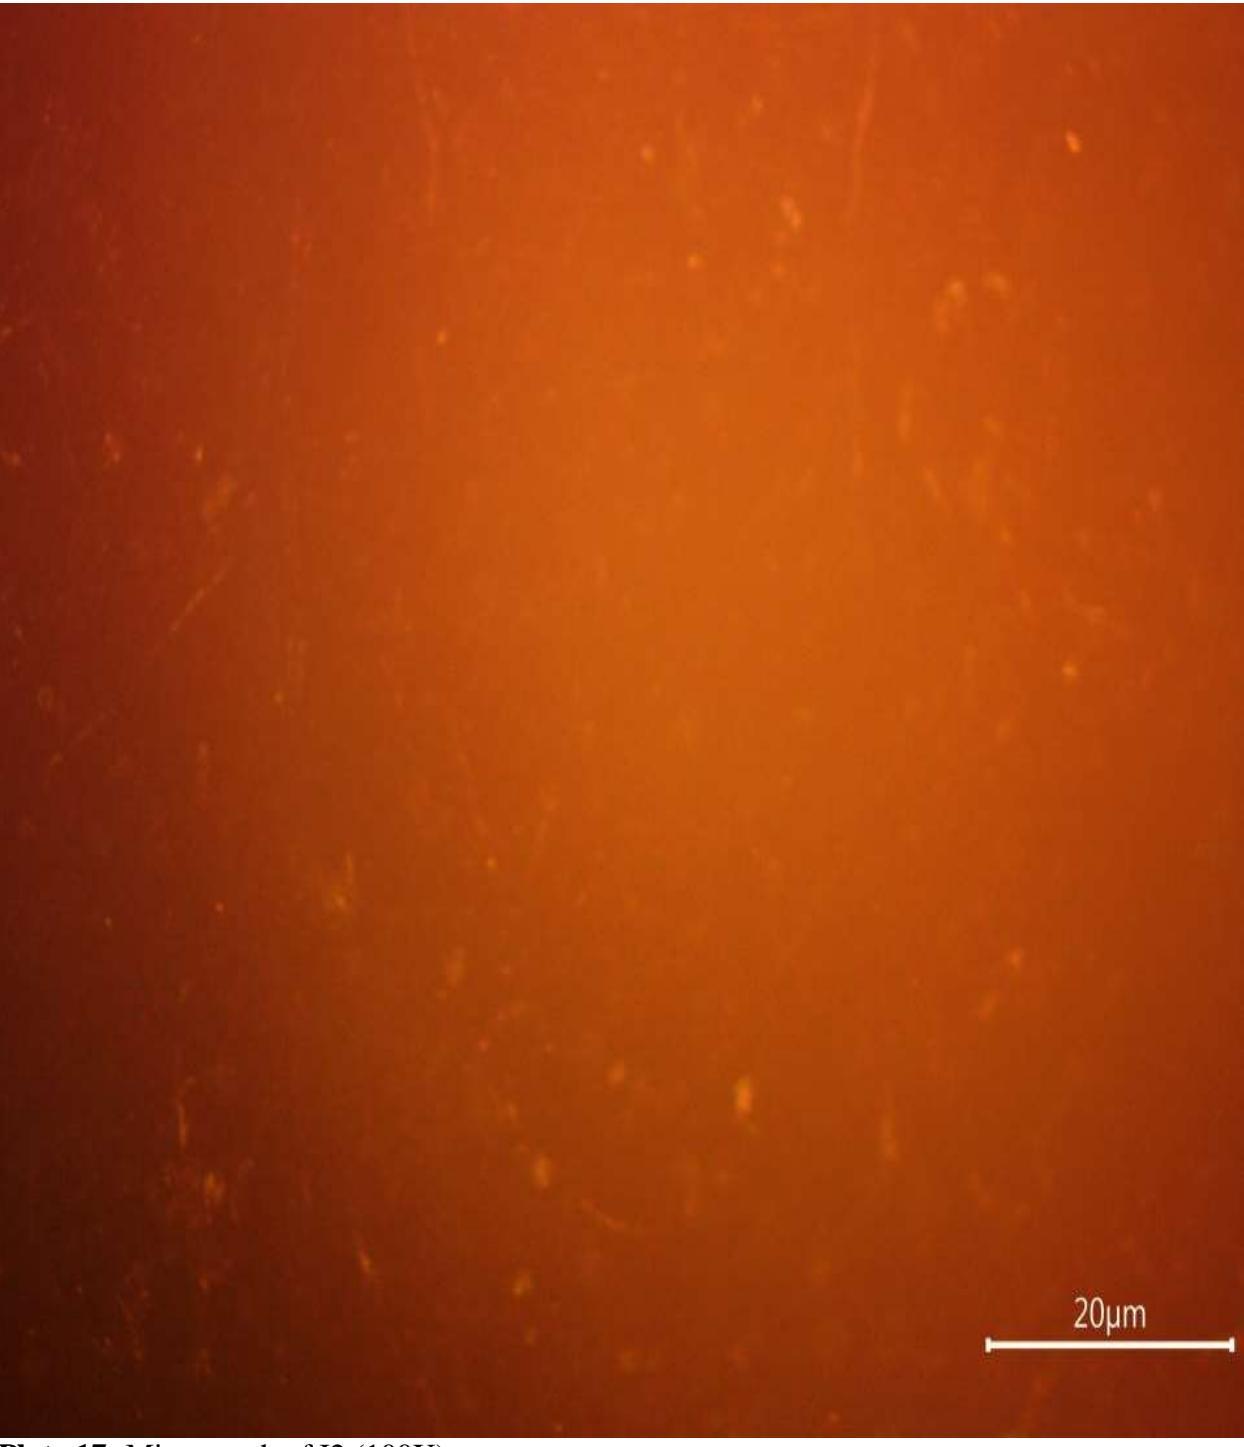
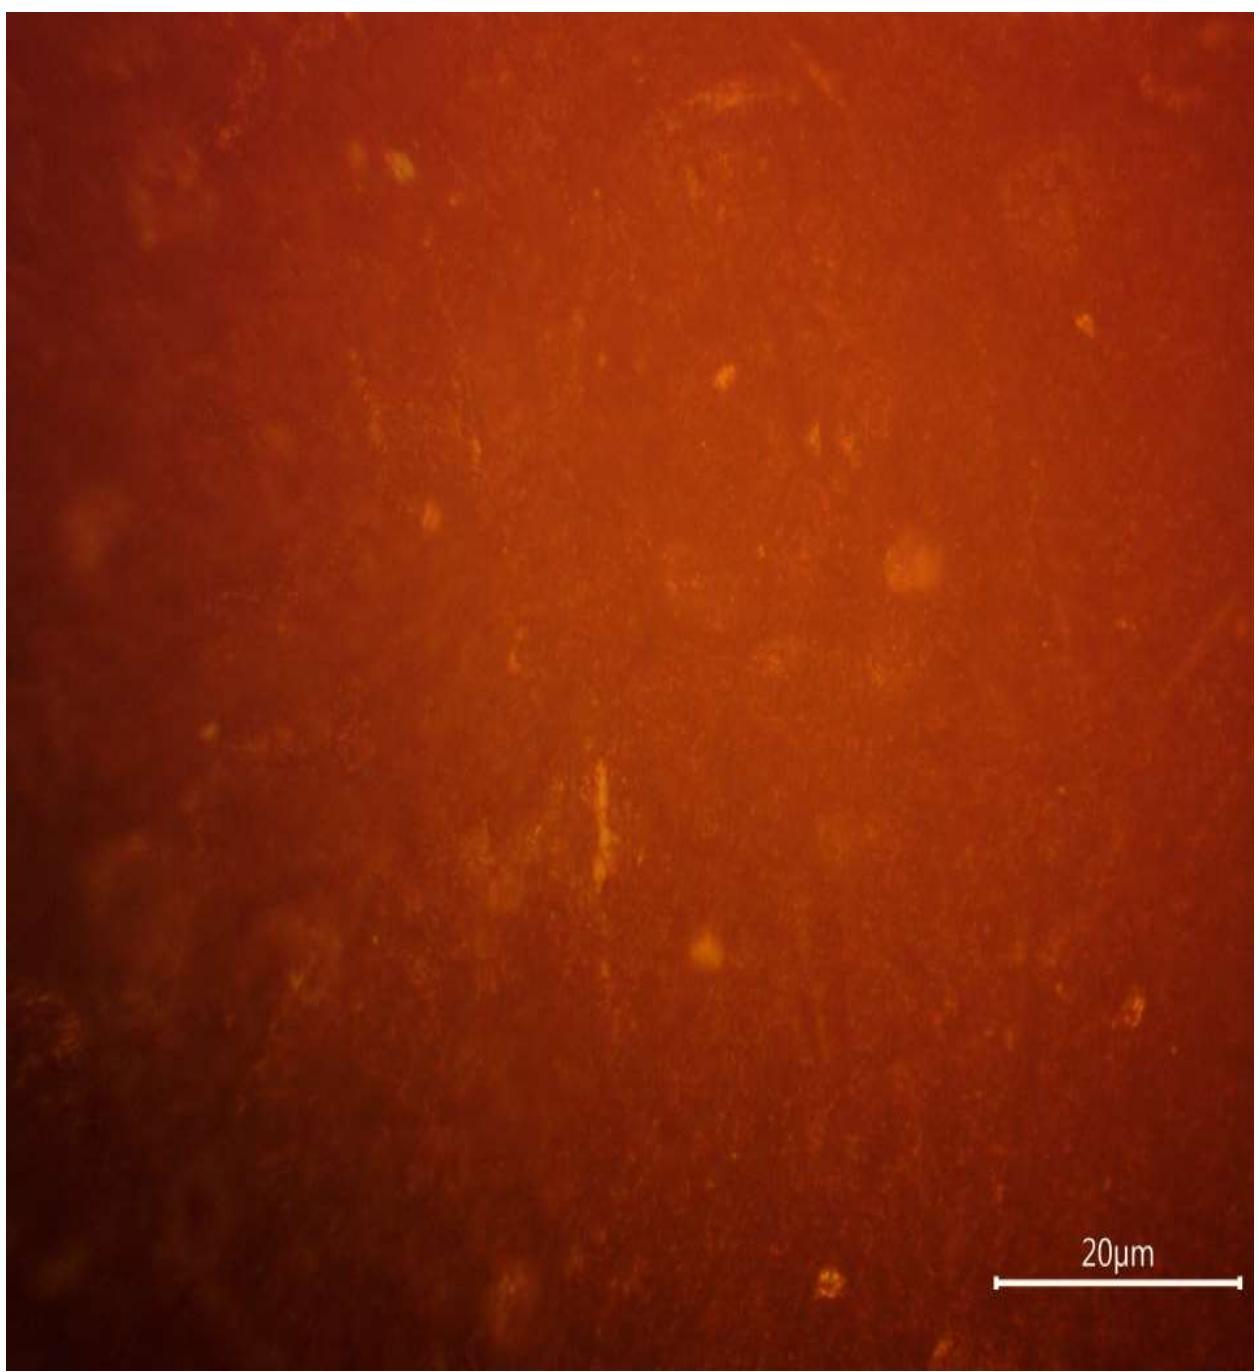
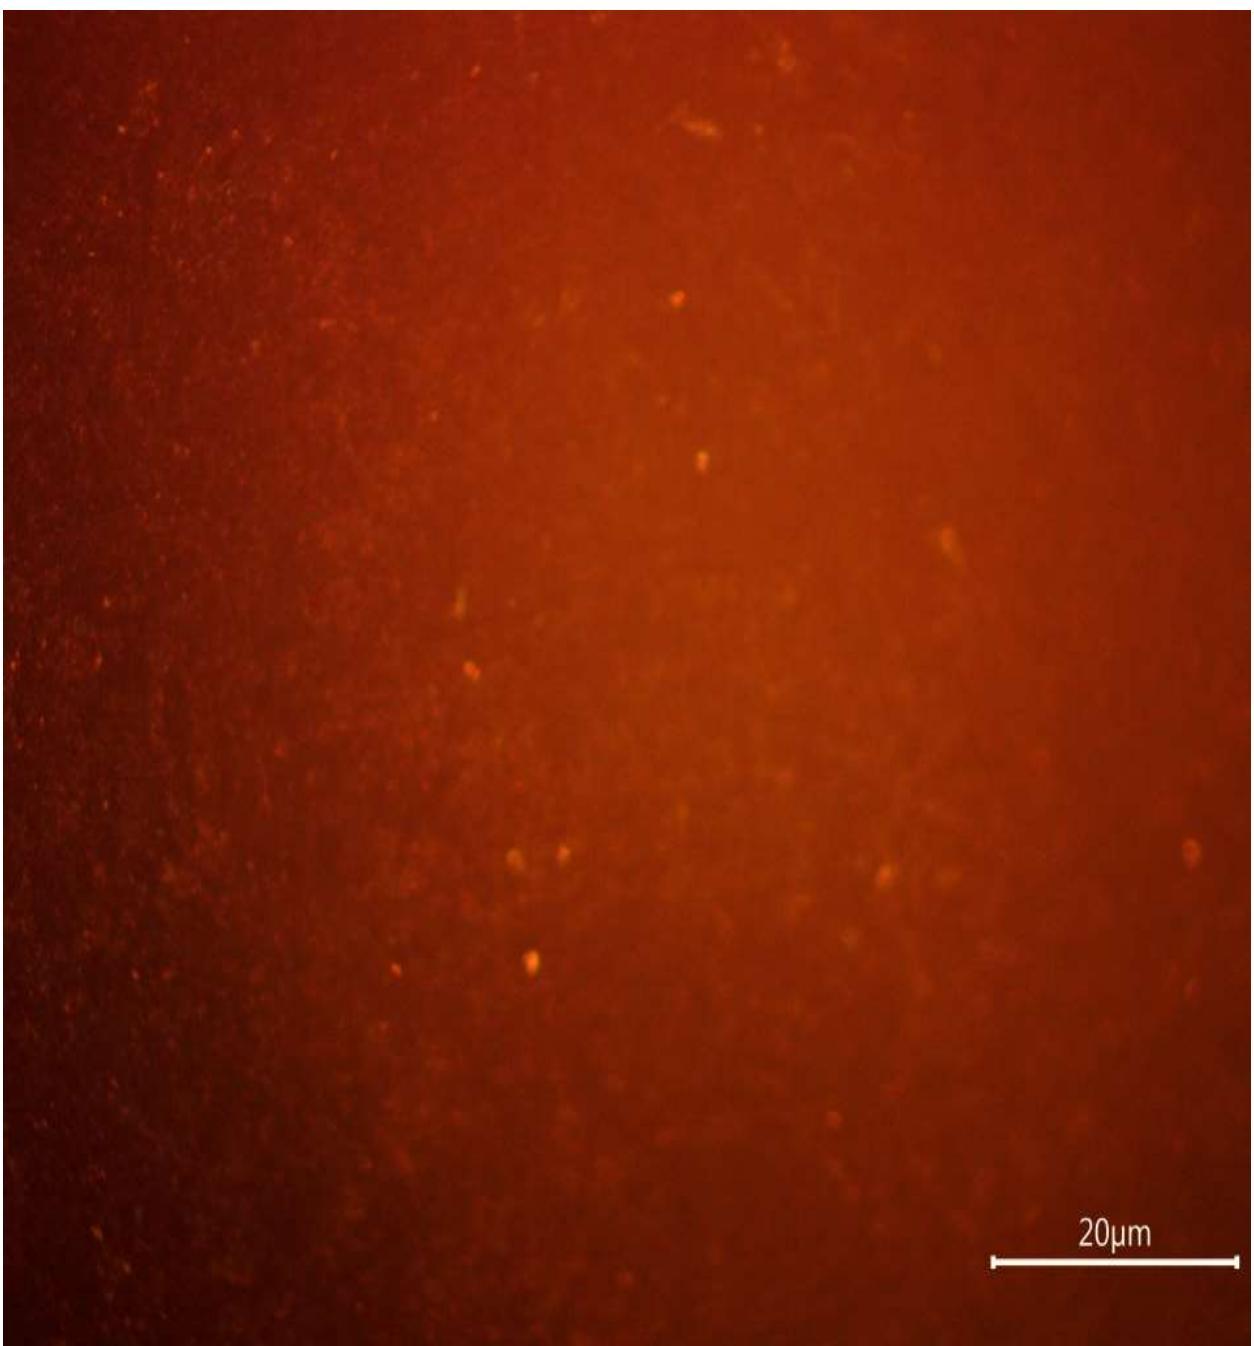
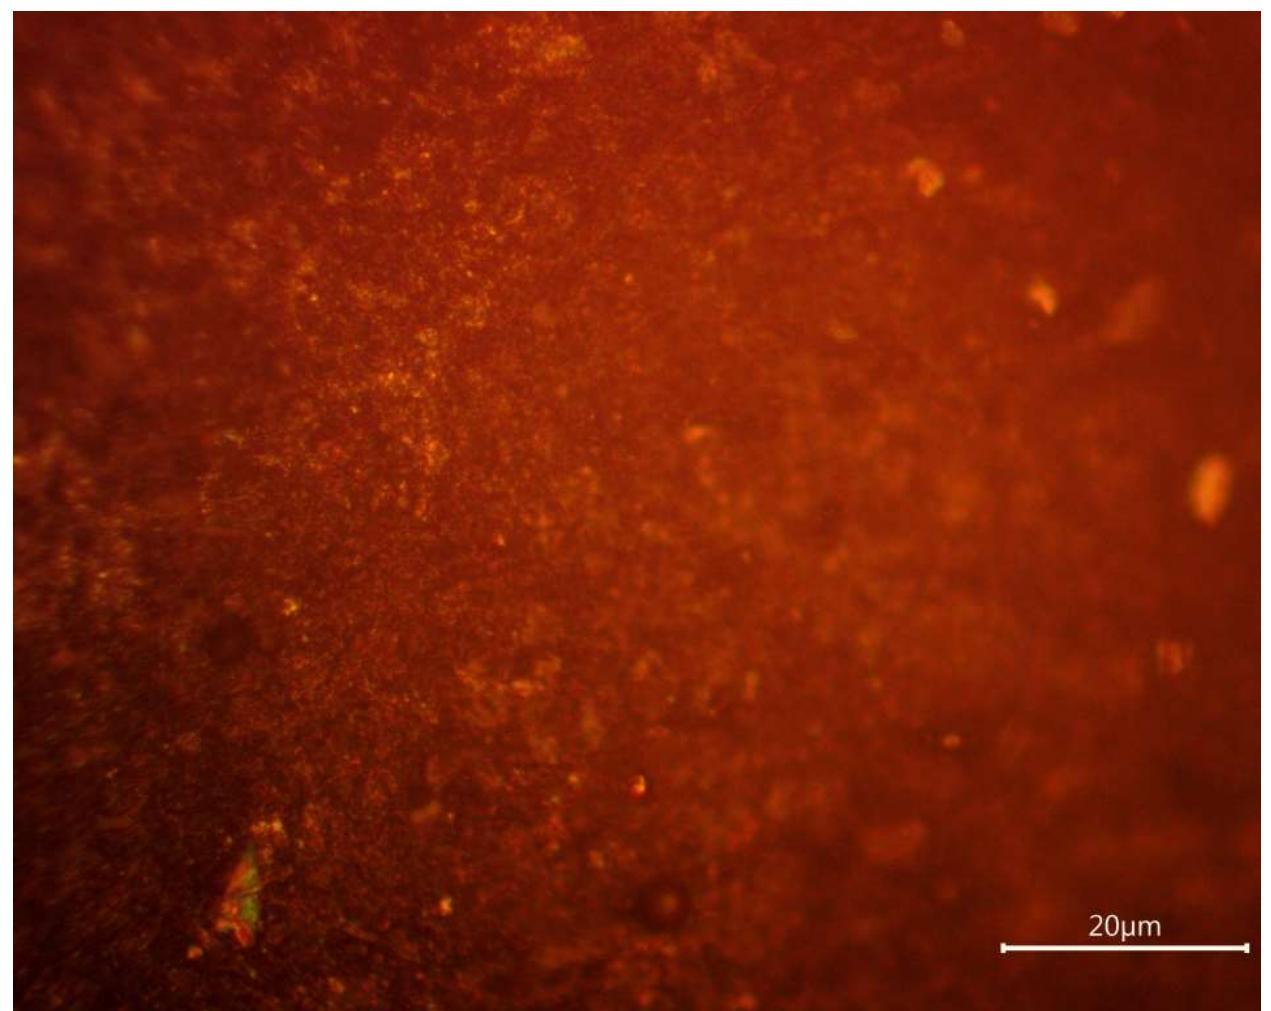
The elemental composition of the steel making up the spring as determined by the SEM with EDS is presented in Table 1, the result of the hardness testing is presented in Table 2 while the electron microscopy results are presented in Plates 3 - 10. Plates 11 - 20 show the micrographs of the samples after. It was observed that the protective layers on the surfaces of the failed springs were damaged the combination of corrosion and fatigue led to the fracture of the samples. From the fractured surface, crack gradually propagated due to the combination of corrosion attack and cyclic loading during motion.
