## **DEFECTIVE CONSTRUCTION IN RESIDENTIAL BUILDINGS: A STUDY OF SUNSHINE GARDENS, AKURE NIGERIA.**

**Ojo, A.M. and Ijatuyi, O. O.**

#### 2.1 SUNSHINE GARDENS, OBA ILE

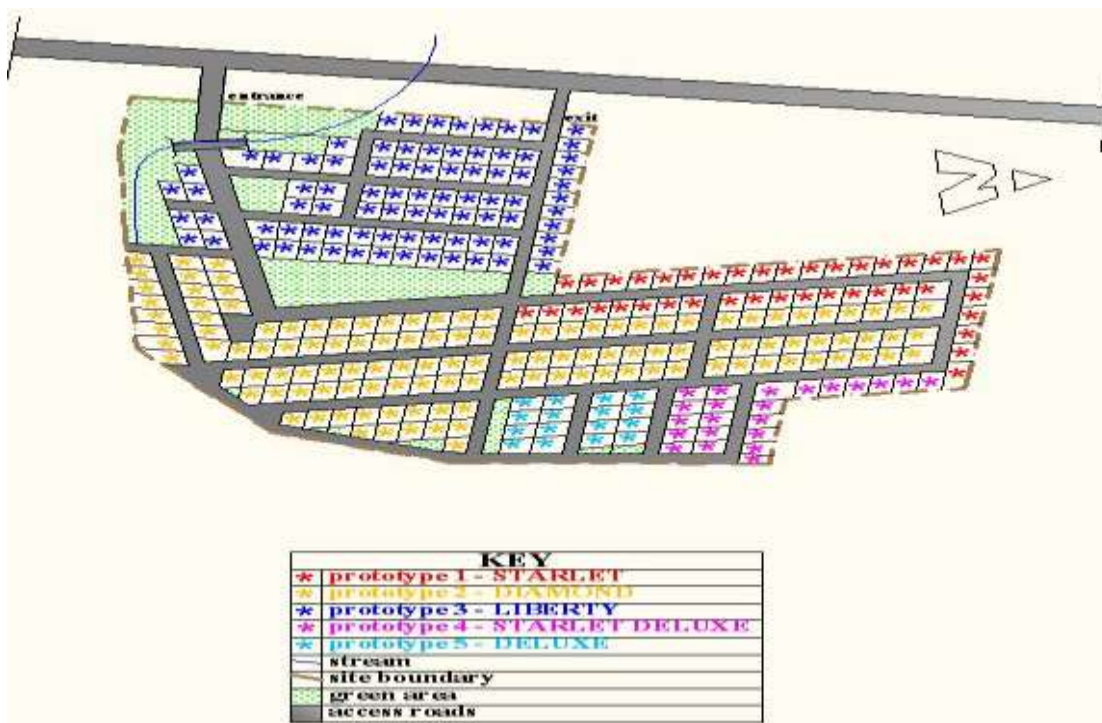
Figure 1: Site layout and prototypes

The site layout is as shown in the figure below indicating the locations of 5 prototypes.

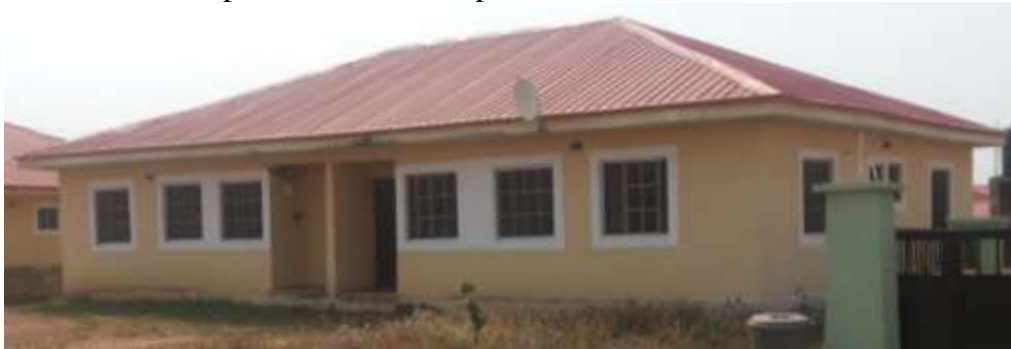
Plate 2: Starlet View

This is a semidetached bungalow, with two bedrooms, one bathroom, one toilet, living room, dining and kitchen with a small terrace. 32 buildings are already completed, most of which have been purchased and occupied; 2 are under construction.

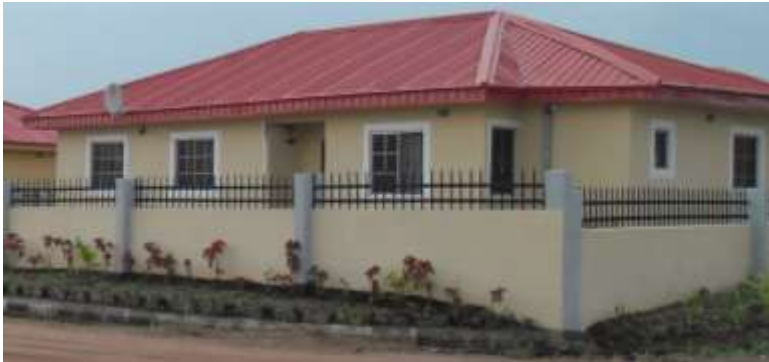
Plate 3: A view of prototype Diamond  
*Source: Researchers' Field Survey, 2013*

This is a detached 3-bedroom bungalow, with one bedroom en-suite, one toilet, one bathroom, living room and kitchen with a small terrace. 106 buildings have been completed, most of which have been purchased and occupied.

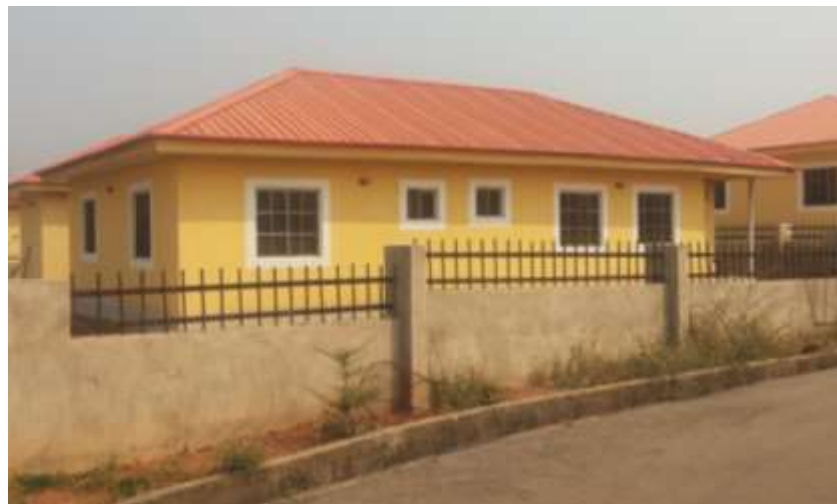
Plate 4: A view of prototype Liberty  
*Source: Researchers' Field Survey, 2013*

This is a detached 3-bedroom bungalow, with all bedrooms en suite, a visitor's toilet, lounge, dining and a kitchen with a small terrace. Over 78 buildings have been completed on site with many purchased and occupied, and with 7 under construction.

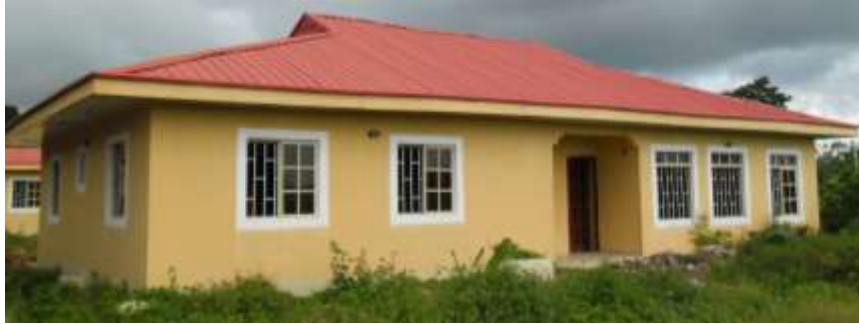
Plate 5: A view of prototype Starlet Deluxe

This is a detached 3-bedroom bungalow, with all bedrooms en suite, one of which is a guest room. Additional spaces include an ante room and visitor's toilet, a large lounge, a distinct dining, and a kitchen with a store and sizeable terrace. 7 of these prototypes have been completed with one under construction.

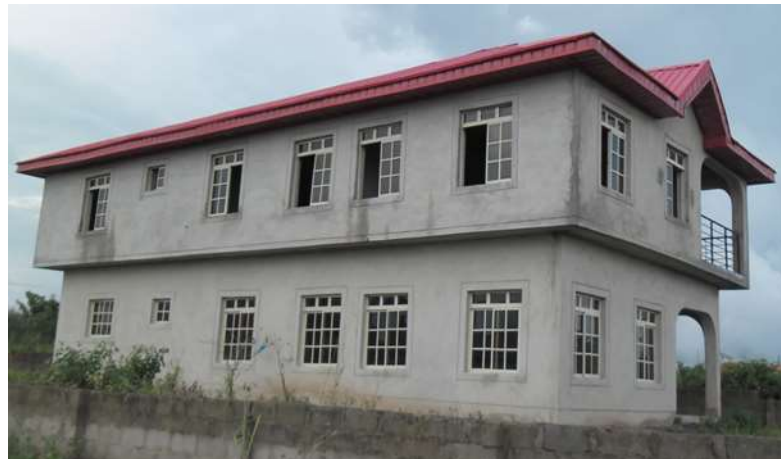
Plate 6: A view of prototype Deluxe

This is a detached duplex with a large entrance porch, ante room, visitor's toilet, large living room, en suite guest room, kitchen and store. The first floor provides spaces for a family lounge, two en suite bedrooms, and a master bedroom with a walk-in closet, bathroom, and terrace. According to the site architect, intending buyers are not satisfied with the simplicity of the design. This explains the reason only one of this prototype has been built so far.
