## **A DOCUMENTATION OF OYO COLONIAL PERIOD FROM THE LENS OF ARCHITECTURE: THE CASE OF APITIPITI AREA OF OYO TOWN**

**Sogbesan Oluwatoyin, & Odunlami Oludare**  
Ajayi Crowther University Oyo,

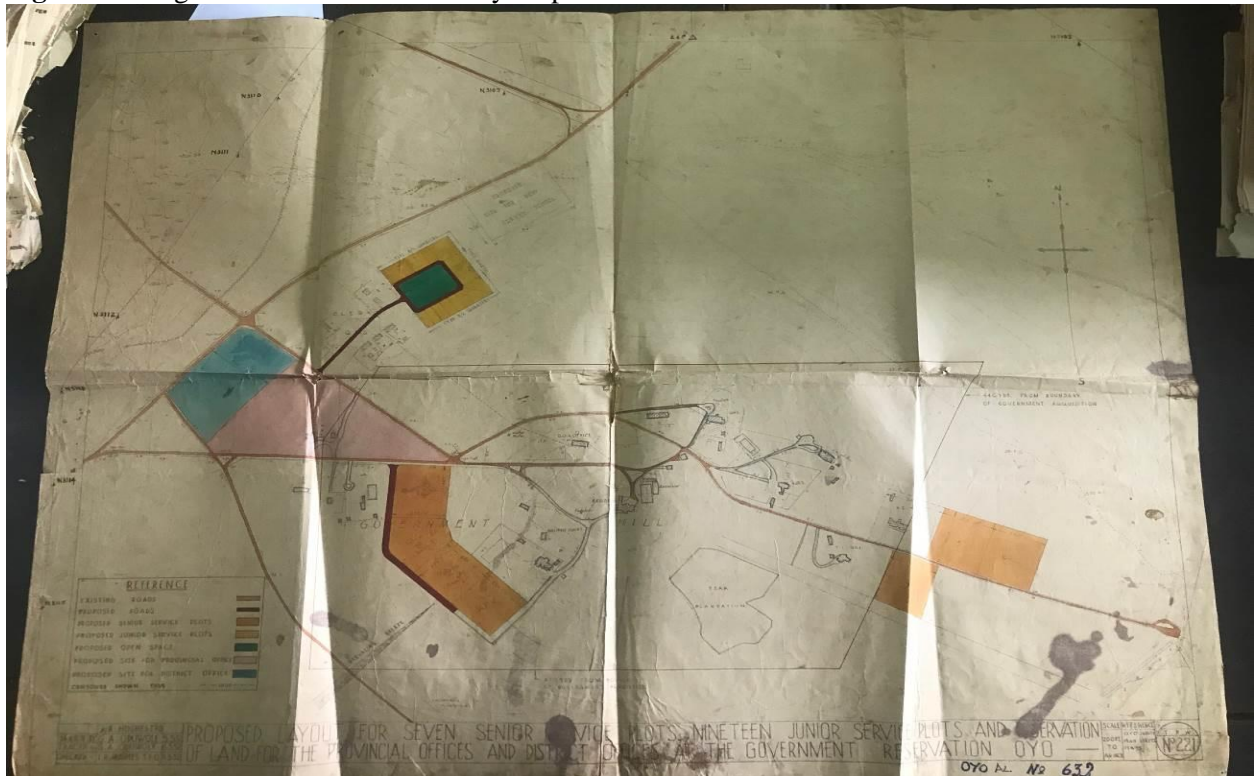
**Fig 4:** Revised layout showing proposed plot for seven senior service plots, nineteen junior service plots and reservation of land for the provincial offices and District Offices at the Government Reservation Oyo.

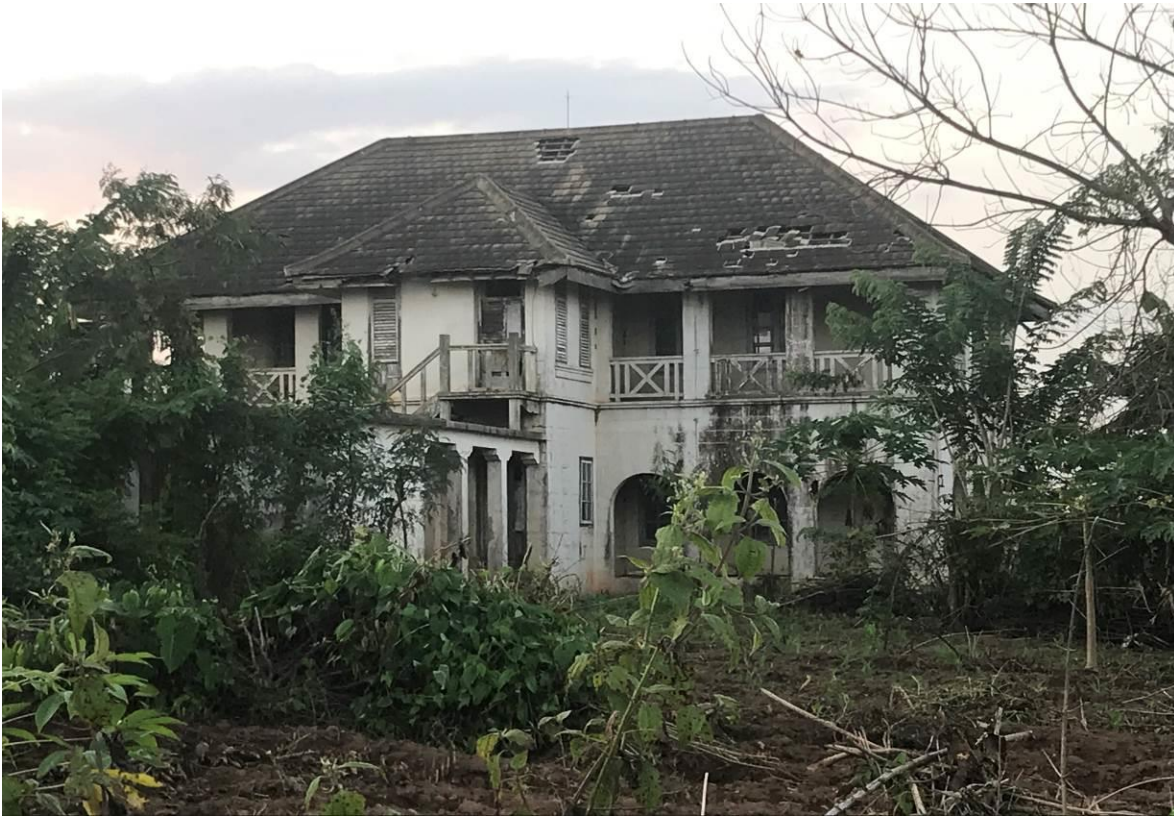
**Fig 5:** Showing one of the storey building used by the District Officer during the Colonial era. (Photo by author)

The buildings over time have been put to different uses from what they were constructed. For example, the story building used by the District Officer has been converted to Local Community Development Authority (LCDA). Some renovation and partitioning have been done with plywood to make out office spaces for various personnel's. The other two are still in their original state unoccupied but left to ruin. Most of the residential quarters are used as farm sheds because they are unoccupied. One of the senior staff quarter is now used as poultry. Another is used as a community club and an annex to the LCDA office. Few of the structures are used as residents while majority are used as farm sheds by farmers who have utilized the surrounding grounds for cultivation of vegetables. By and large, a large percentage of the structures are in dire need of restoration.

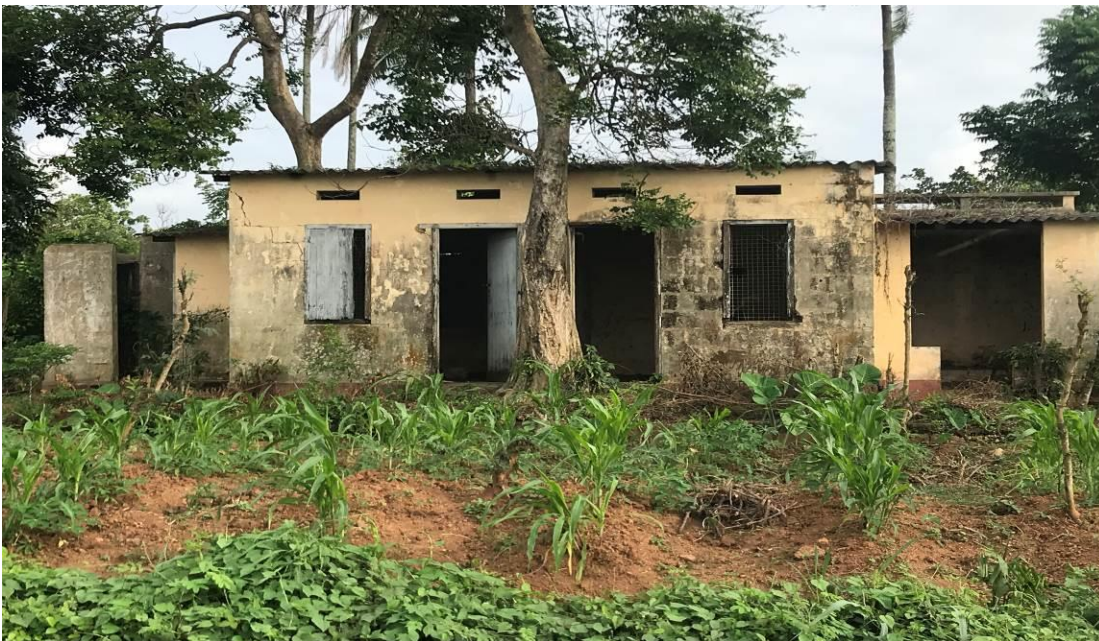
**Fig 6:** Showing a 2-room type of domestic staff quarter. (Photo by author)

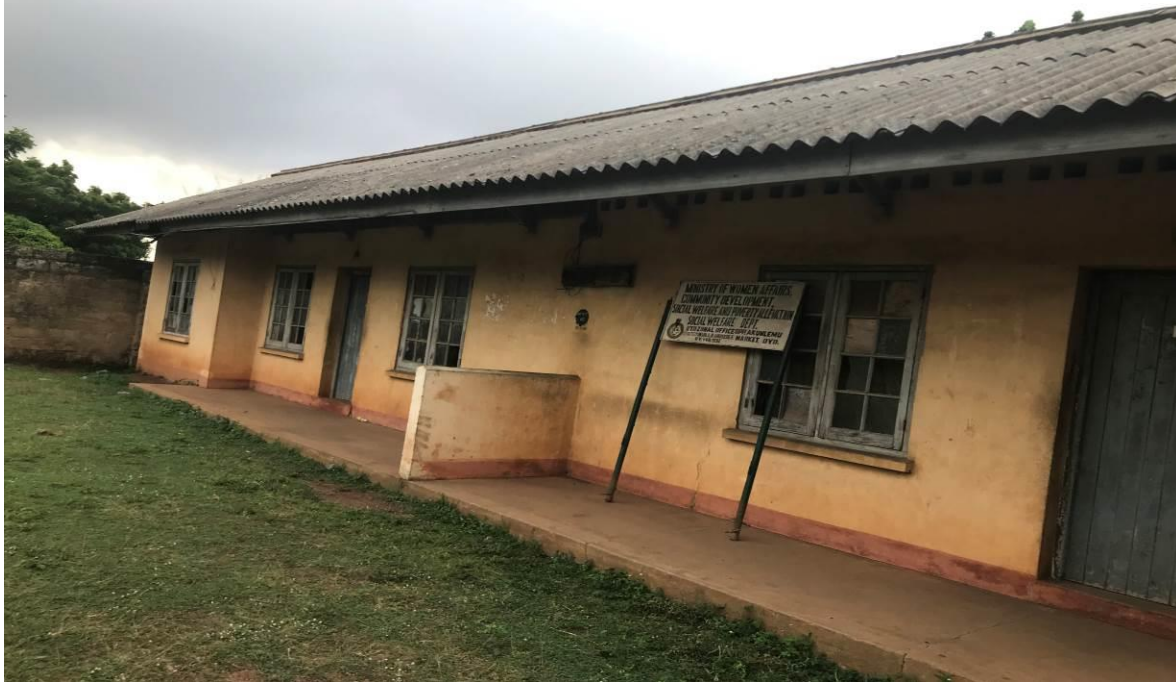
**Fig 7:** Showing a semi detached 2 bedroom junior staff quarter. (Photo by author)

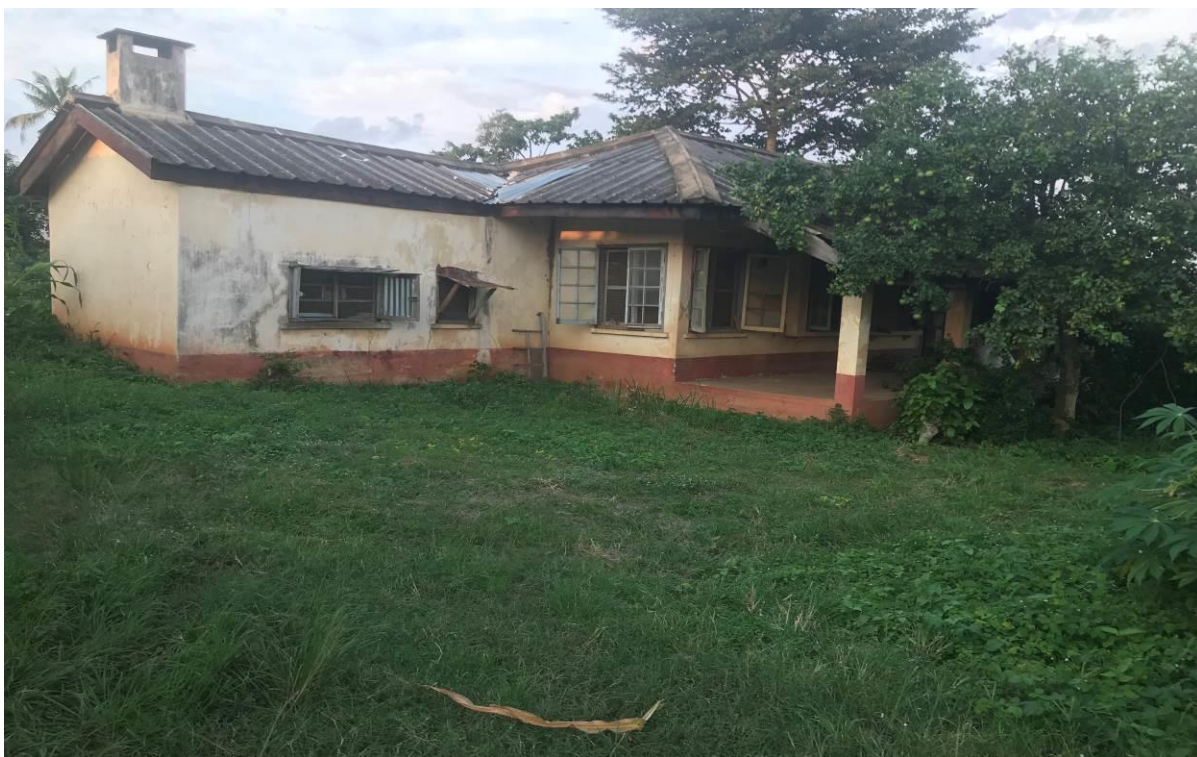
**Fig 8:** Showing Type A Senior Staff Quarter. (Photo by author)

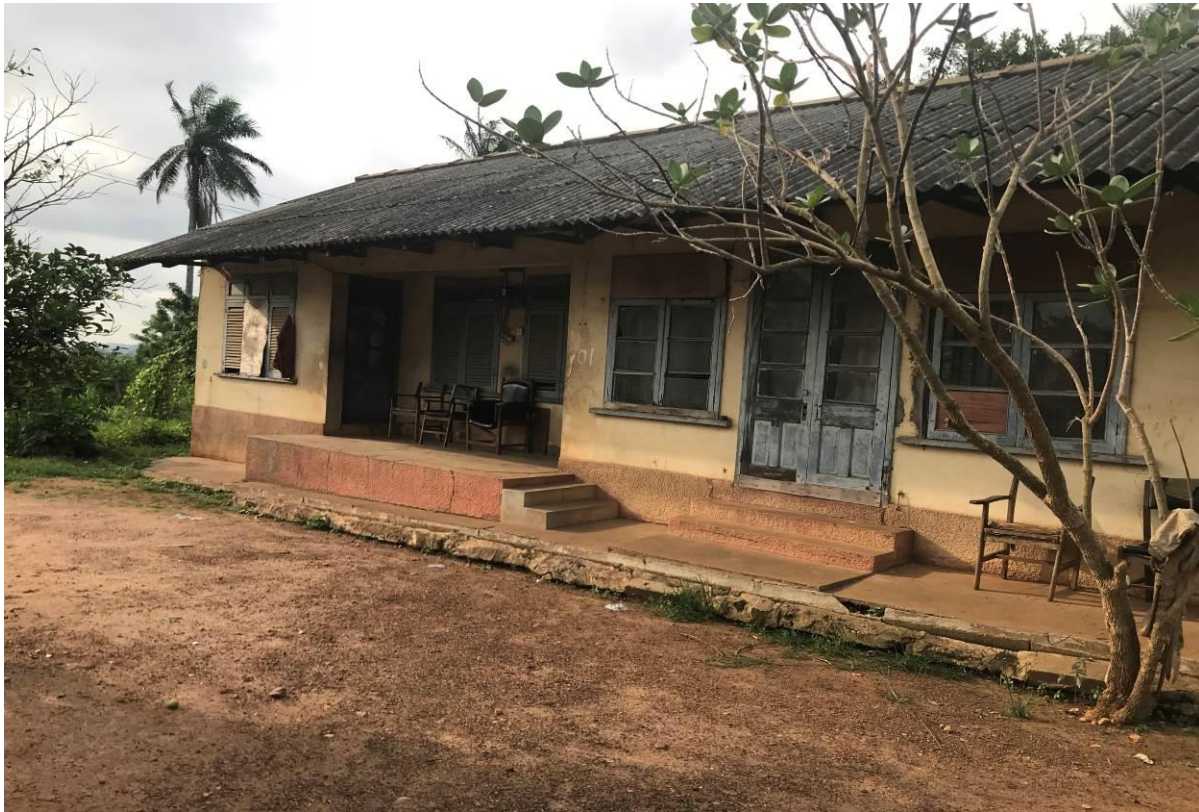
**Fig 9:** Showing Type B Senior Staff Quarter. (Photo by author)

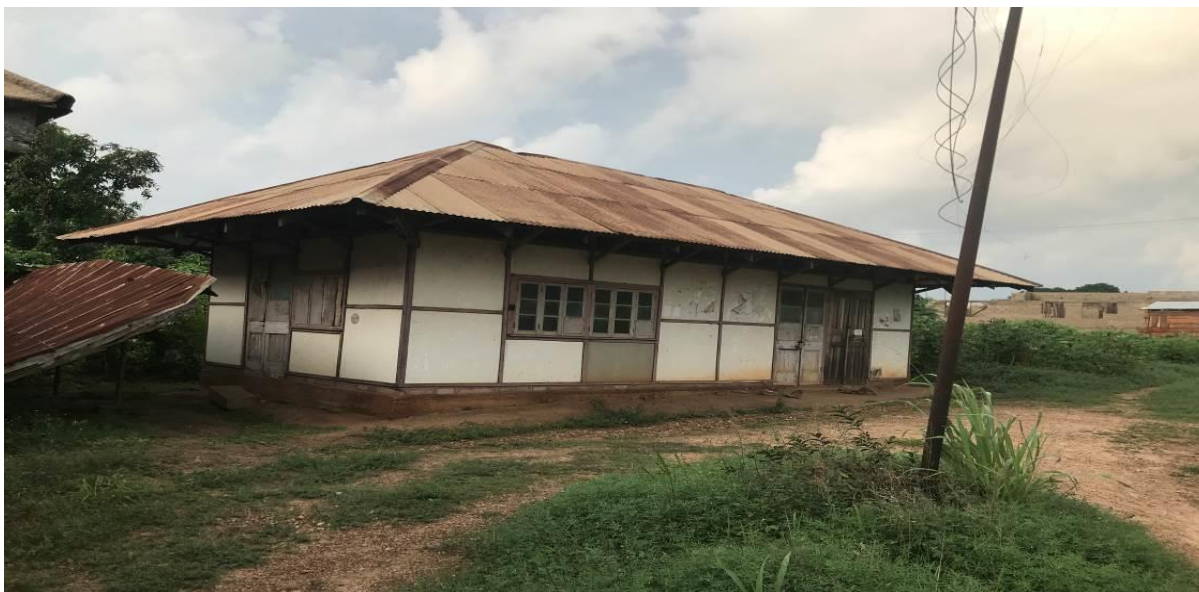
Fig 10: Showing Office constructed using Asbestos. (Photo by author)
