MATERIAL COMPATIBILITY IN CONSERVATION OF TRADITIONAL EARTH BUILDING IN NIGERIA (CASE OF ORIGBO COMMUNITIES IN OSUN STATE IN SOUTH-WEST OF NIGERIA).

Akinkunmi, Olukunle Joel

KEYWORDS: Earth Building, Conservation, Deterioration, Material Compatibility.

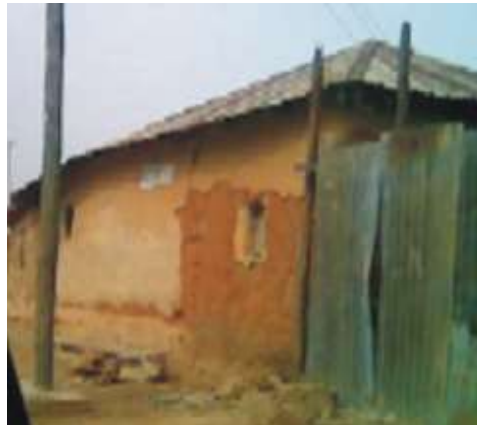
Figure 1I showing the peeling-off of Portland Cement Coat on traditional earth building at the study area.

When the wall of earth building is laid on ground, the capillary rise is easily observed because the wet surface is darker than the dry wall. Water rises inside the pure system until an equilibrium is established when the amount evaporated from the surfaces which keeps increasing and the wet surfaces are extended, balances the water uptake from the soil. The inclusion of cement stabilizer prevents the evaporation of water, the prolonged dampness causes the earth to be weakened and cement plaster coat gradually separated and peel off.

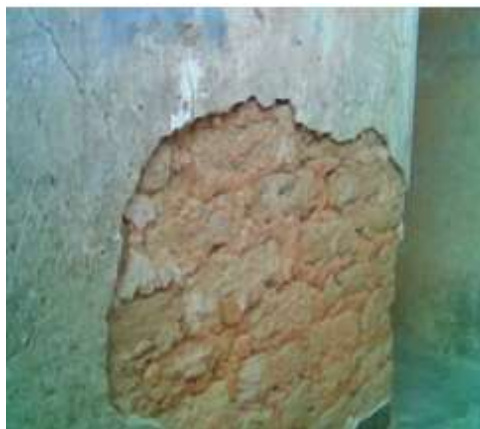
Figure III showing the weakness of Portland Cement Coat on traditional earth building.

- (iii) Because of its high strength, it lacks elasticity and plasticity when compared with earth, thus throwing greater mechanical stress on earth and hastening their decay.
- (iv) Cement is impermeable and has low porosity, so it traps vapour as well as water and prevent evaporation. Consequently, it is no good for curing damp earth walls.
- (v) Cement shrinks on setting, leaving cracks for water to enter and because it is impermeable, such water has difficulty in getting out. Therefore, it increases defects caused by moisture.
- (vi) Cement produce soluble salts on setting which may dissolve and damage porous materials and valuable decoration (Leroy, 1996, Bernard, 2003, Giorgio, T. 2009).

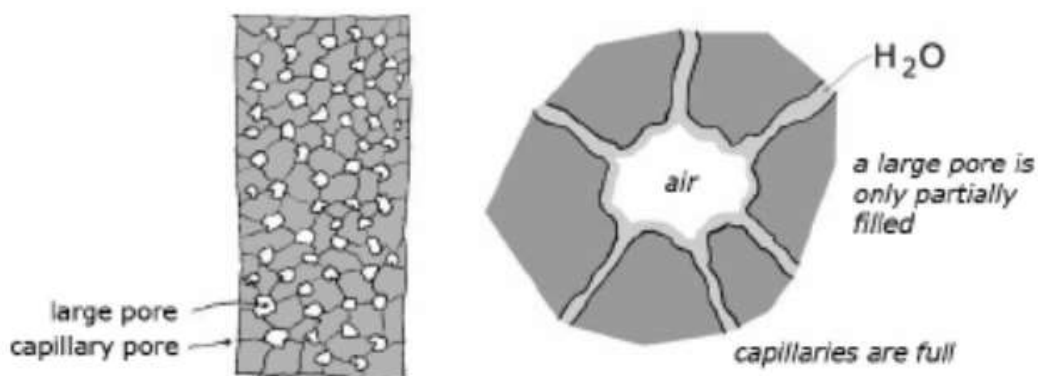
Figure: IV Showing the pore of the earth structure

The pores in porous earth building materials have variable dimensions and shapes (Figure, IV). This normally represented in a simplified model assumed to be cylindrical tube whose diameter roughly designated as large pores of larger than $10\mu\text{m}$ or capillary pores of diameter between 1 and $0.1\mu\text{m}$ (Matthew, et al. 2013).
