CHARACTERISATION OF MORTAR DETERIORATION IN HISTORIC BUILDINGS IN BAGAMOYO, TANZANIA

Charles Lucian

Ardhi University (ARU), P.O. Box 351761, Dar es Salaam, Tanzania

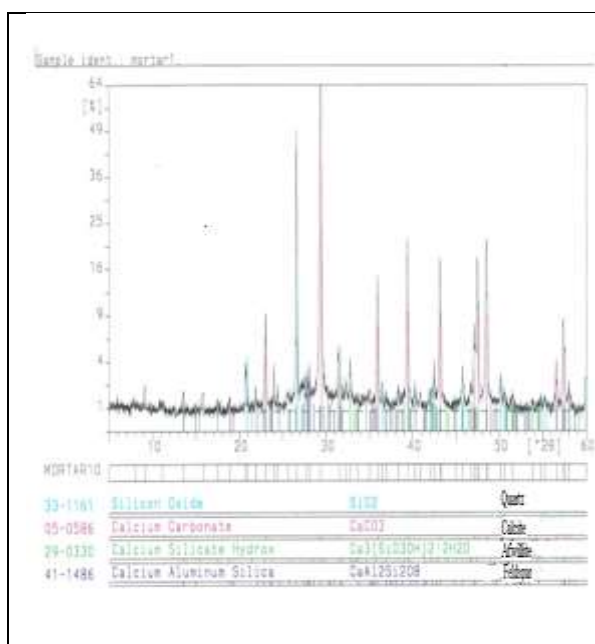
Figure 8: X-ray diffractogram showing the peaks attributed to the calcite, quartz and feldspar.

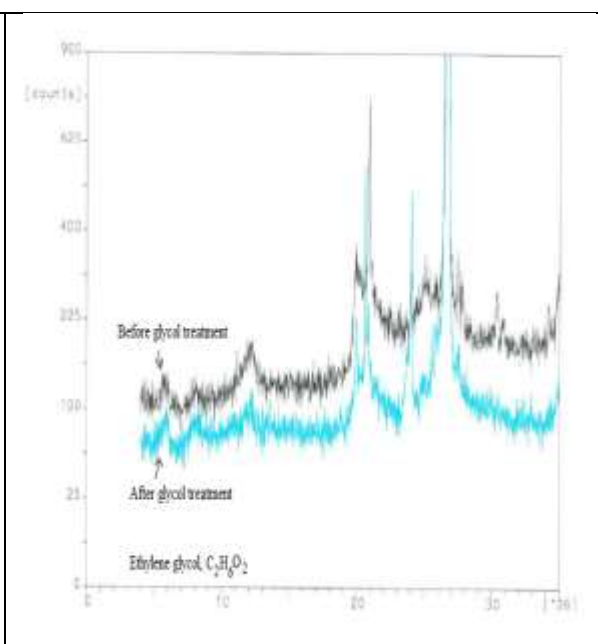
Given the observation made in previous studies that examined the structural composition of building materials at the site, all historic buildings were constructed of similar building materials. That is coral stone in lime mortars hence differences in damages or deterioration results from other factors such as maintenance rather than presence of expandable chemicals. Thus expandable chemicals were not considered as a reason for damages on construction elements of the Bagamoyo building heritage site.

Figure 9: X-ray diffractogram showing peaks before and after treatment with ethylene glycol
