EXPERIMENTAL INVESTIGATION AND FINITE ELEMENT ANALYSIS FOR SOLVING VERTICAL PUMPS STRUCTURAL WEAKNESS

Sami A. A. El-Shaikh

Mechanical & Electrical Research Institute, National Water Research Center, Ministry of Water Resources & Irrigation, Delta Barrage, Egypt

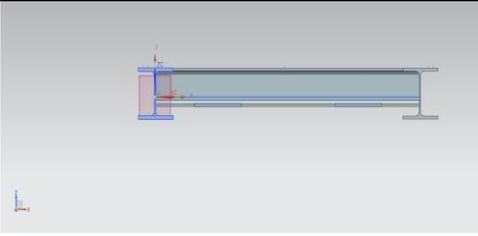
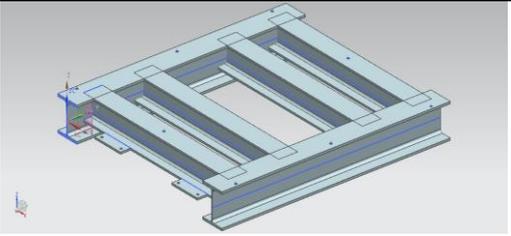
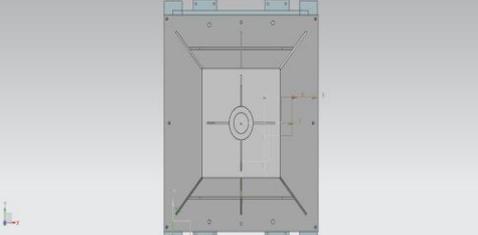
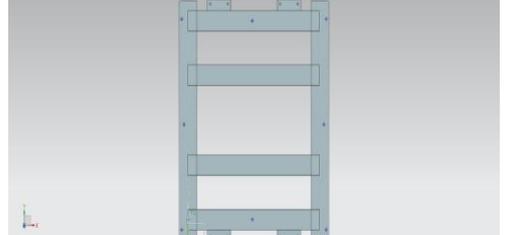
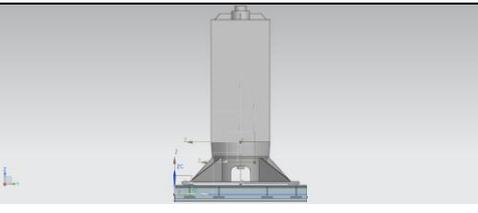
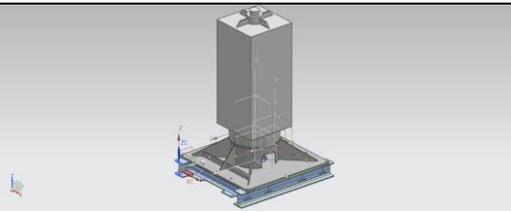
Figure (7-e) "Foundation with motor and pump side"	Figure (7-f) "Foundation with motor and pump isometric"
Figure (7) "Foundation modification "showing the required base drawing to be fabricated"

The model consists of a motor weighing 8700 kg, a steel base, and a concrete foundation. The motor is assumed to be rigid over the frequency range of interest. Concrete is assumed to be a homogeneous and isotropic material and to behave in a linear elastic manner. The mechanical properties of the concrete are assumed to be (Modulus of elasticity: 32 GPa, Poisson's Ratio: 0.2, and Weight density: 2400 kg/m³). Steel is assumed to be a homogeneous and isotropic material behaving in a linear elastic manner. The mechanical properties are assumed to be (Modulus of elasticity: 200 GPa, Poisson's Ratio: 0.3, Weight density: 7800 kg/m³). A simple geometrical structure was selected and used to simulate the unconstrained condition using solid elements. When a 3D model of solid volumes is generated, solid modeling is generally more convenient compared to direct generation. Solid modeling is tedious and too much time consuming. A solid model in ANSYS is built from the bottom up by creating key points. They represent the model vertices. They are used to define higher order entities such as lines, areas, and volumes. The boundary conditions assumed that the concrete foundation is fully clamped, as shown in **Figure (7a, 7b, 7c, 7d, 7e, and 7f)**.

A simulation was done by the theoretical program to solve the problem that leads to decreasing the level of vibration, enhancing the characteristics of operating pumping station condition. The theoretical program indicates to add Stainless steel supports of motor foundation. Stainless steel support was manufacturer by a certain thickness and height and then, vibrations measurements was repeated again and doing analysis for the results. Modal Shape for motor, and motor foundation before adding support, are shown in **Figures (8a, 8b, 8c, 8d, 8e, and 8f)**.
