FRACTOGRAPHY OF FAILED AUTOMOBILE ABSORBER SPRINGS

¹Peter Odesanmi Ojo, and ²Olanrewaju Retime Bodede ^{1,2}Department of Mechanical Engineering Technology Rufus Giwa Polytechnic, Owo. Ondo State.

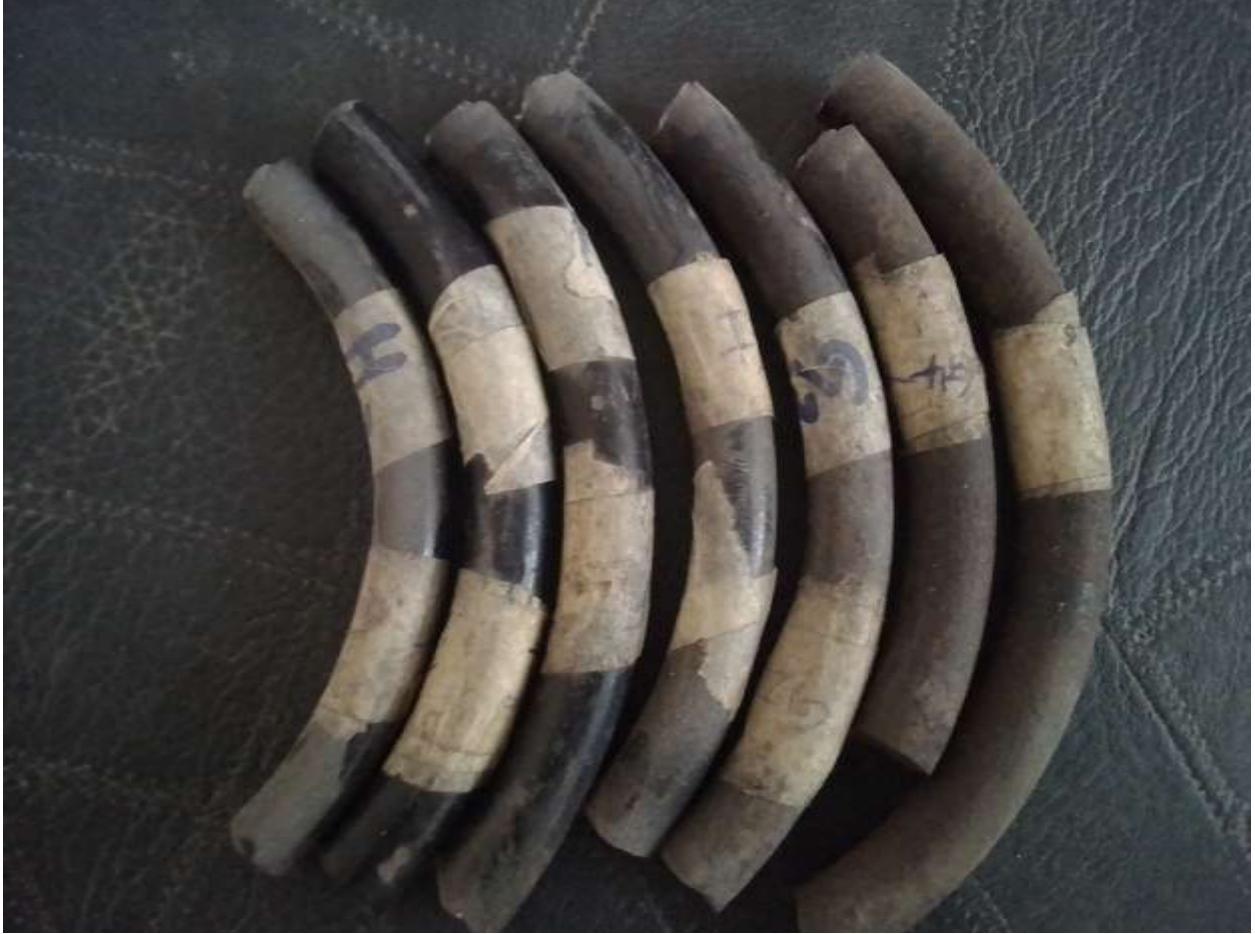
Plate 2: Samples of Prepared Absorber Springs

Samples of failed absorber springs namely F1, G1, H1, I1, J1; F2, G2, H2, I2, J2; F3, G3, H3, I3, J3 and F4, G4, H4, I4, J4 were cut into pieces with a cutting disc and prepared as follows (see plate 2)
