Evaluation of Architectural and Other Safety Measures Against Bomb Blasts in Market: An Avenue to Improve Security in Nigeria

Citation: Odaudu U.S., Ekule A.A., Idachaba M.K., Nuhu A.A., and Abdul C.I. (2022) Evaluation of Architectural and Other Safety Measures Against Bomb Blasts in Market: An Avenue to Improve Security in Nigeria, International Journal of Engineering and Advanced Technology Studies, Vol.10, No.3, pp.68-82

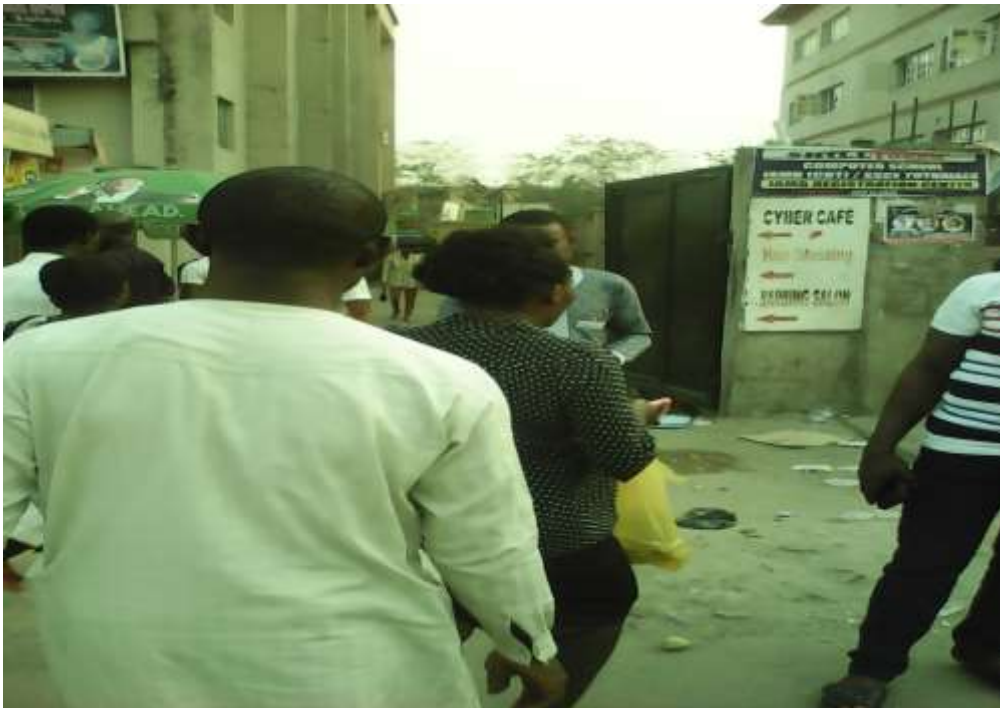
It was revealed via the focus group discussion with the participants (buyers) that the entire landmass of the market is fenced. However, the observation showed that the fence walls are made up of sandcrete blocks without burglary proof design on some parts of them and also, the market gates have no burglary wire on them to resist the bombers from jumping over them. Plate I shows one of the exit gates of the market without burglary wire or any other security protective device on it. The discussion with the participants showed that all the entrance and exit gates of the market are not bomb detecting type. Observation showed that the market is not landscaped to monitor the movement of bombers; if the bombers can get into the market, it will be easy to attack people. Plate II shows the part of the market without ground cover for landscape.

Plate I: Exit Gate of the Market in FCT without Burglary Wire or any other Security Protective Device on it (Source: Researchers' Field Work, 2020).

- i. Adequate architectural design against bomb blasts should be provided in the markets.
- ii. The fence walls of markets should be made up of stones or reinforced concrete blocks with a complete burglary proof design on them to resist the bombers from jumping over them.
- iii. The market gates should have burglary proof design on them to resist the bombers from jumping over them.
- iv. All the entrance and exit gates of the markets should be bomb detecting type.
- v. Markets should be landscaped to monitor the movement of bombers.
- vi. Car parking spaces should be defined in the markets to reduce indiscriminate parking of cars in any available space, in order to properly check the activities of bombers.

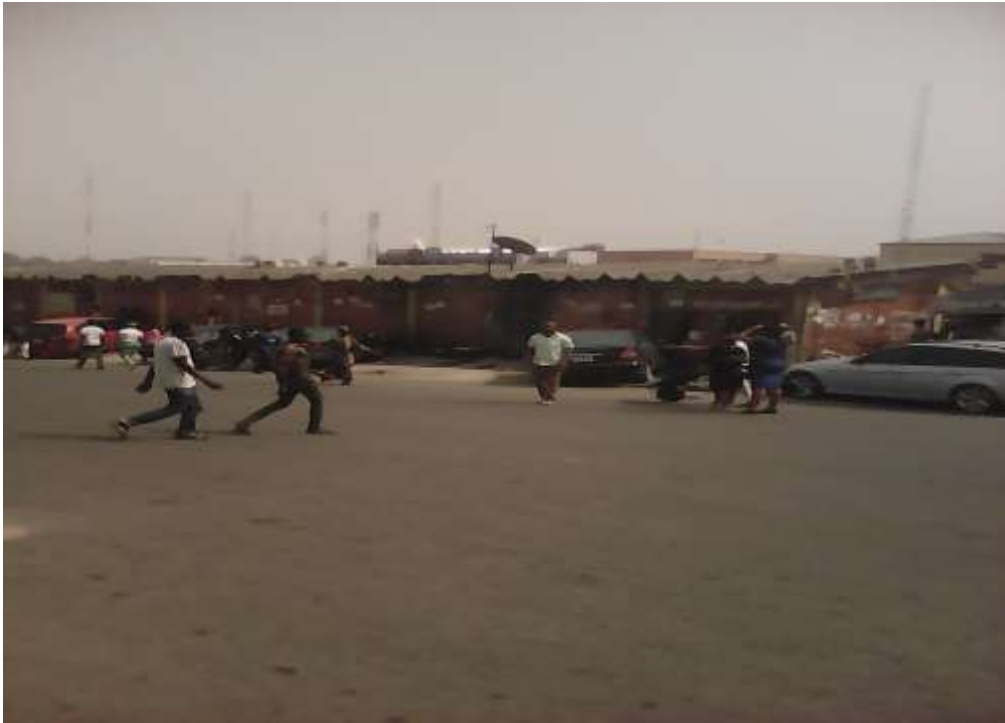
Plate II: Part of the Market in FCT without Ground Cover for Landscape (Source: Researchers' Field Work, 2020).

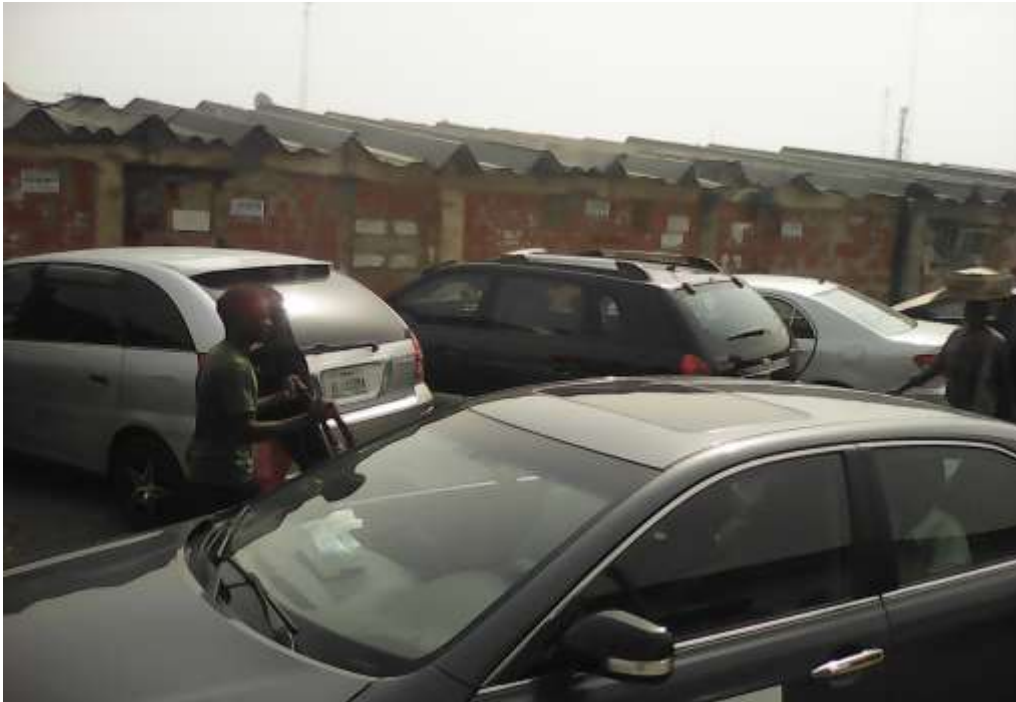
Observation showed that car parking spaces are not defined in the market and as a result of this problem, people park cars indiscriminately in any available space. In this case, there is poor security check against bomb blasts because the bombers can use this opportunity to bomb the market. Plate III shows indiscriminate parking of cars closed to the lock-up shop buildings in the market. Observation also showed that the buildings in the market are made up of sandcrete block walls; this type of wall can easily collapse when there are bomb blasts on it and this is because it has been stated by Pe (2017) and National Academies Press (2003) that through effective structural design the overall damage levels may be reduced to make it easier for people to get out of building environment in time of explosions. Moreover, it was observed that the spaces between buildings range from two metres to four metres in some areas of the market. When there is a bomb blast on one building in this case, the probability of the nearby buildings to damage is significantly rated high. Plate IV shows the lock-up shop buildings in the market with inadequate spaces between them.

Plate III: Indiscriminate Parking of Cars Closed to the Lock-up Shop Buildings the Market in FCT (Source: Researchers' Field Work, 2020).

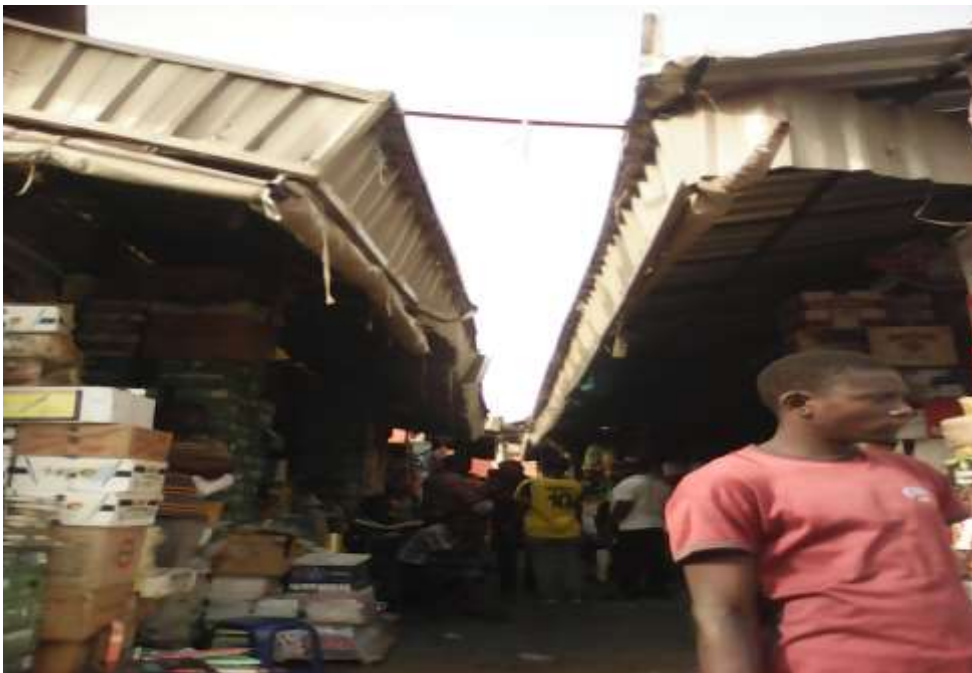
Plate IV: Lock-up Shop Buildings in the Market in FCT with Inadequate Spaces between them (Source: Researchers' Field Work, 2020).

- vii. Buildings in the markets should be made up of stones or reinforced concrete block walls, so that in case of bomb blasts, they can considerably withstand their effects on them.
- viii. Adequate spaces of at least eight meters between market buildings should be provided at the design stage of markets, so that in case there is a bomb blast on one building, the probability of the nearby buildings to damage will be low.
- ix. Adequate road networks should be provided at the design stage of markets to reduce traffic congestion that can create chances for the bombers to release explosions in such condition.

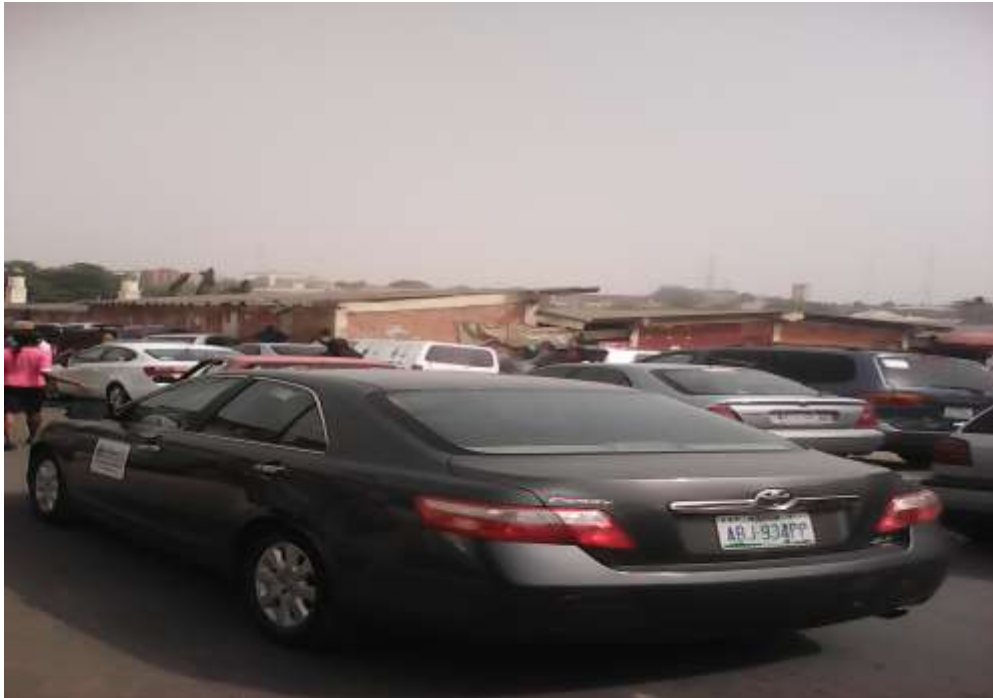
In addition, it was seen that there are no adequate road networks in the market; this issue is leading to traffic congestion in the market. In this case, there is a chance for the bombers to release explosions in the midst of traffic congestion in the market. Plate V shows a traffic congestion in the market.

Plate V: Traffic Congestion in the Market in FCT (Source: Researchers' Field Work, 2020).

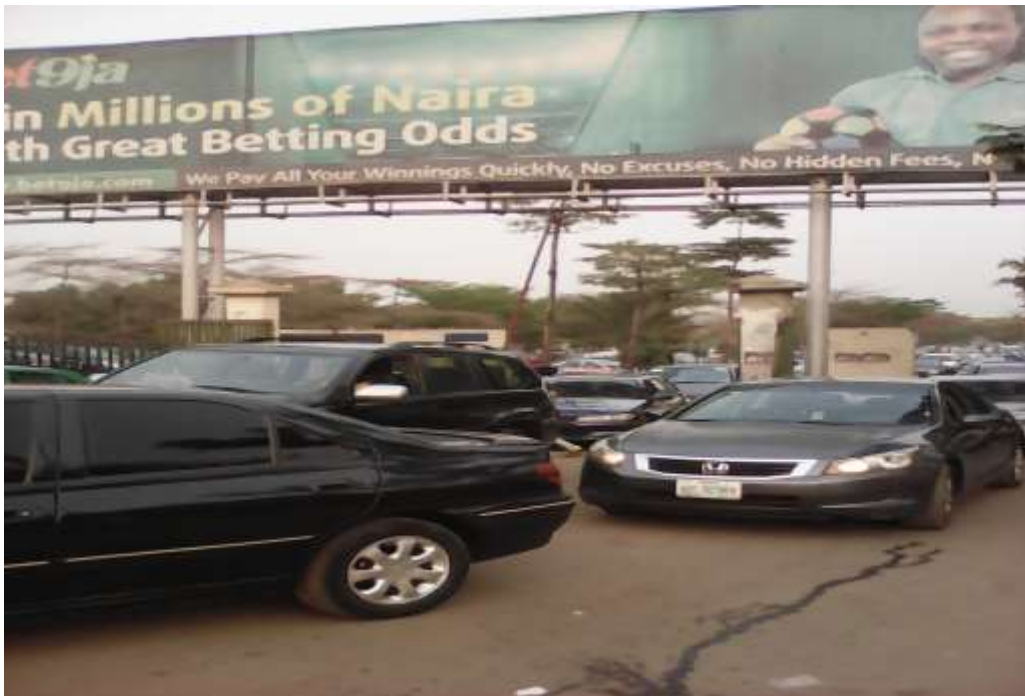
Observation revealed that the incoming vehicles to the market are not well checked against bomb blasts as vehicles gain access into the market indiscriminately. Plate VI shows the incoming vehicles to the market without a proper check against bomb blasts.

Plate VI: Incoming Vehicles to the Market without a Proper Check against Bomb Blasts (Source: Researchers' Field Work, 2020).

- i. The government of Nigeria should provide adequate security gargets against bomb blasts in the markets.
- ii. The government of Nigeria should provide adequate security personnel against bomb blasts in the markets.
- iii. The security personnel should be properly checking the incoming vehicles to the markets against bomb blasts.
