Improving Indoor Air Quality in Condominiums Through Green Architecture

CASE STUDY ONE: Titanium Towers, Ikoyi, Lagos

CASE STUDY TWO: 1004 Estate, V.I., Lagos

CASE STUDY THREE: Eko Courts, V.I., Lagos

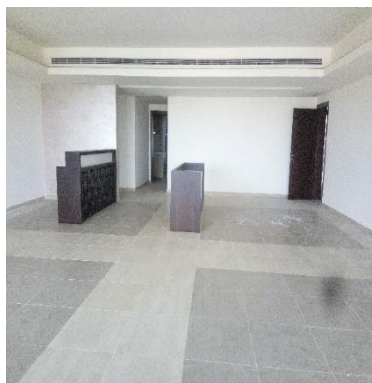
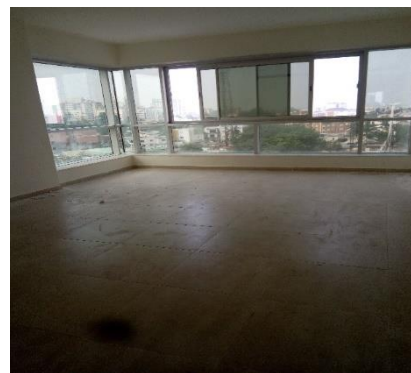
Plate 3 & 4: interior view of the building

concentration of contaminants can easily increase hereby leading to IAP. Most of the building interior finishes (paint) emit VOCs into the interior and as such contribute to IAP. There are leakages in the basement. This increases the relative humidity of the spaces and high humidity encourages the growth of molds on walls and furniture. Release of the spores into the air can endanger the health of the occupants.

Also, attention should be paid to sustainable materials for interior finishes and furniture with particular emphasis on materials that do not contribute to indoor air pollution.

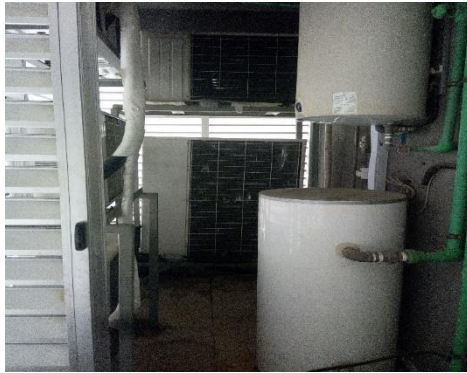
Plate 5: HVAC system

1. Structurally sound building achieved through the use of durable materials and framed construction system.
2. Good interior finishes and internal arrangement
3. Aesthetic outlook of façade.
4. Presence of landscape elements that could be used to harness the microclimate.
5. High dependency on mechanical cooling systems (air-conditioners)
6. Cross ventilation was not achieved in any of the spaces.
7. Trees, shrubs and grasses are sparsely planted around the building

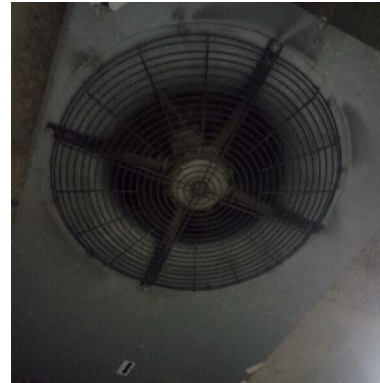
Plate 6: showing vent

S/N	GREEN BUILDING INDEX	FEATURES	COMMENTS
1	Green index	None	
2	Daily energy-saving index	Use of large openings, large swimming pools	serving as passive cooling systems
3	Water resources	Water treatment plant	
4	Biodiversity	none	
5	Carbon dioxide reduction	Fair usage of wood material for furniture though in refined forms	
6	Waste reduction		
7	Base water		
8	Sewage and trash improvement index	Sewage treatment plant	
9	Interior index	Vents

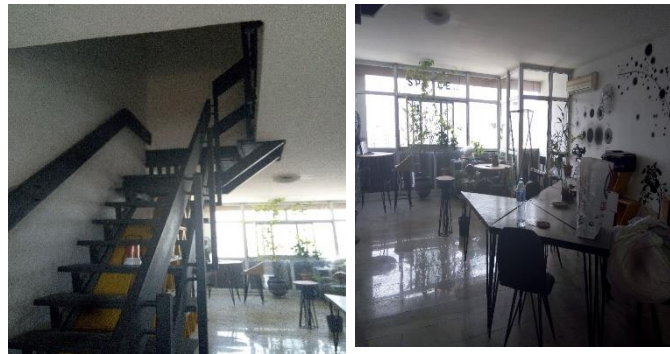
Plate 9 & 10: interior view of an apartment

High humidity in the air led to mold formation on furniture. The building interior is painted with emulsion paint which emits harmful chemicals into the building interior. However, due to the large windows, there is in flow of air into the building hereby leading to the reduction in the contaminant by dilution. Also, there are potted plants in the apartment and on the lobbies which aid reduction of carbon dioxide in the building through the process of photosynthesis.

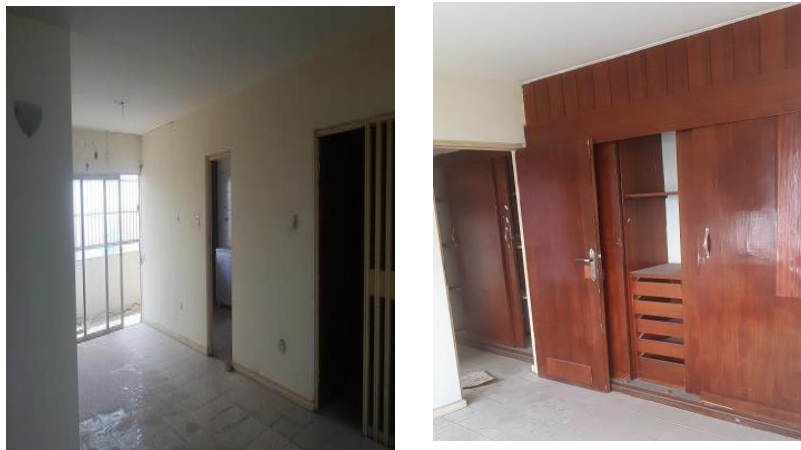
Plate 14 & 15: interior view of an apartment

1. Presence of soft landscape elements
2. Free flowing living spaces
3. Balconies to enhance view and enjoy nature
4. Rooms are not cross ventilated
5. Mold on some furniture and biological growth on walls (sign of poor indoor quality)

Though it is visually imposing, its aesthetic value is very low. The building depends mostly on mechanical ventilation. Passive cooling techniques help improve air quality. Biological growth can be seen on the walls due to poor maintenance of the facility. This can encourage the growth of mold hereby leading to the spread of spores in the air.
